AL-HOCEIMA EARTHQUAKE 24 02 2004

FIELD REPORT

Patrick Murphy Corella *Architect* June 2004

The Al-Hoceima earthquake

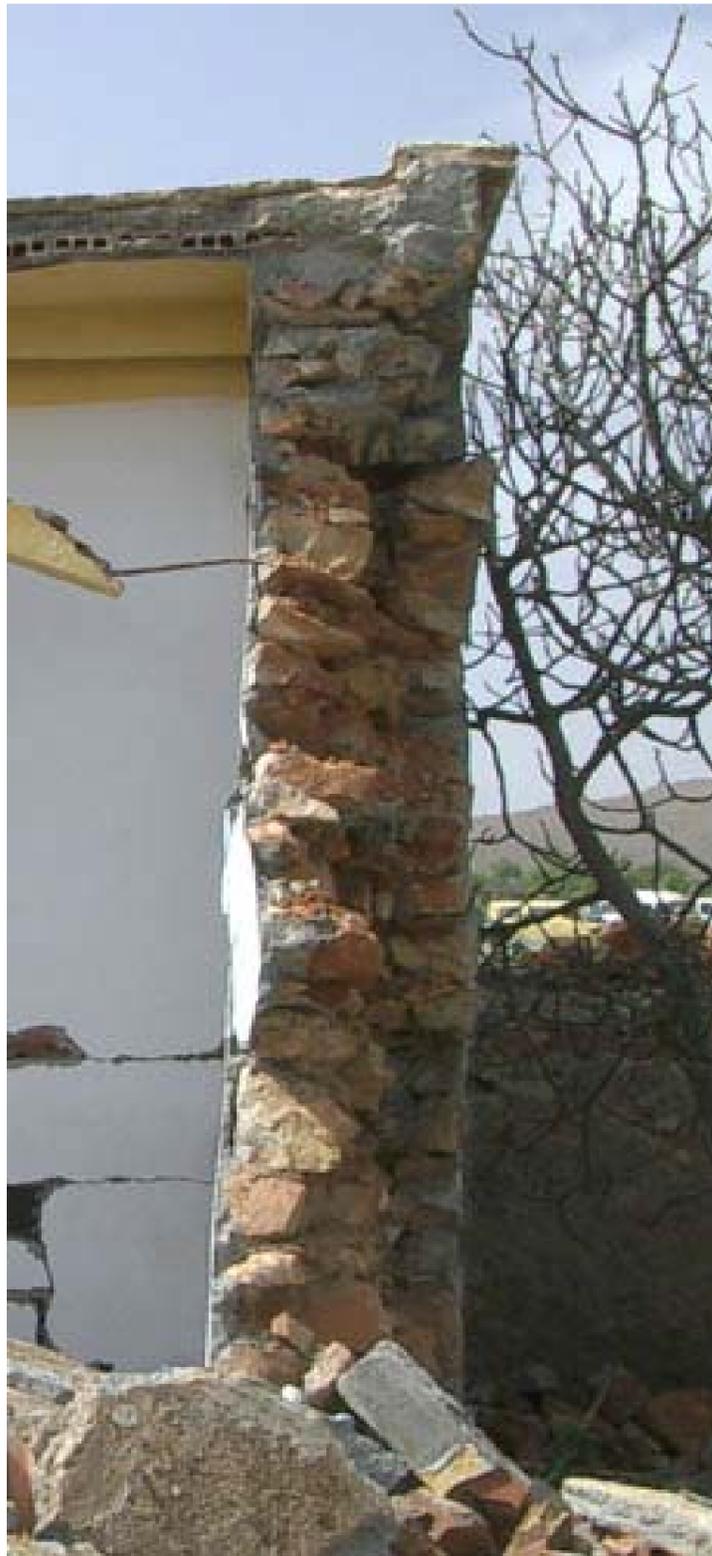
2.1.1 Section through a masonry wall with fieldstone arranged in a weak mortar. The bond is irregular but the stones are sorted to form an internal and external face. With time, the weaker fill material deteriorates resulting in two independent walls.

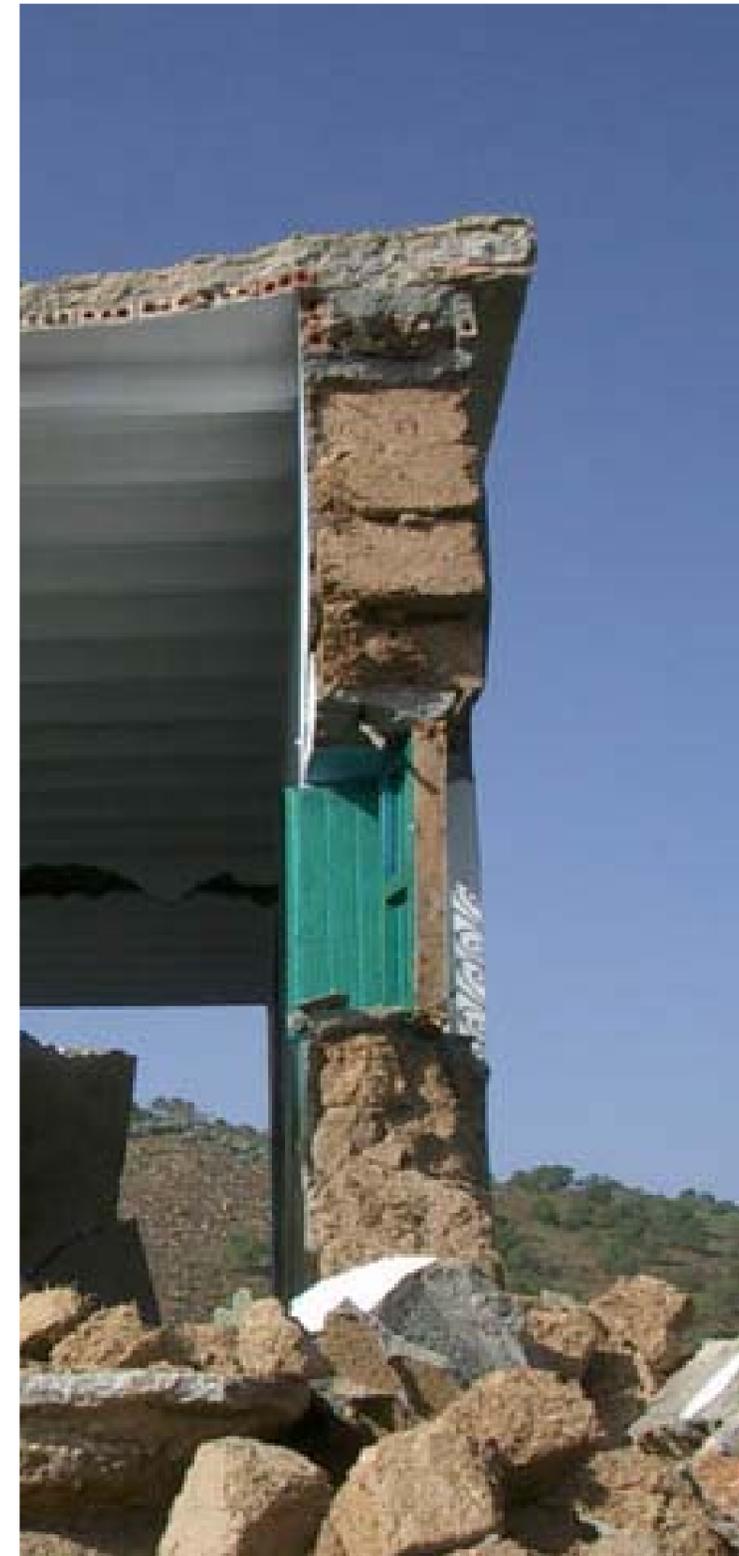
2.1.2 Section through an adobe brick wall with a weak diaphragm roof.

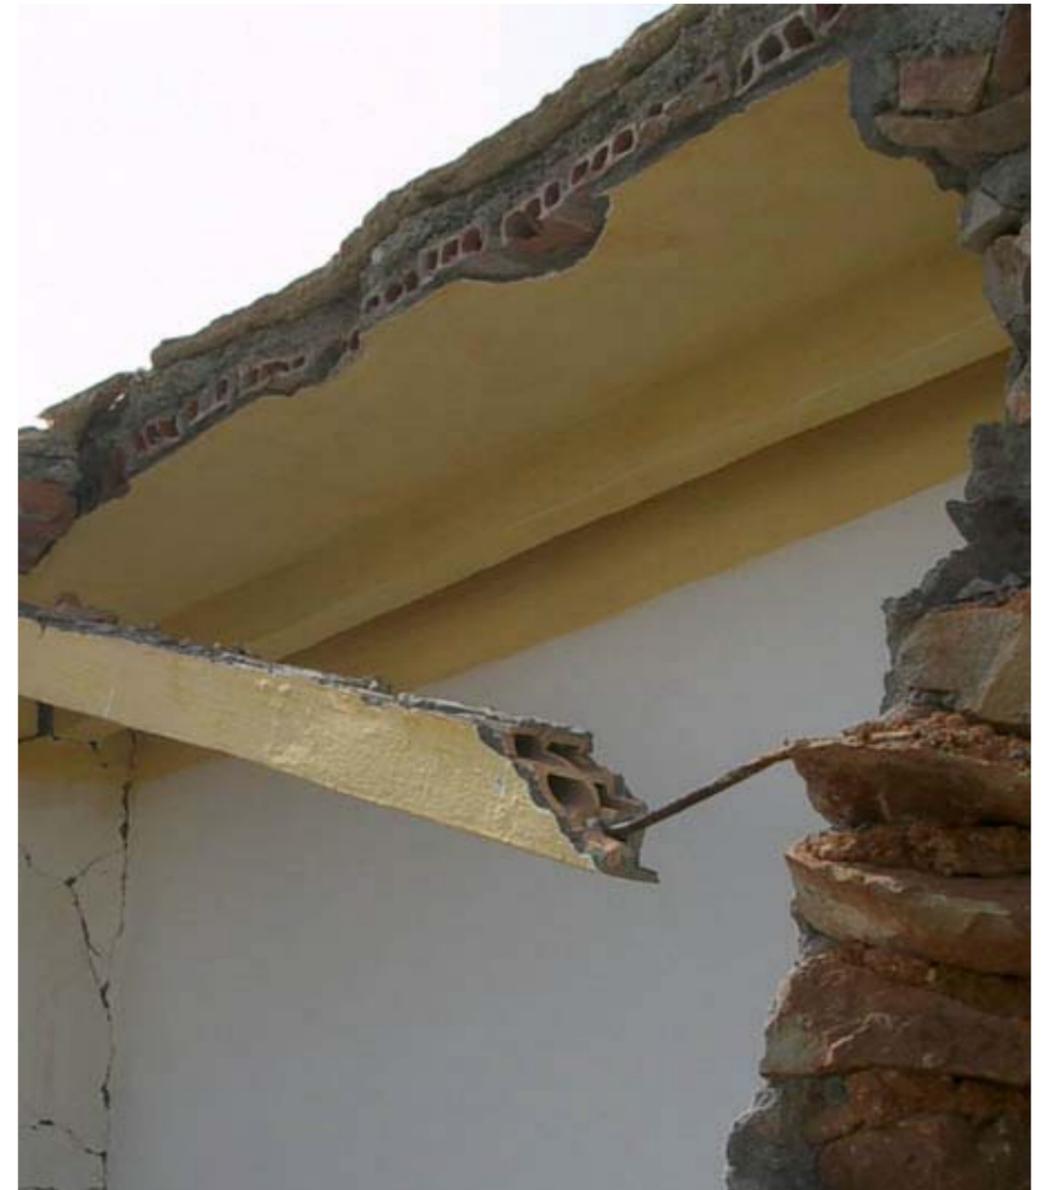
2.3.3 View of a failed 'beam' as detailed alongside.

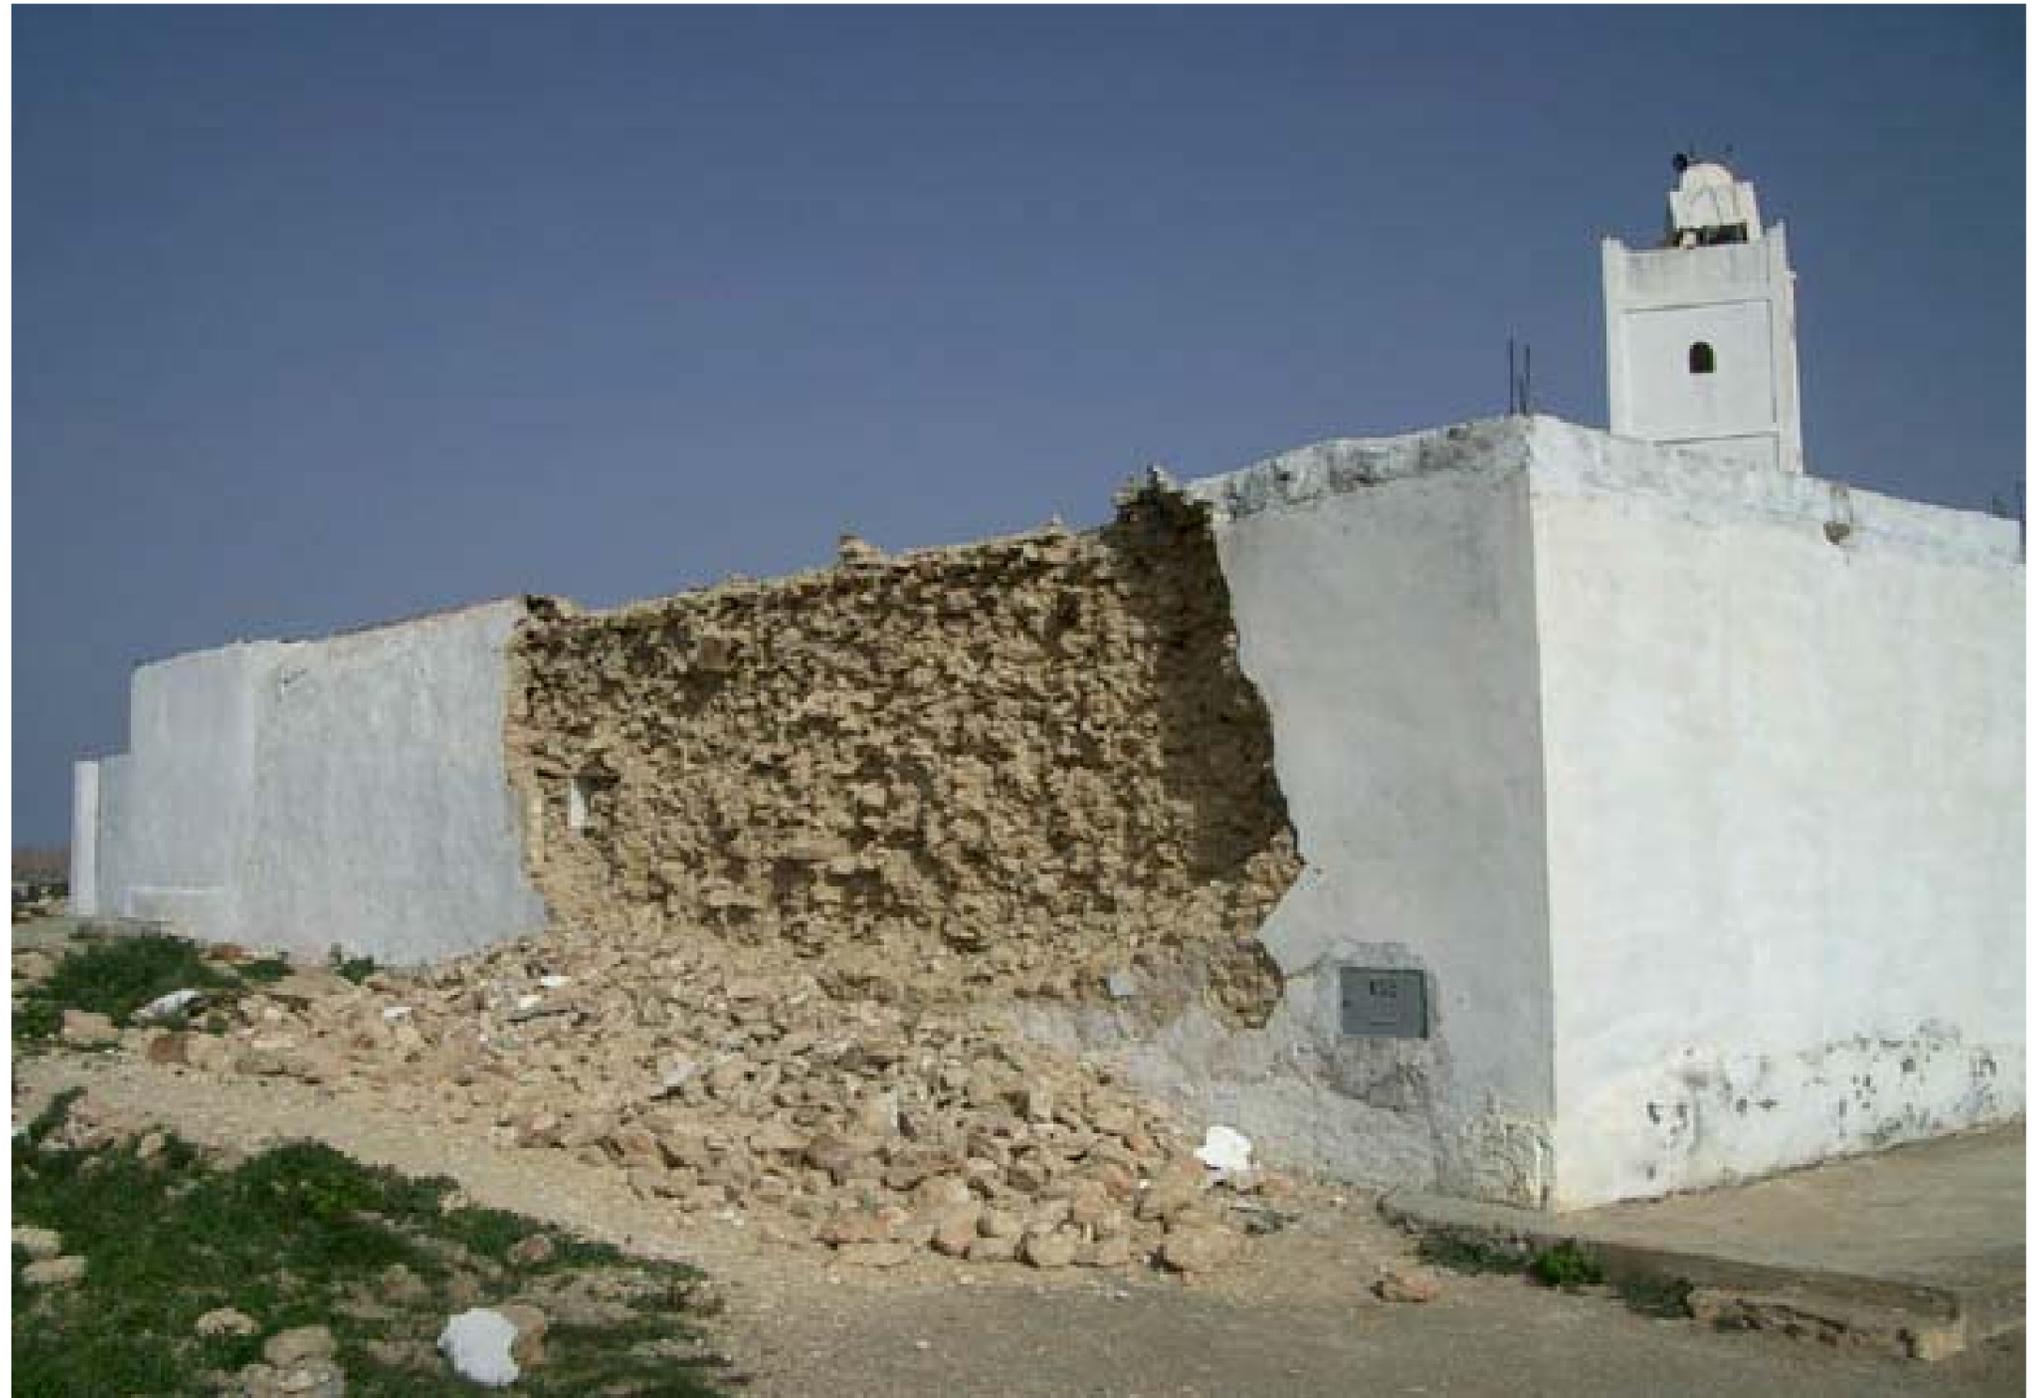
3.2.1 Loss of the external wall of this masonry loadbearing wall in a mosque in Izemurrene (*grade 3 vulnerability A*)

3.2.2 The poor mortar fill of traditional masonry fieldstone construction often results in a behaviour approaching that of two independent walls. A common observed damage is the loss of one of the two wall components, as modelled above.

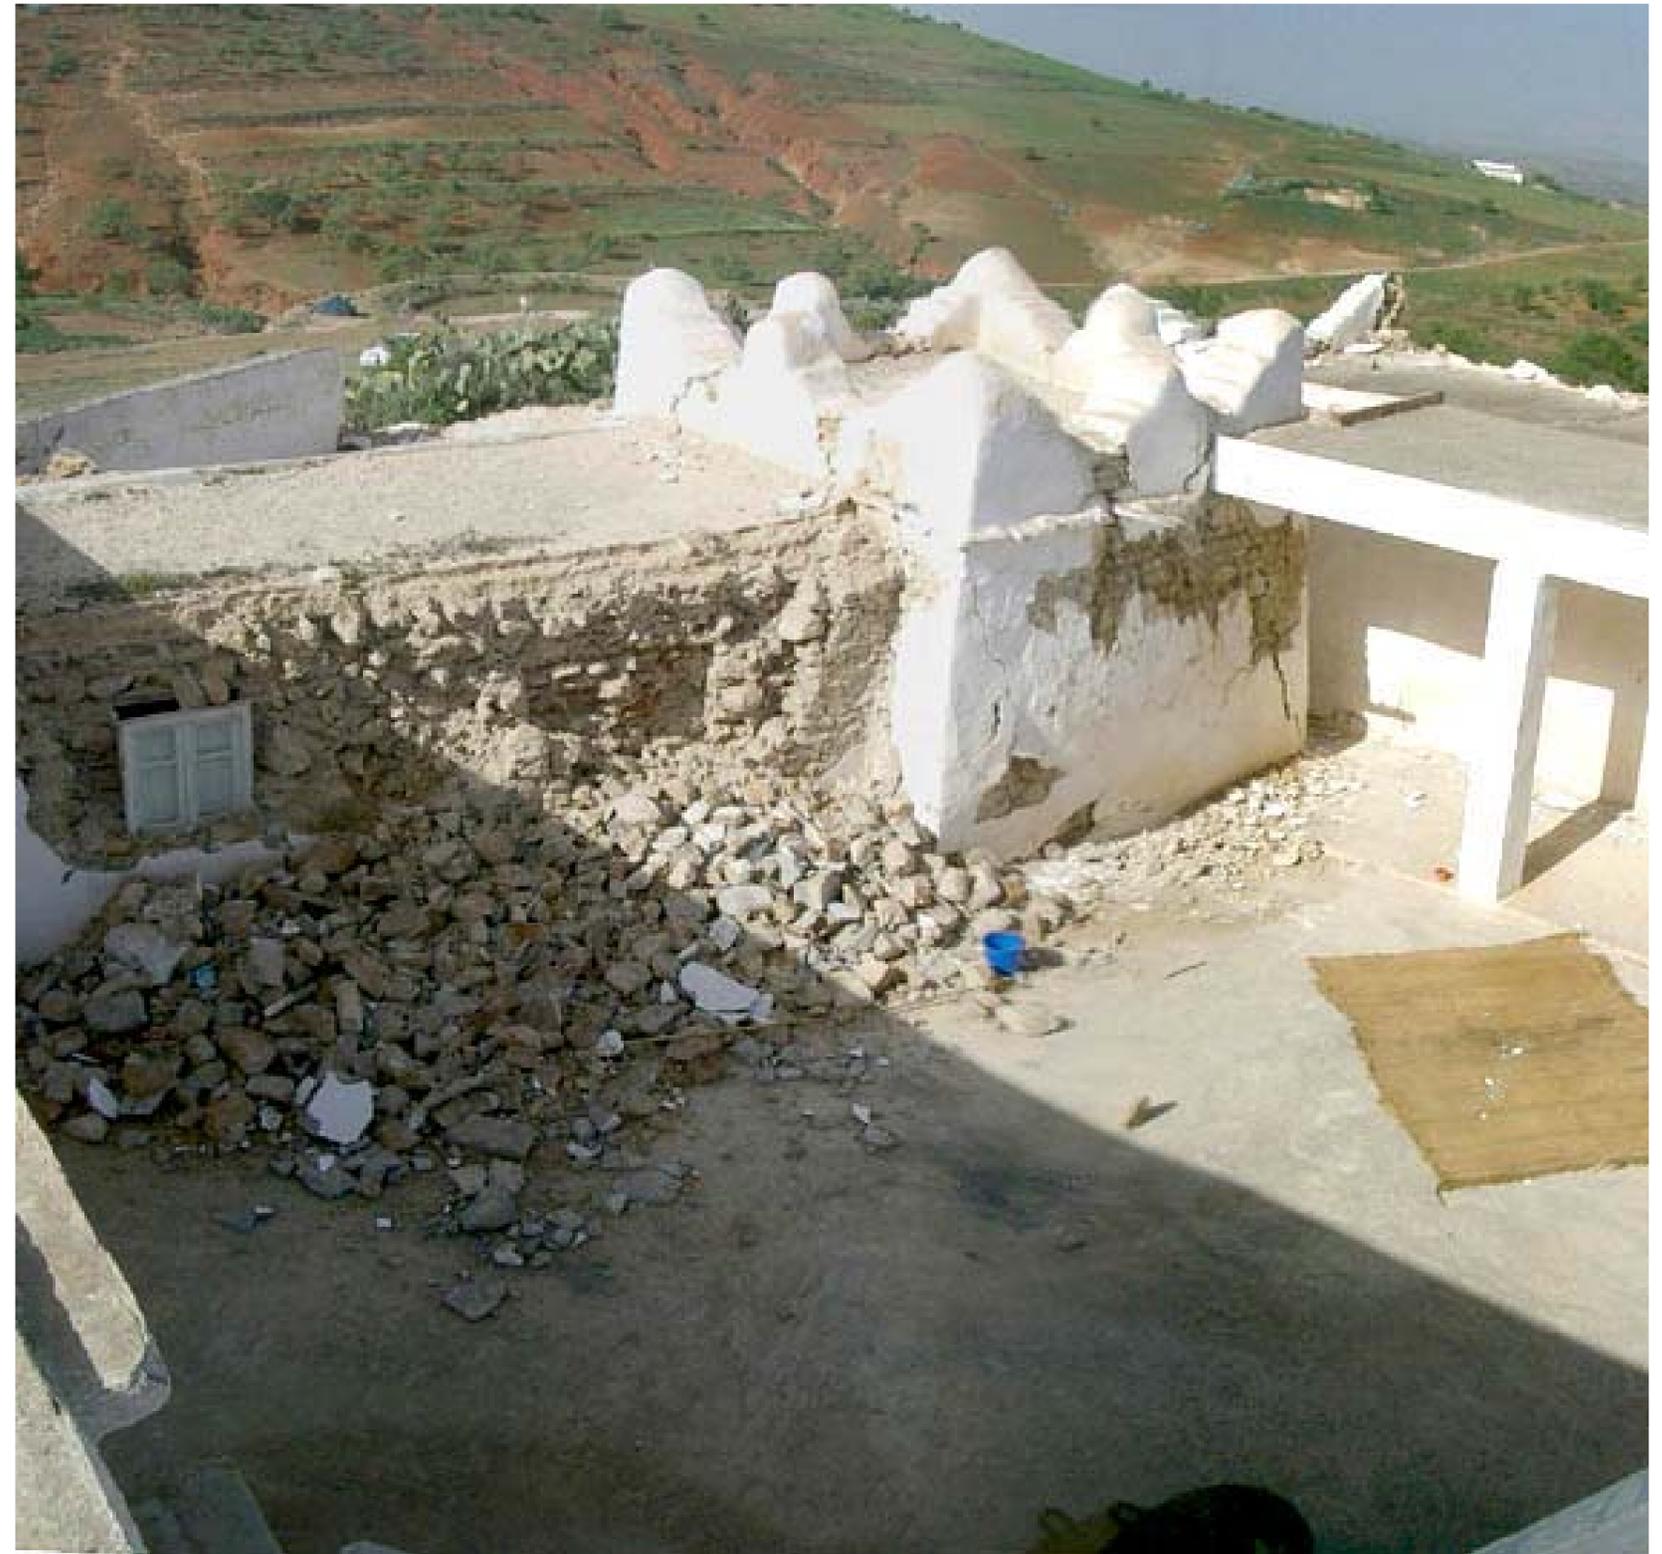
3.3.3 Failure of external skin in this masonry wall in a mosque in Ait Jamra. Note that the loss of a whole skin has not jeopardised the load bearing ability of the whole. (*grade 3 vulnerability A*)

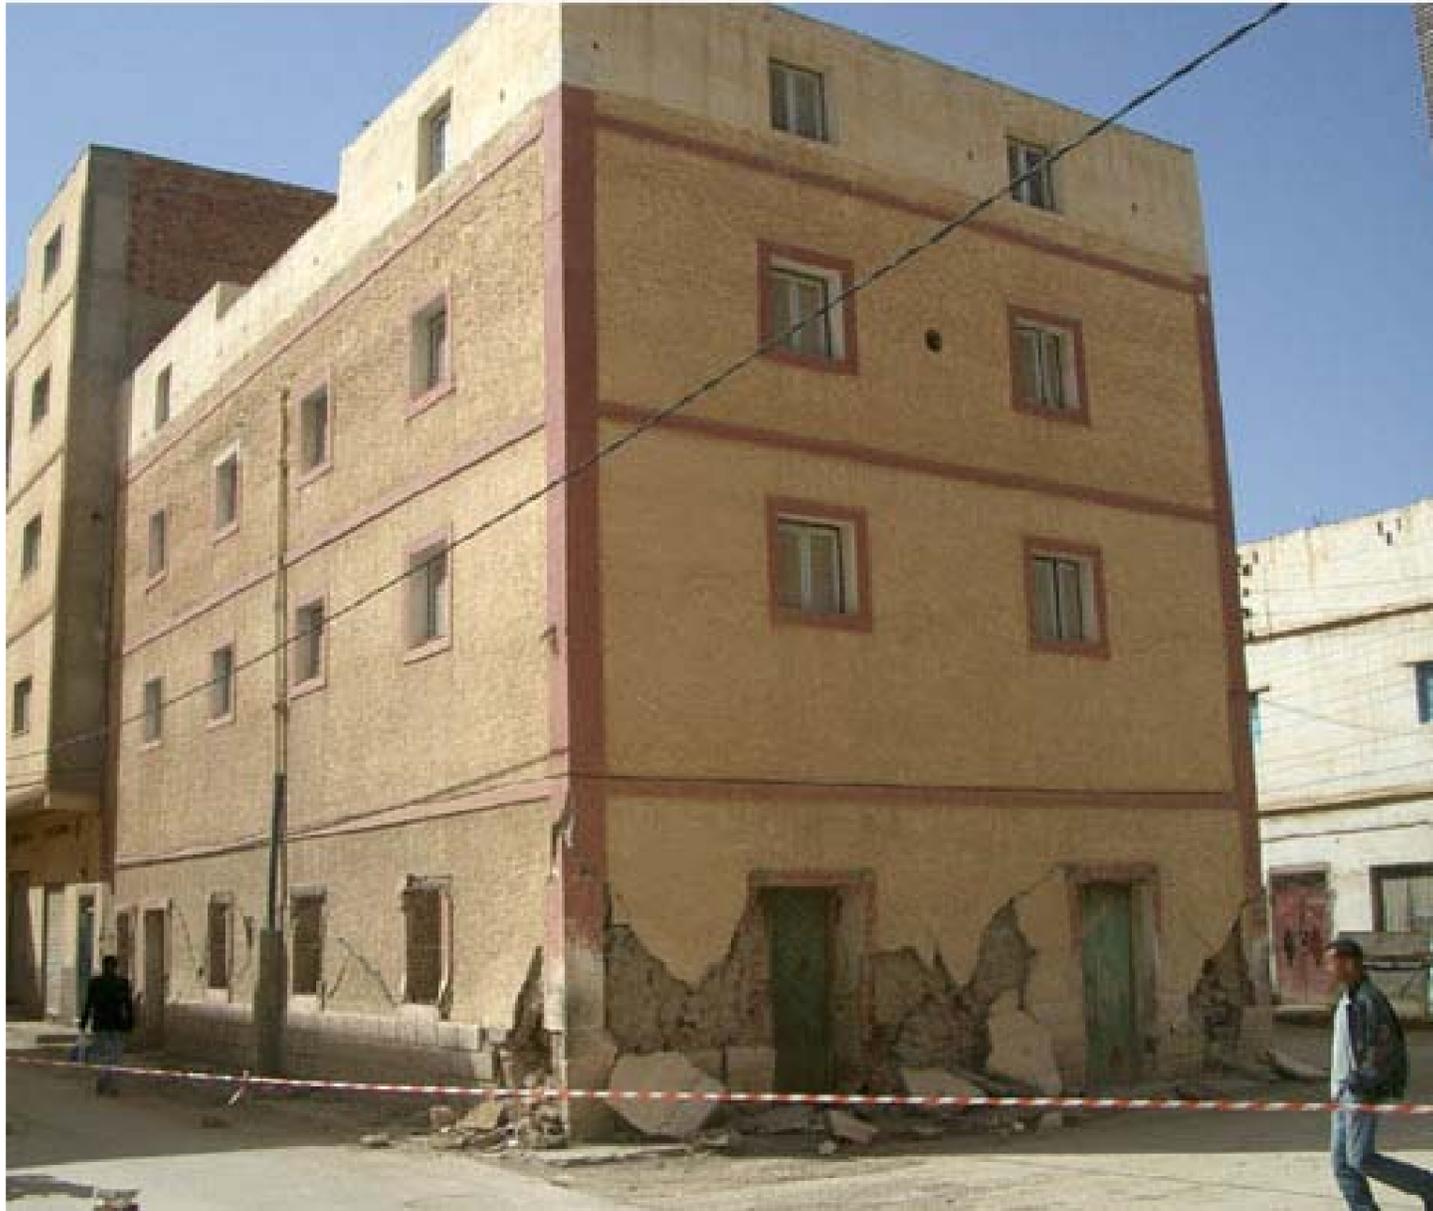
3.4.1 Shear damage to the piers on the ground floor of this unreinforced brick and stone masonry building in Imzurén. (*grade 3 vulnerability A*)

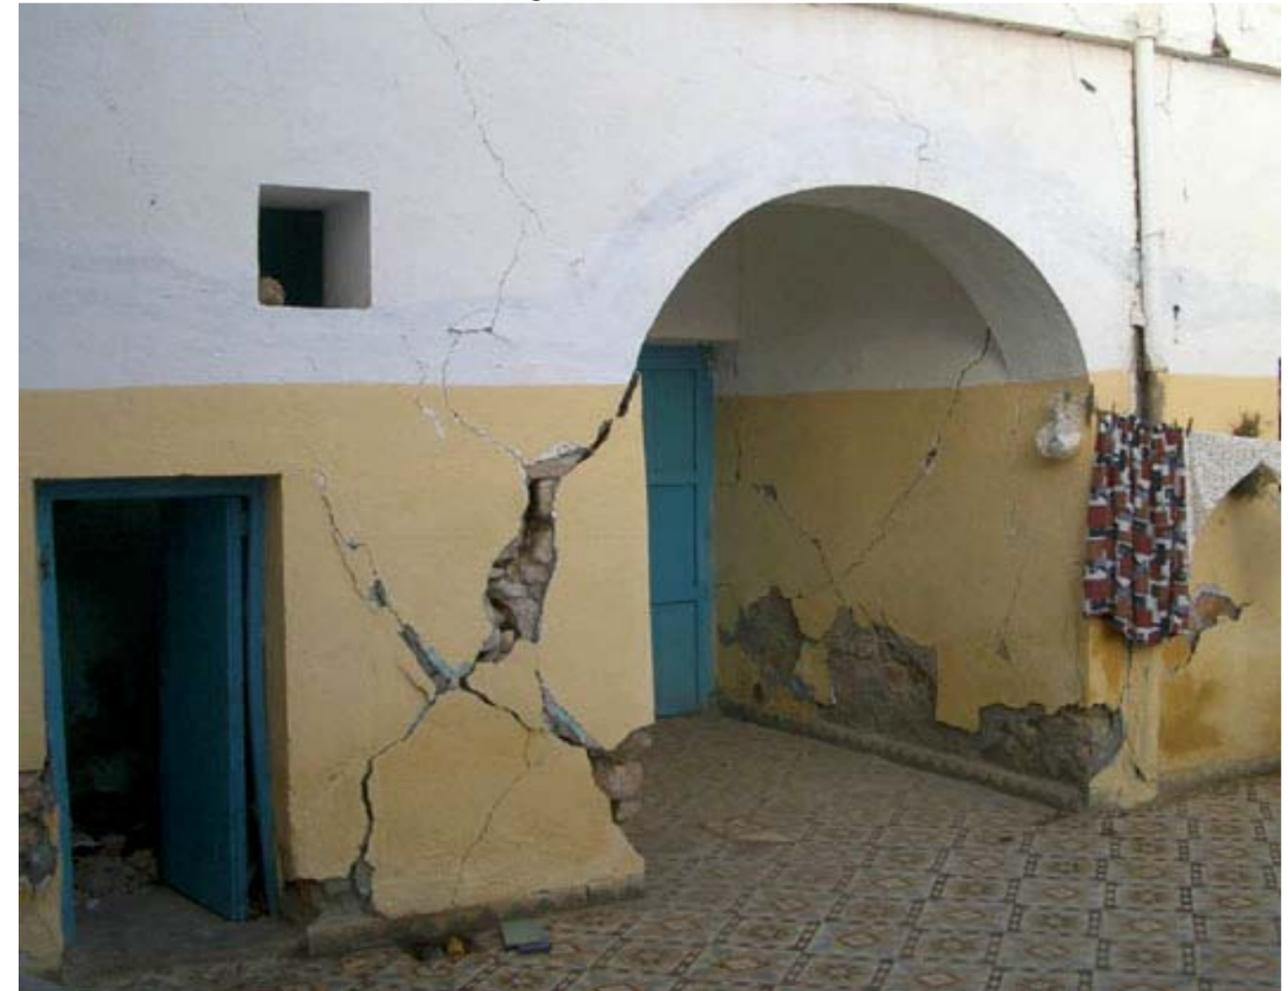
3.4.3 Shear damage in two perpendicular walls in a house in Tazaghine (*grade 3 vulnerability A*)

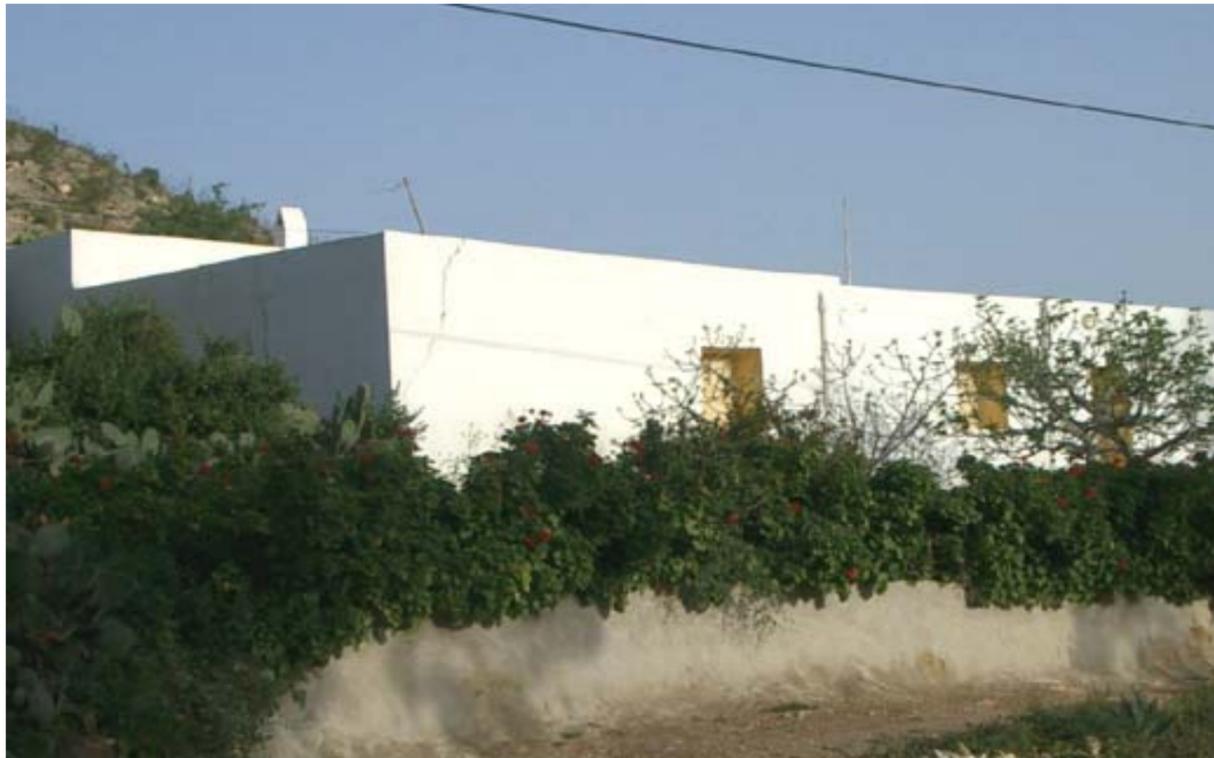
3.5.1 Slight corner damage in Ajdir (*grade 2 vulnerability A*)

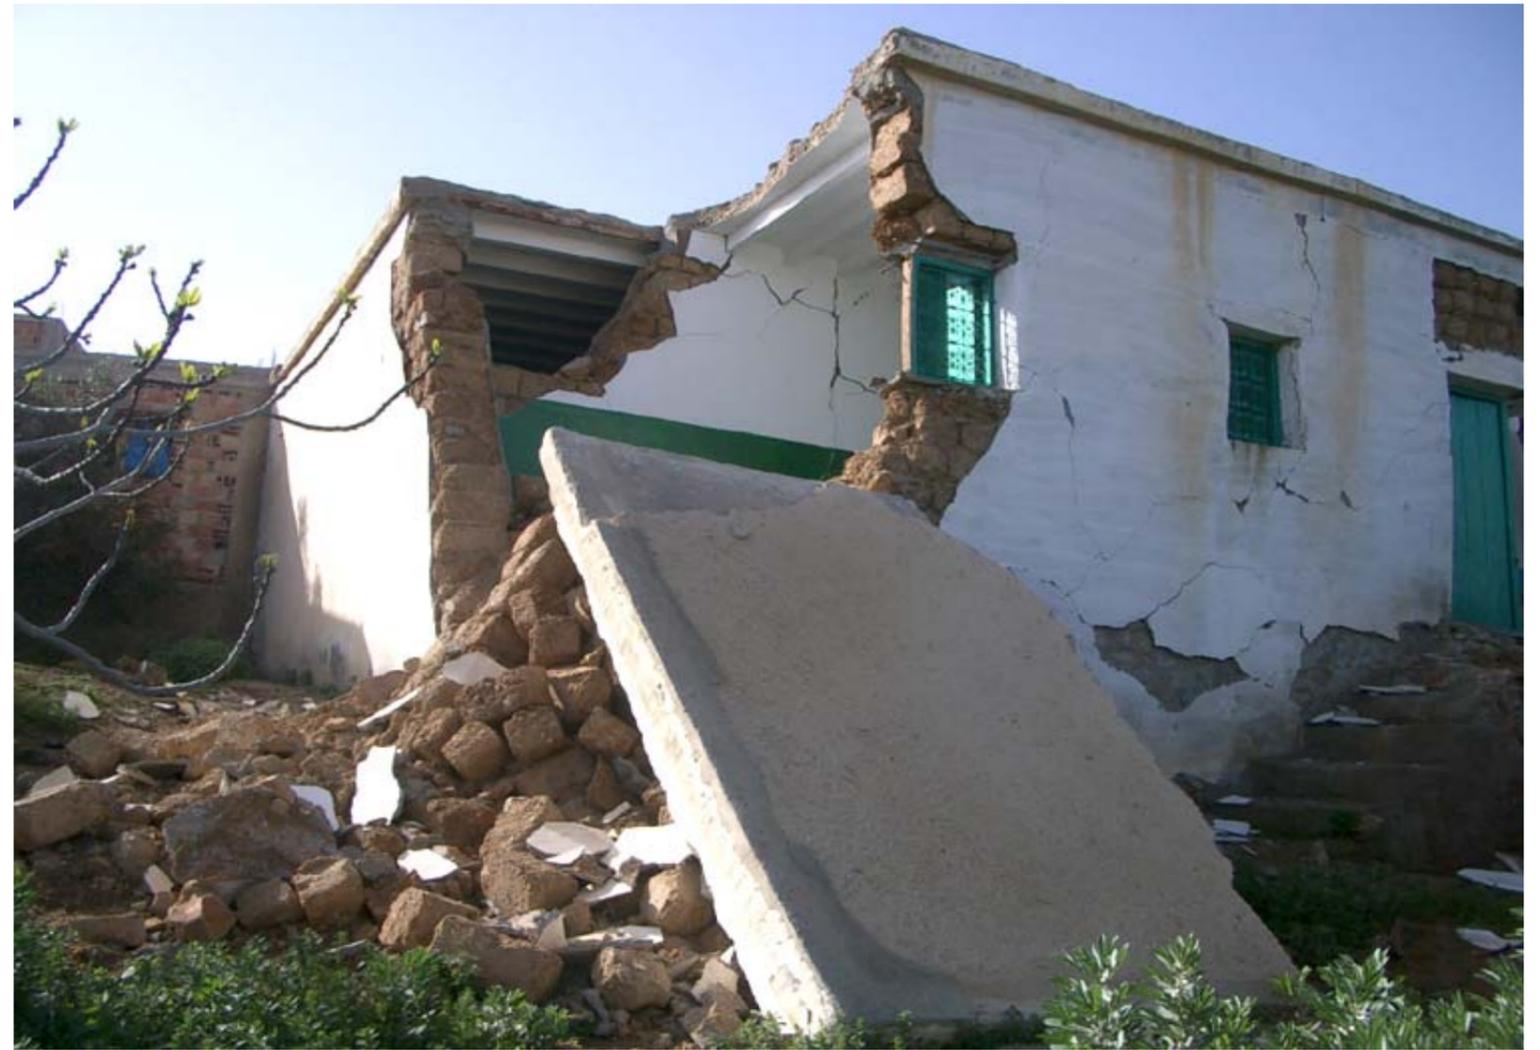
3.5.3 Advanced corner failure can cause the roof slab to collapse. (*grade 4 vulnerability A*)

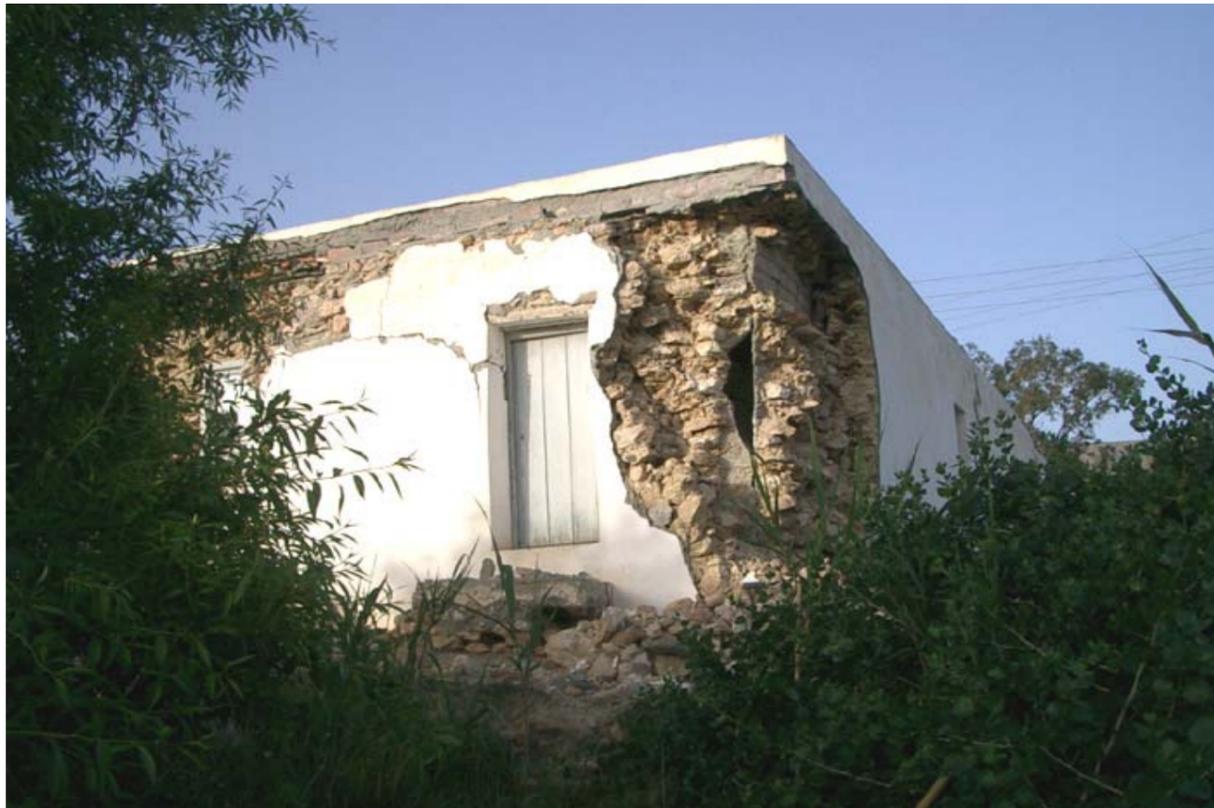
3.5.2 Moderate corner damage with loss of material. (*grade 3 vulnerability A*)

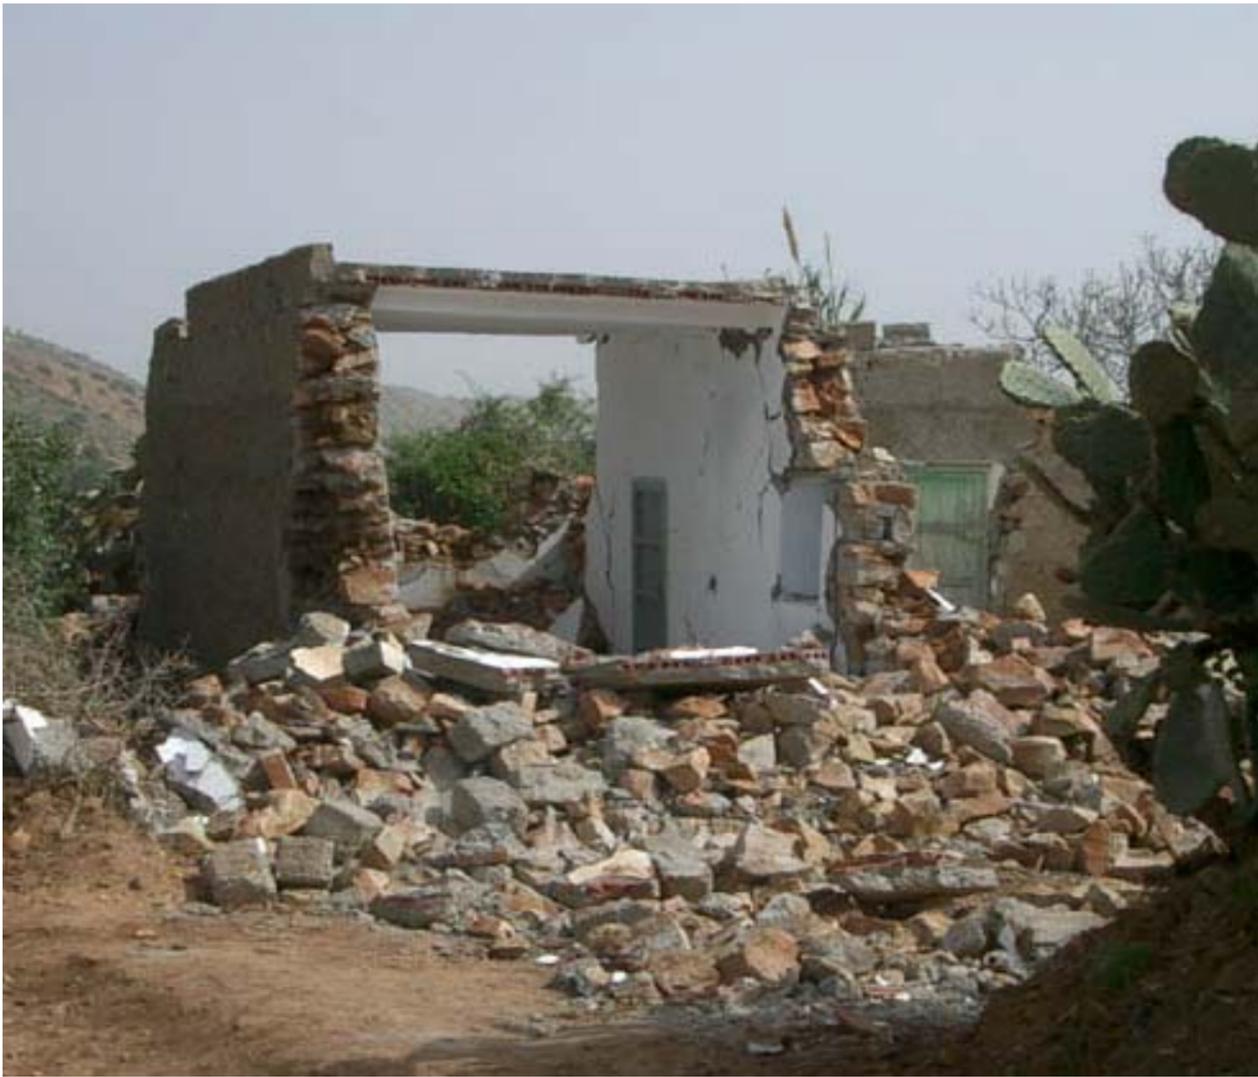
3.6.1 Corner failure and loss of unloaded gable wall. Ait Jamra (*grade 4 vulnerability A*)

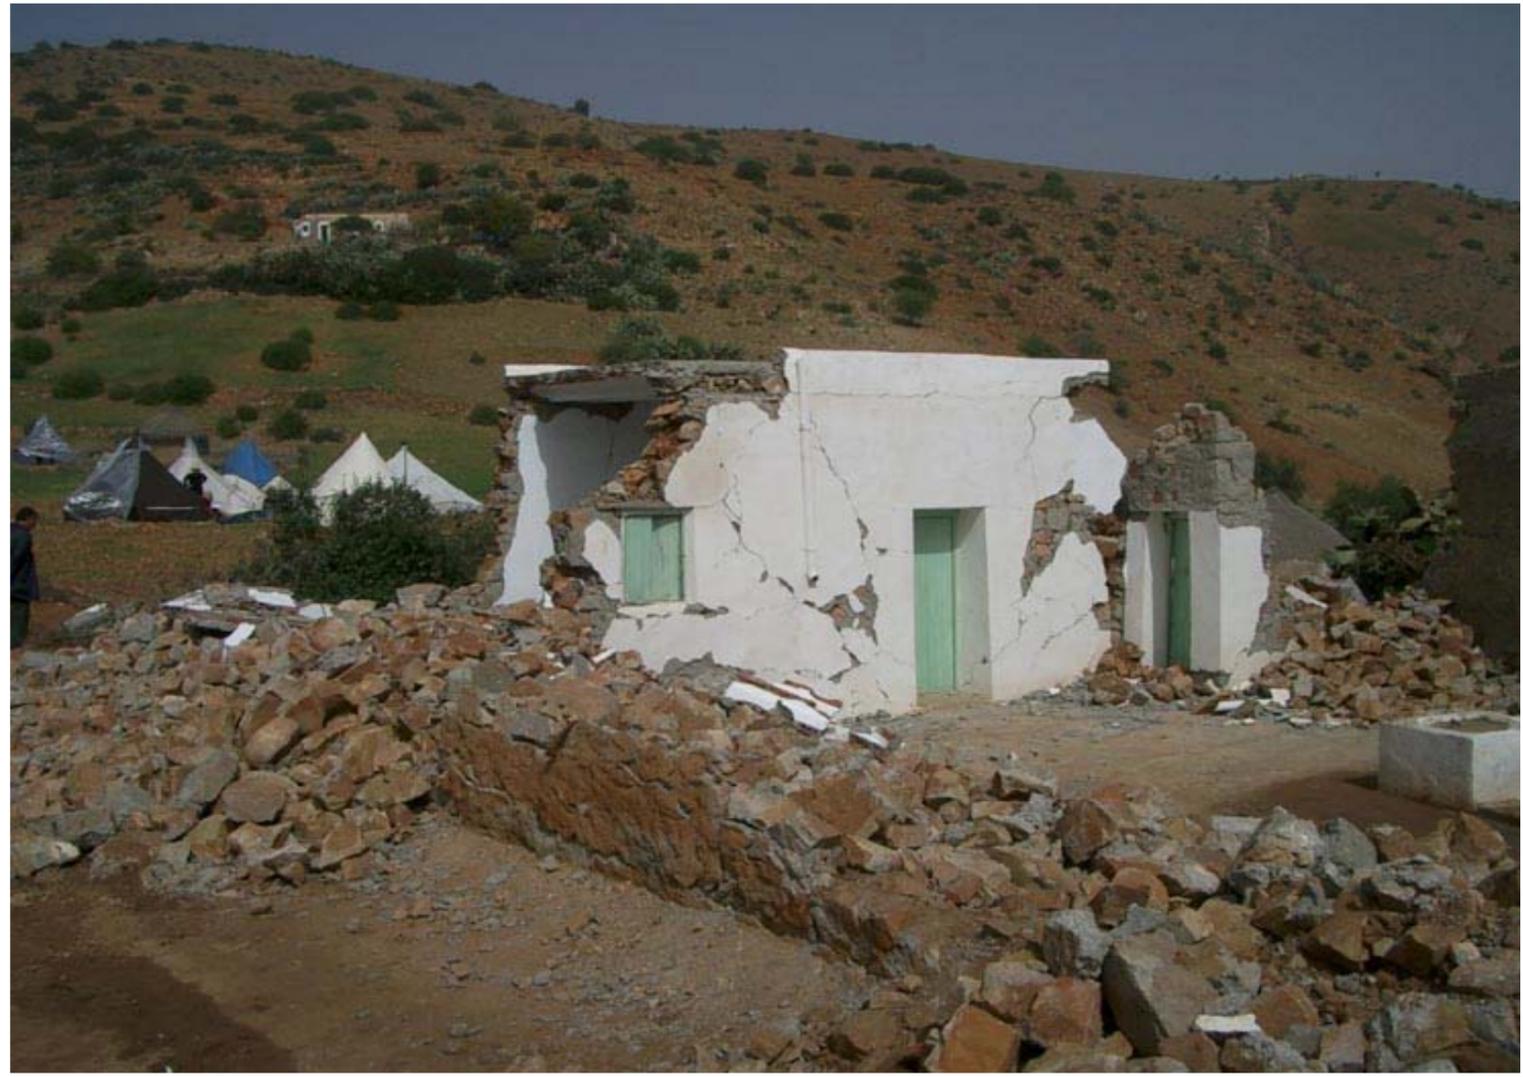
3.6.2 Same building from a different angle, incorporating failure of freestanding patio masonry wall. Refugee camp in the background.

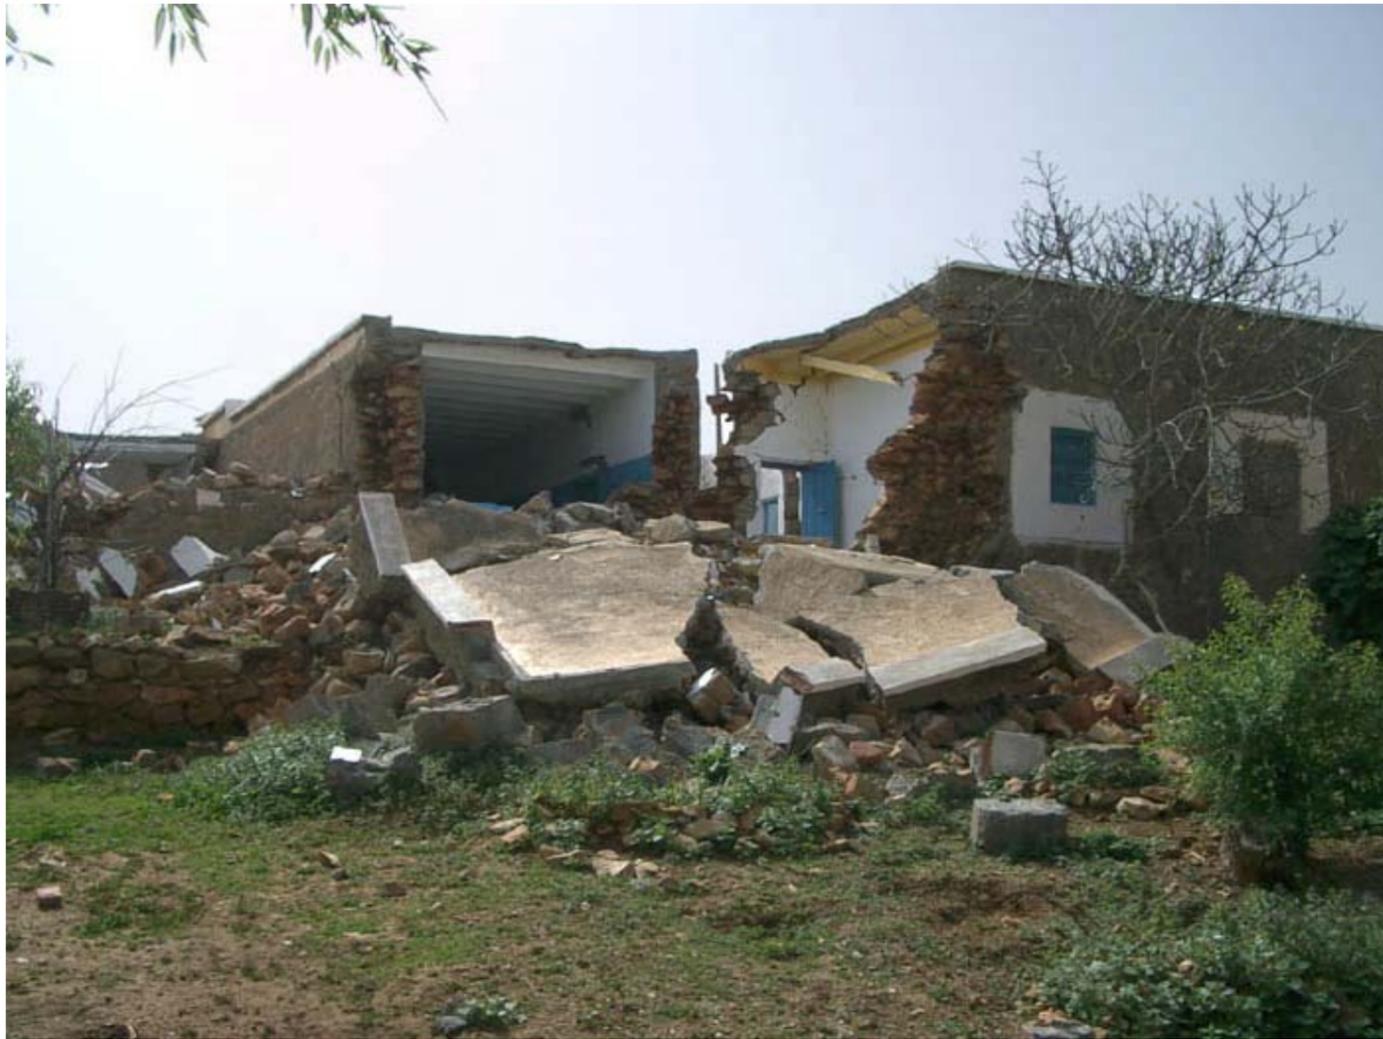
3.7.1 Advanced corner failure with loss of roof slab. Ait jamra. (*grade 4 vulnerability A*)

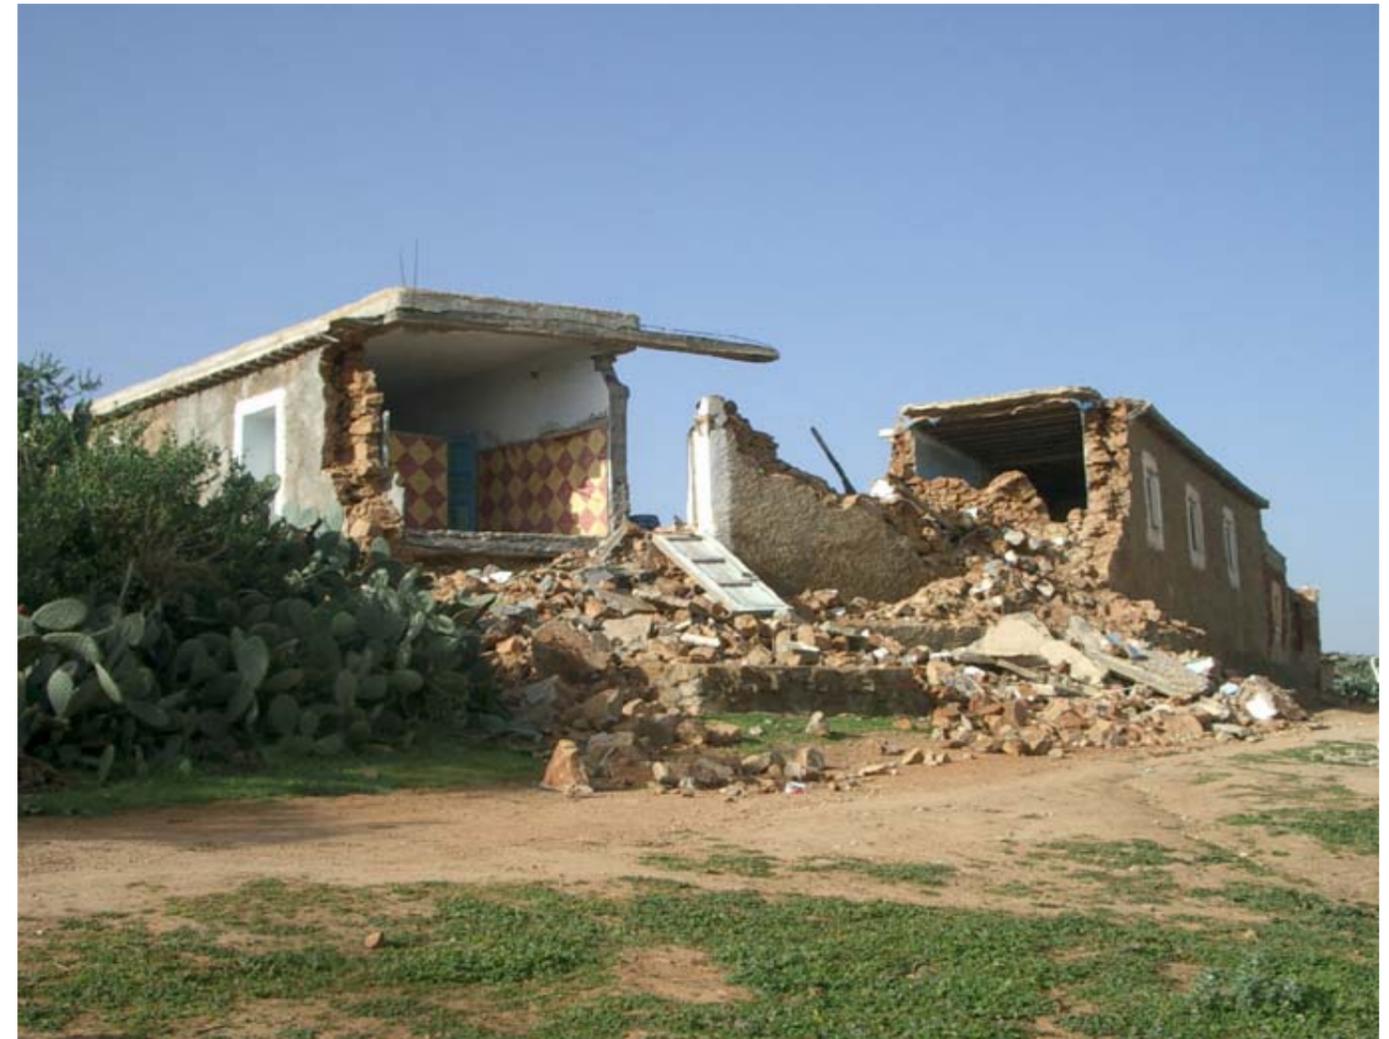
3.7.2 Advanced corner failure and loss of unsupported gable wall. Ait Jamra. (*grade 4 vulnerability A*)
