AL-HOCEIMA EARTHQUAKE 24 02 2004

FIELD REPORT

Patrick Murphy Corella *Architect* June 2004

The Al-Hoceima earthquake

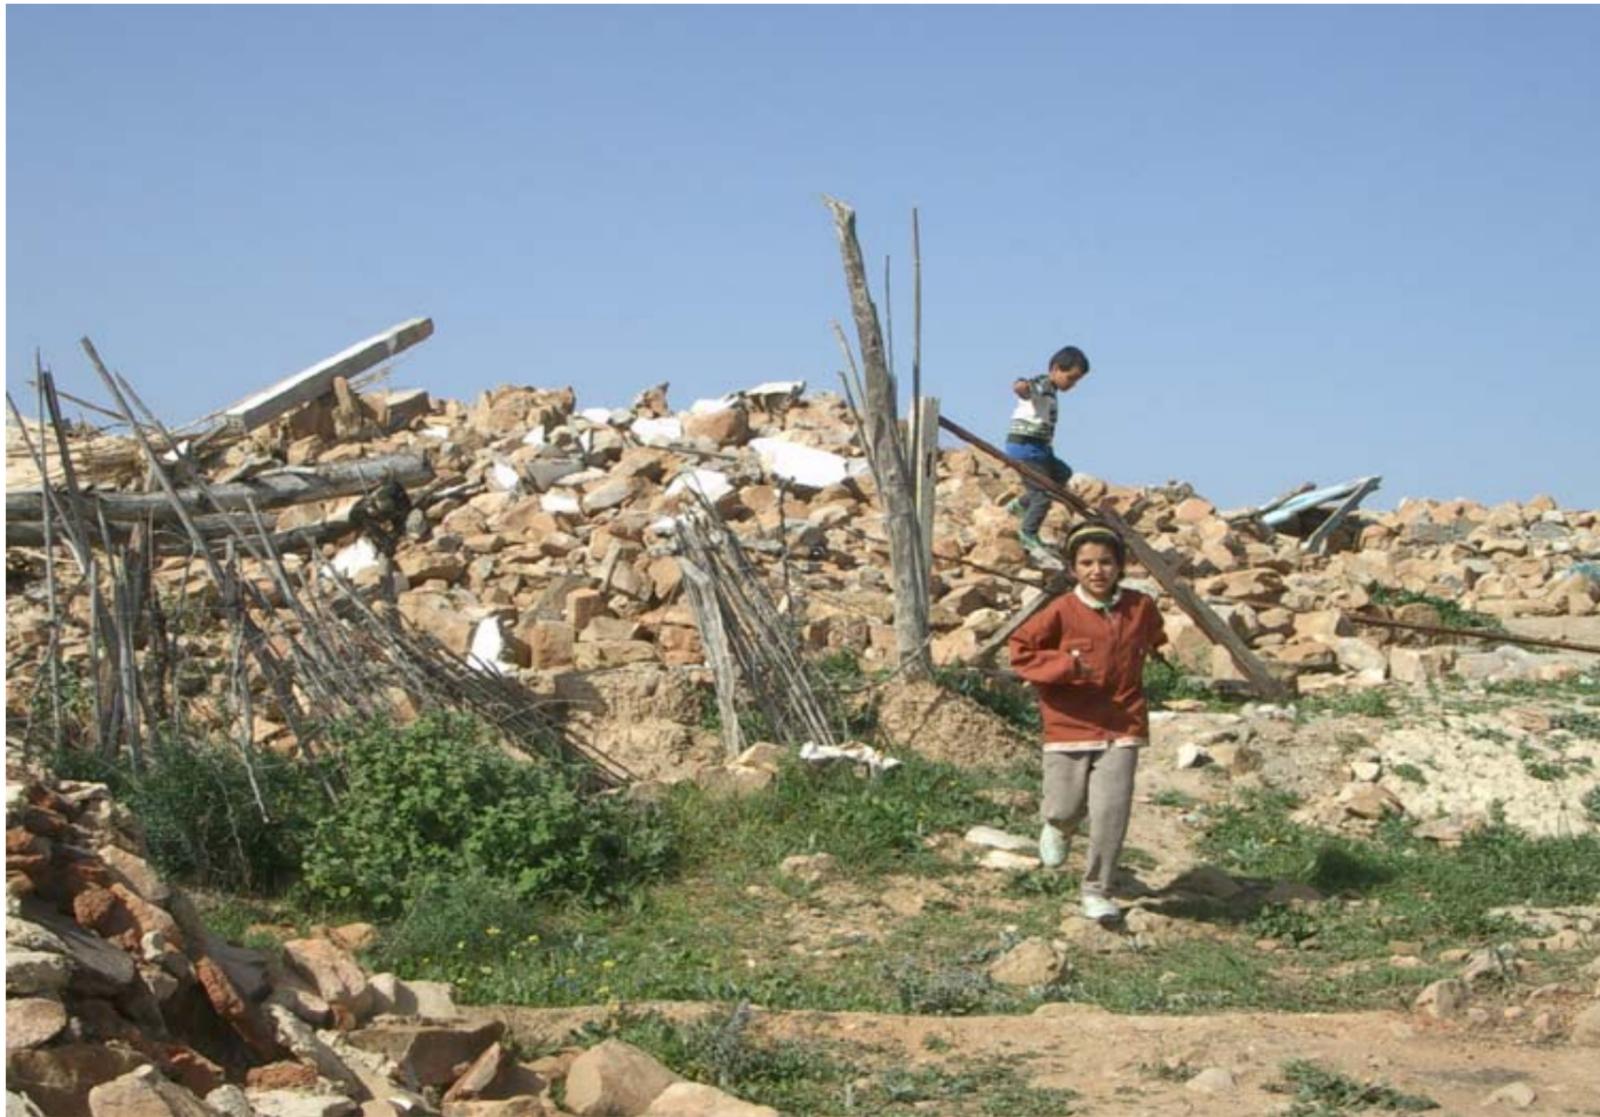
3.8.1 In the chaotic damage of grade 5 it is often difficult to discern the original form and plan of the building, and is thus of limited use for damage analysis.

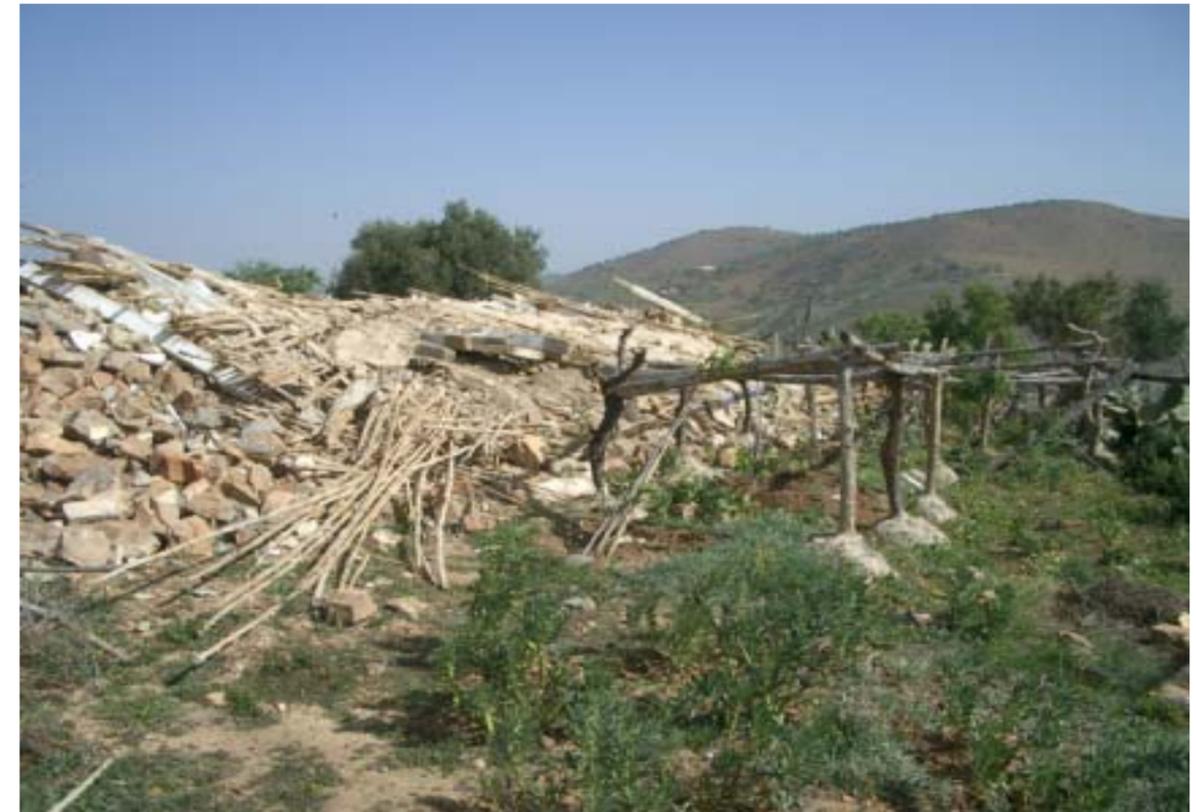
3.8.2 Another view of the damaged building.

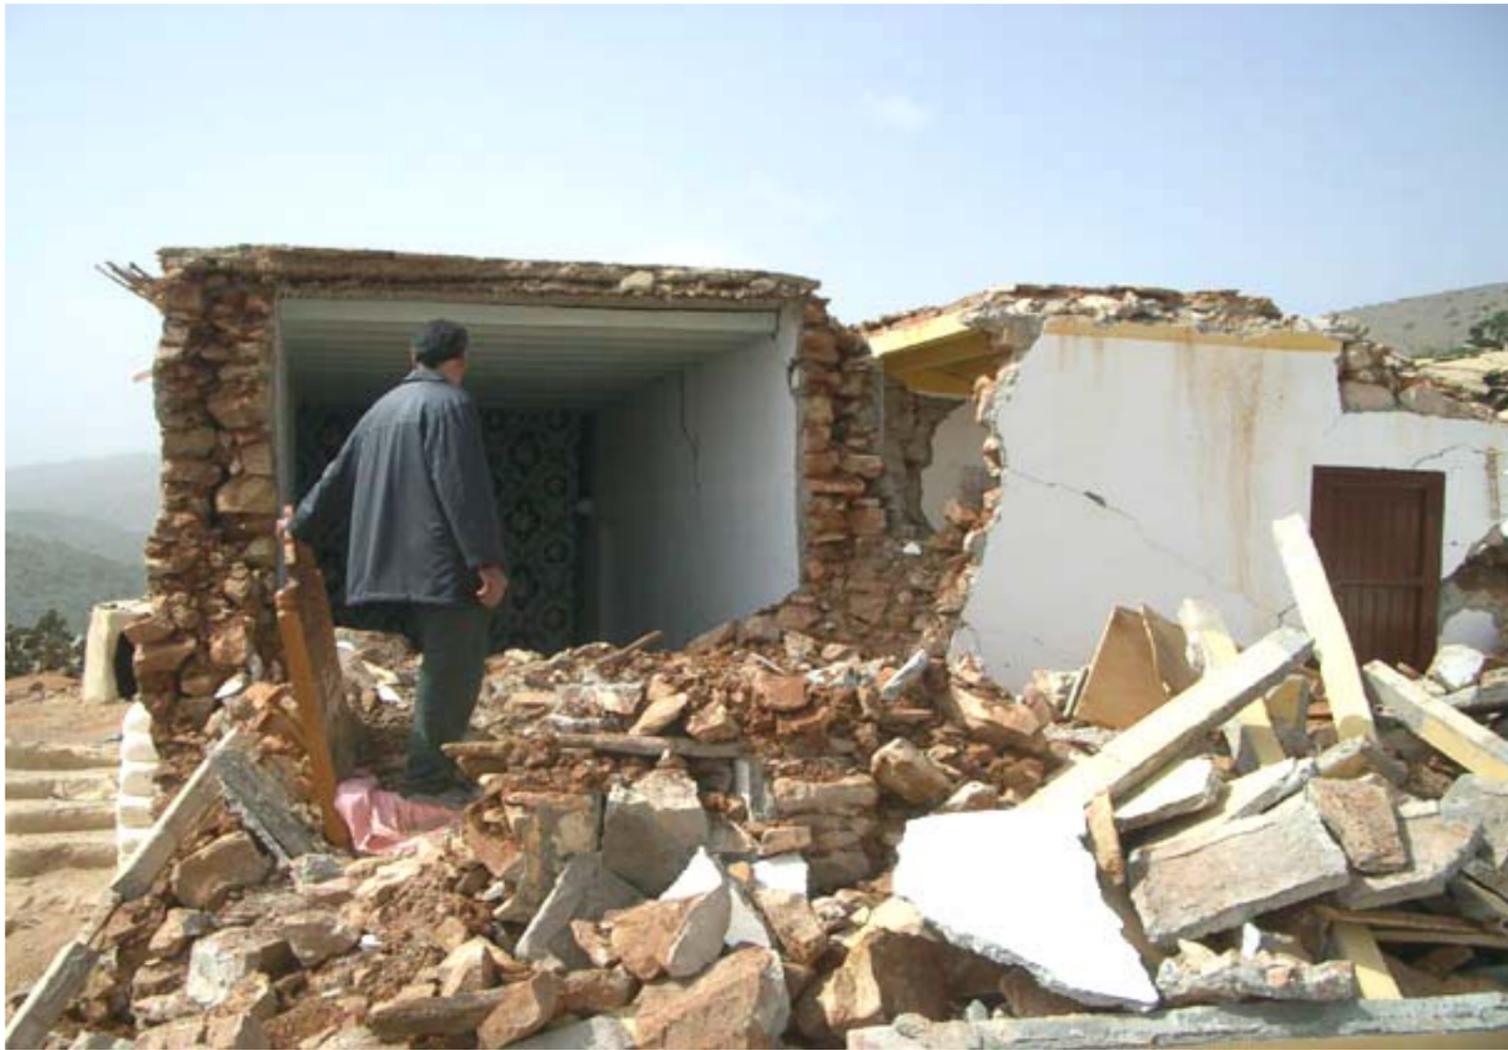
3.10.1 Corner failure and loss of the end gable wall has caused the collapse of the dormitory wing of this house and killed the wife of the owner. He is standing on the remains of the bed. Note the exposed wall construction and how it has been cracked into two skins.

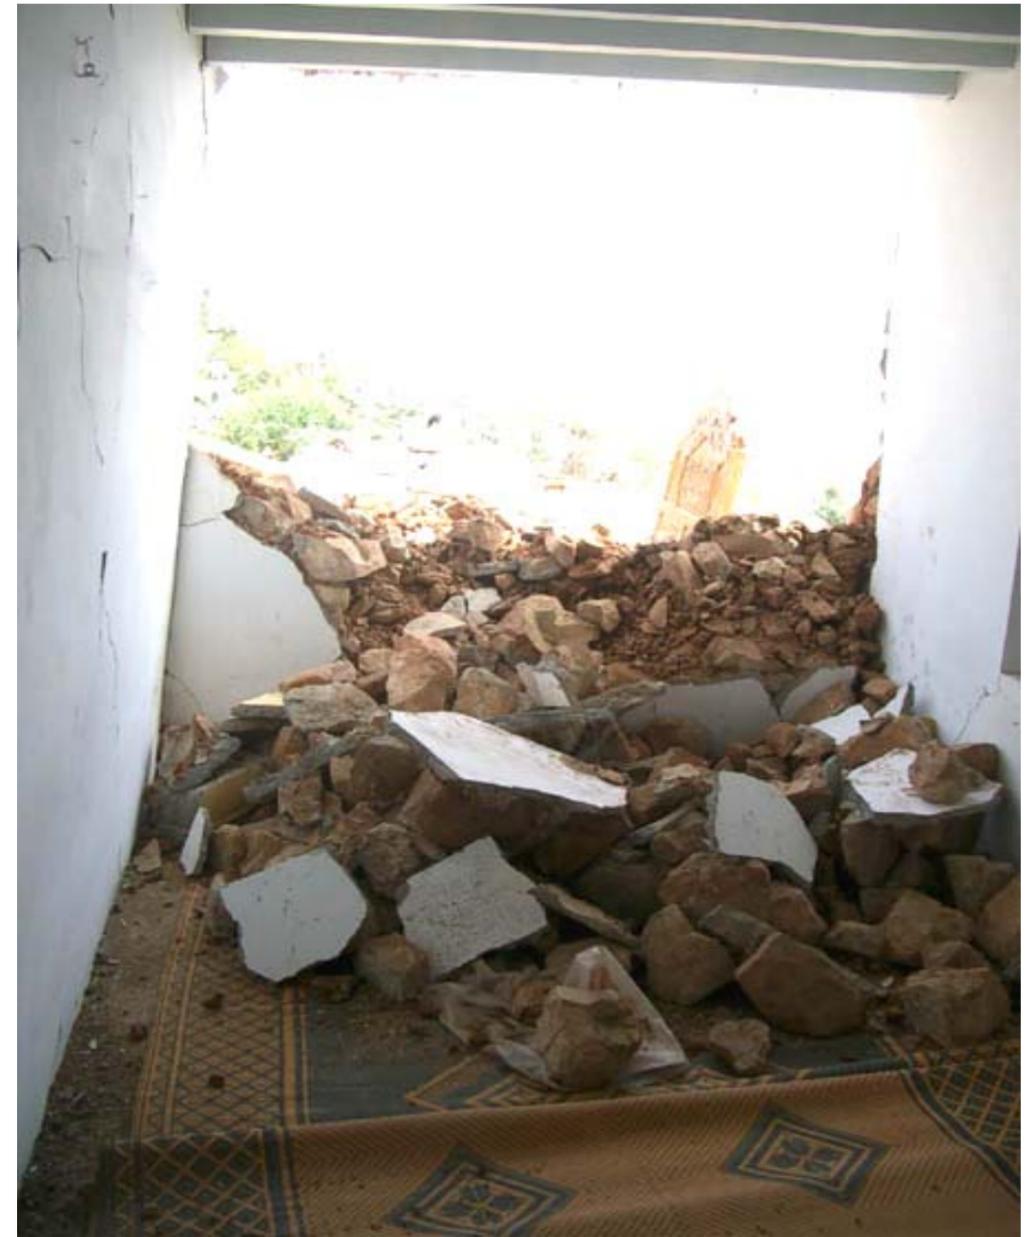
3.10.1 View from the inside of the dormitory.

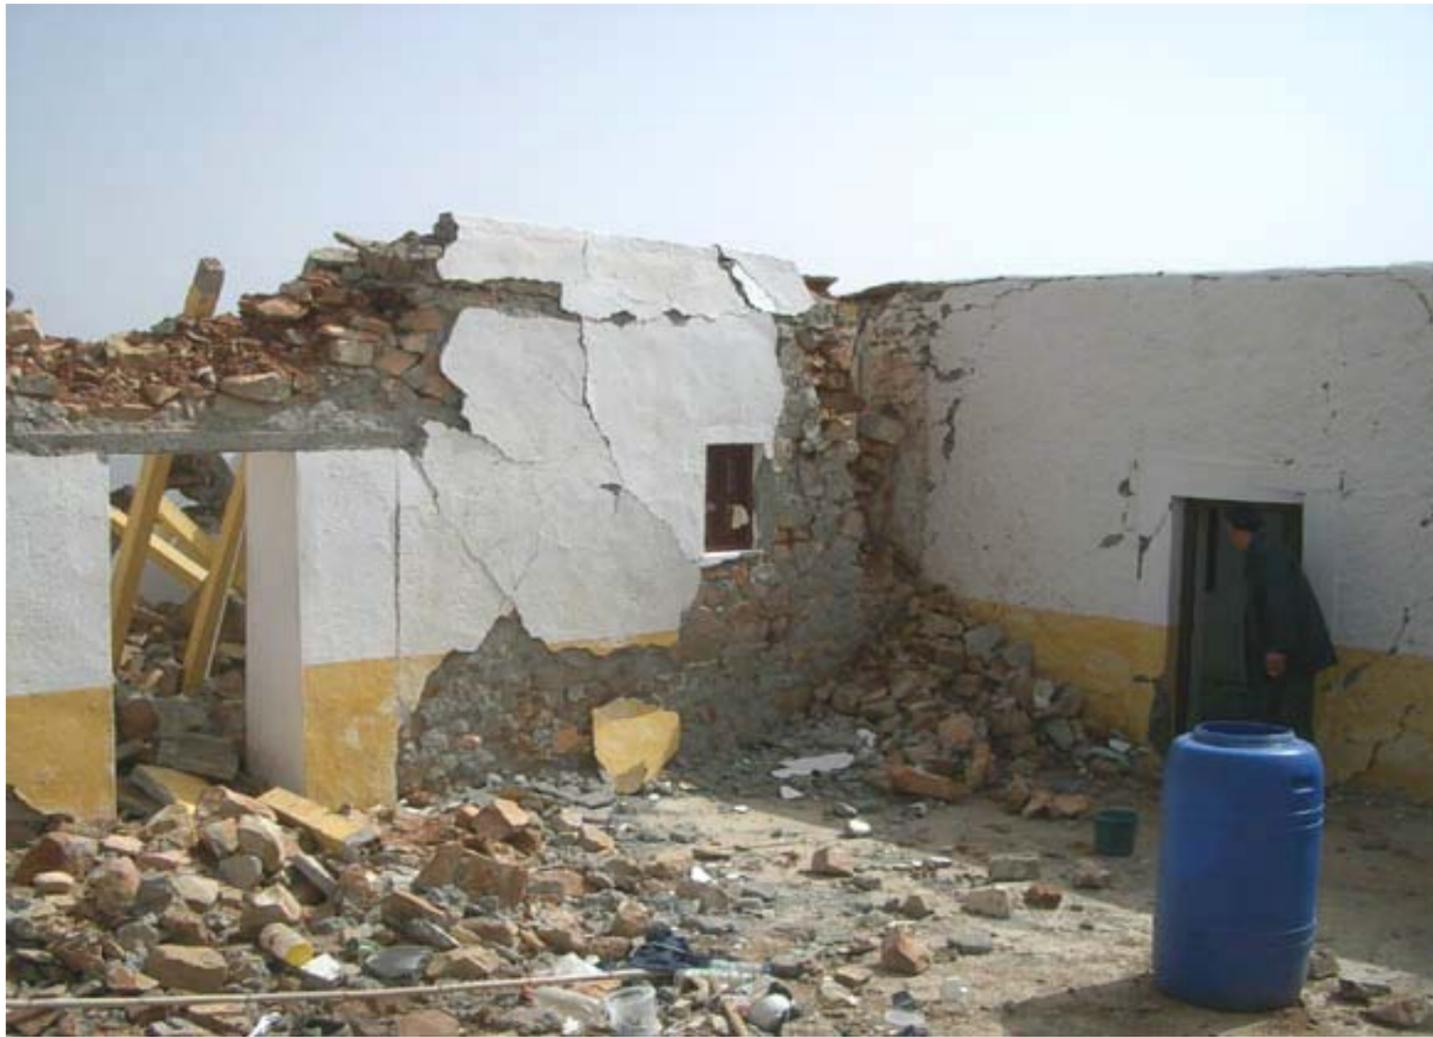
3.11.1 Shear damage to walls and hammering between two perpendicular planes in the corner.

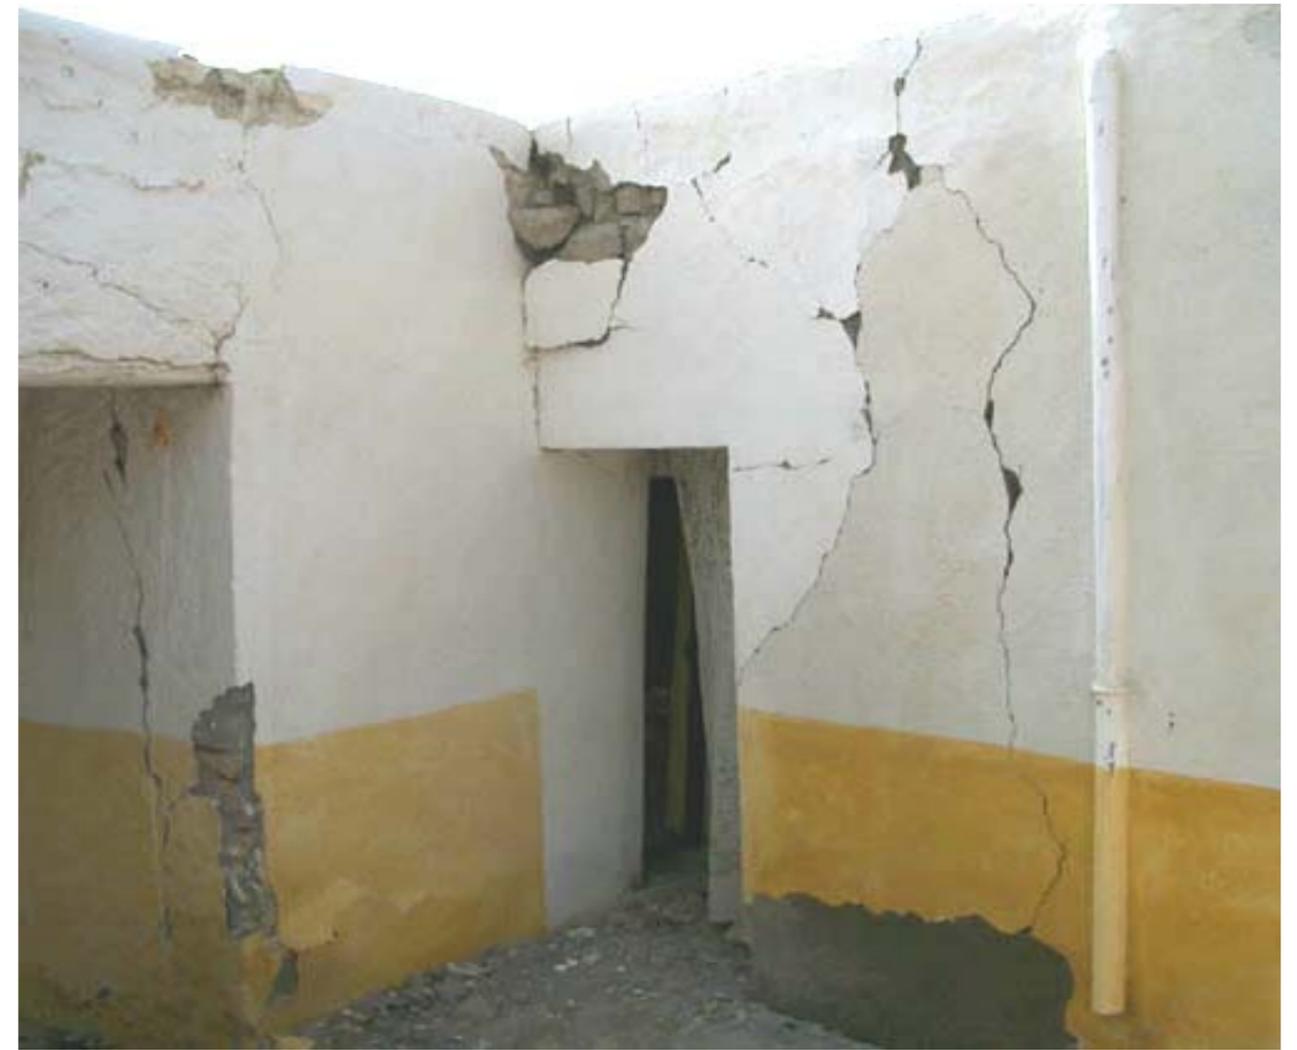
3.11.2 Shear damage to walls and further hammering damage to the corner.

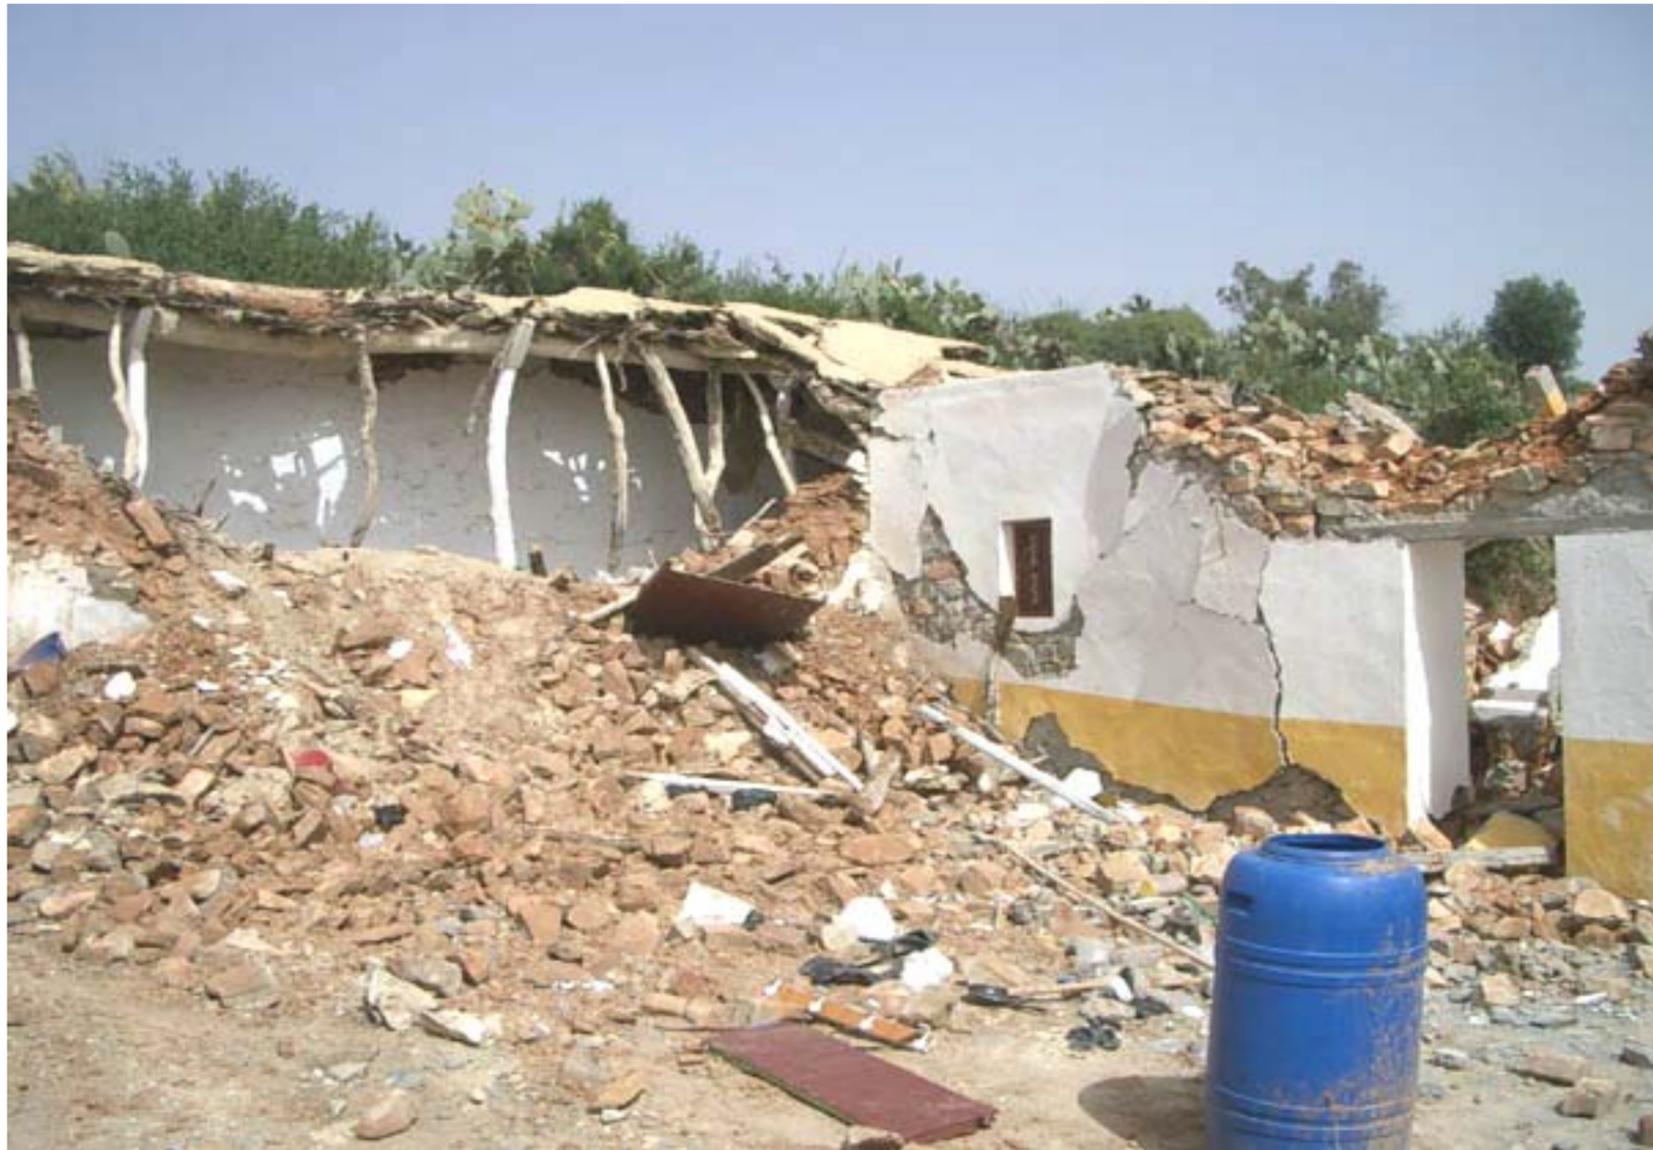
3.12.1 Failure of a loadbearing wall, note the very traditional roofing structure with the wooden posts offering a very limited diaphragm action. Compare with the better performance in photo 3.12.2

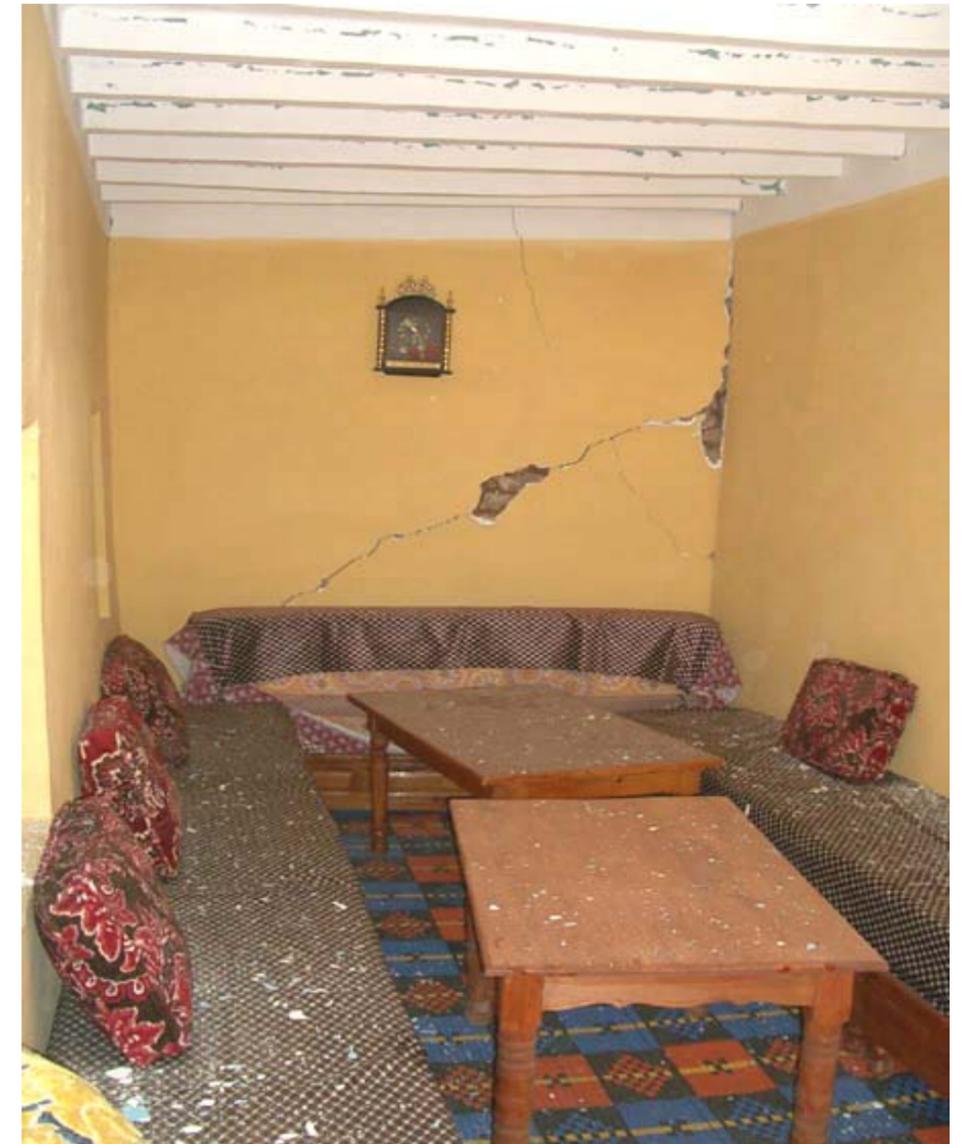
3.12.2 This front of house living room was roofed using tiny concrete beams described earlier, contributing enough diaphragm action to avoid failure despite shear damage to the gable wall at the end. These semi-technological home improvements may have resulted in critical life-saving performance.

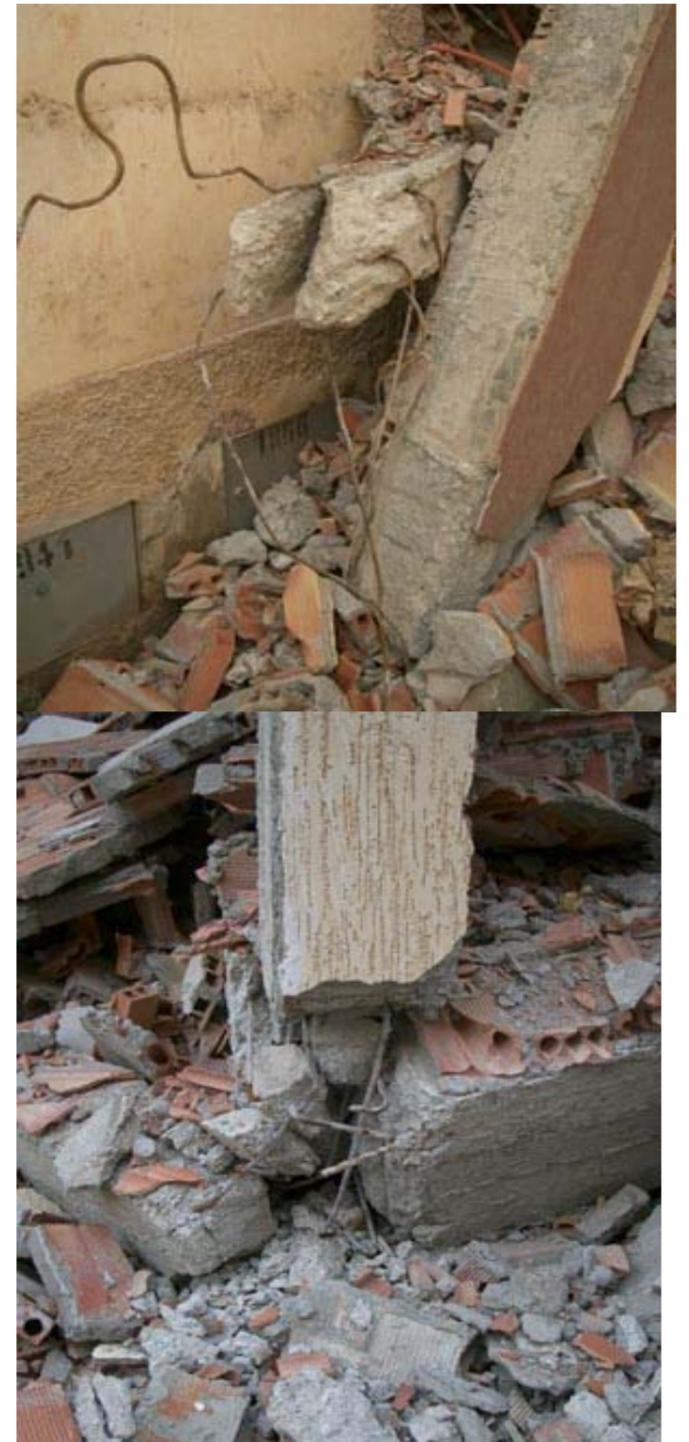
4.1.3 Note the use of non-corrugated steel and inadequate reinforcing layout as well as very small column and beam sections in this failed RC frame building in Imzuren.

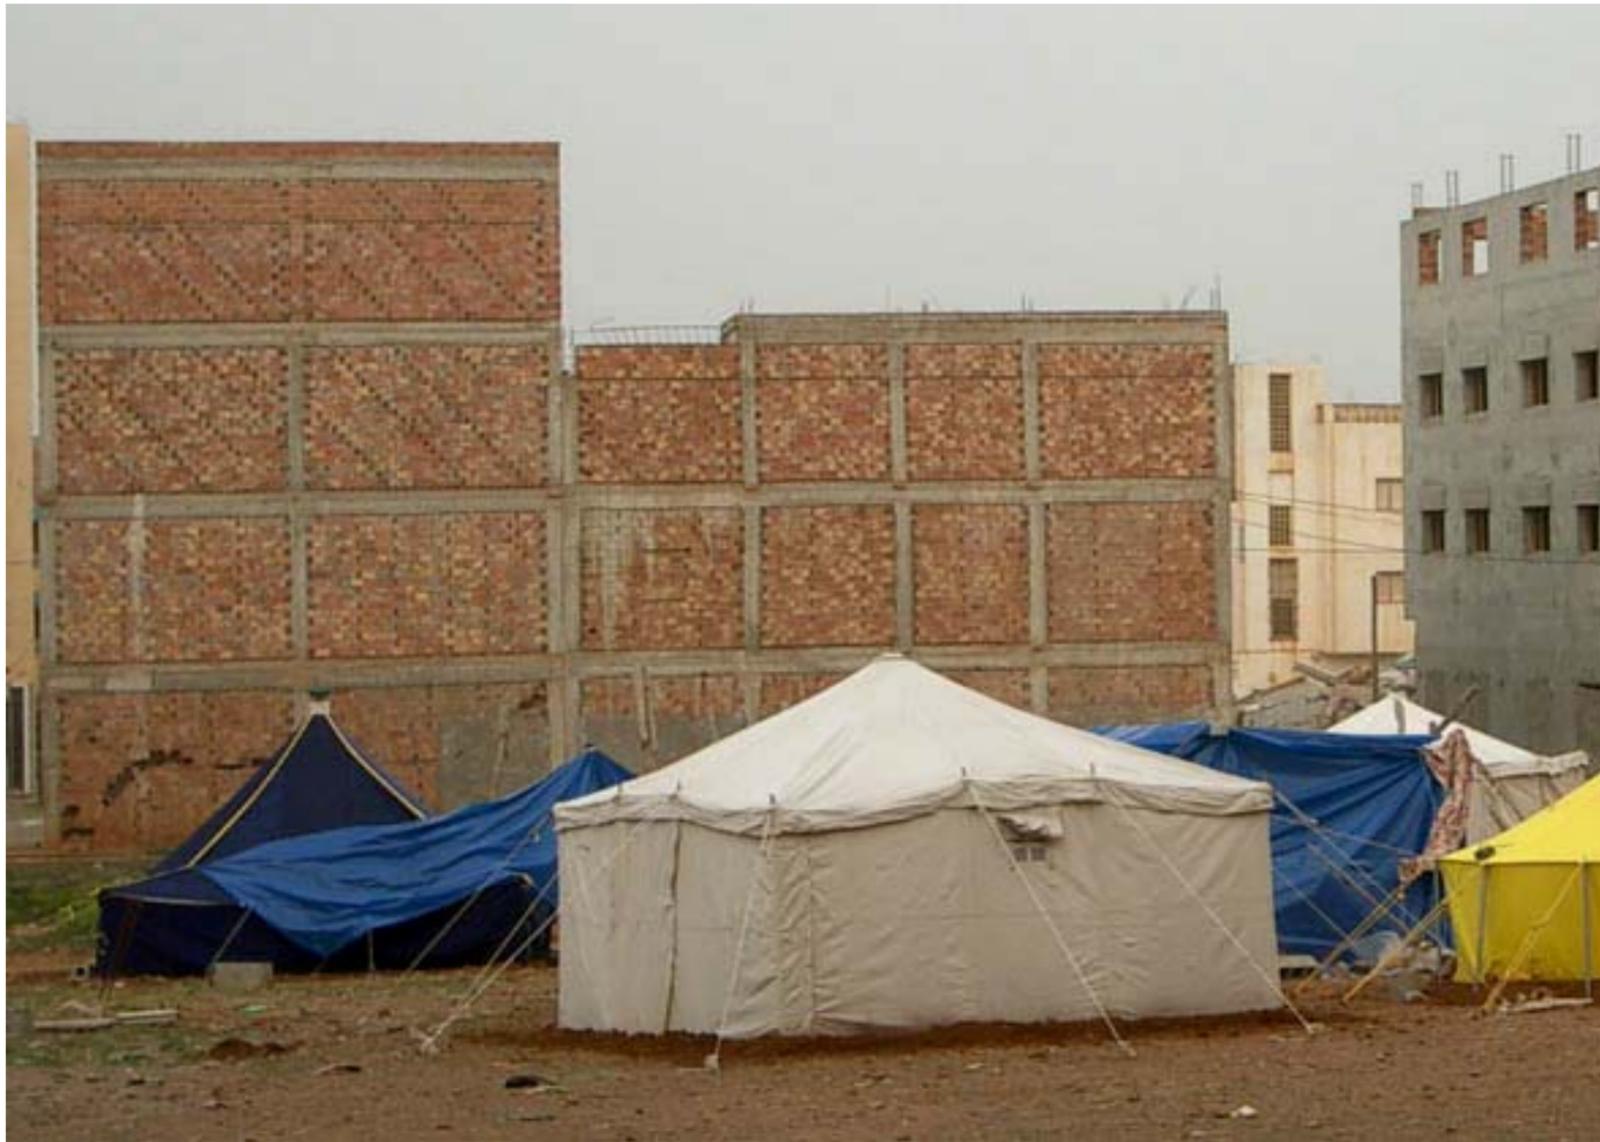
4.3.1 The lack of stiffness of the main RC structure is compensated by the participation of the hollow brick infill panels, which provide an added rigidity to the whole, in particular in those floors densely divided into flats. The unforeseen participation of the brick partitions single them out as especially vulnerable to damage and as we shall see later, can modify the response of the structure. (*grade 2 vulnerability C*)

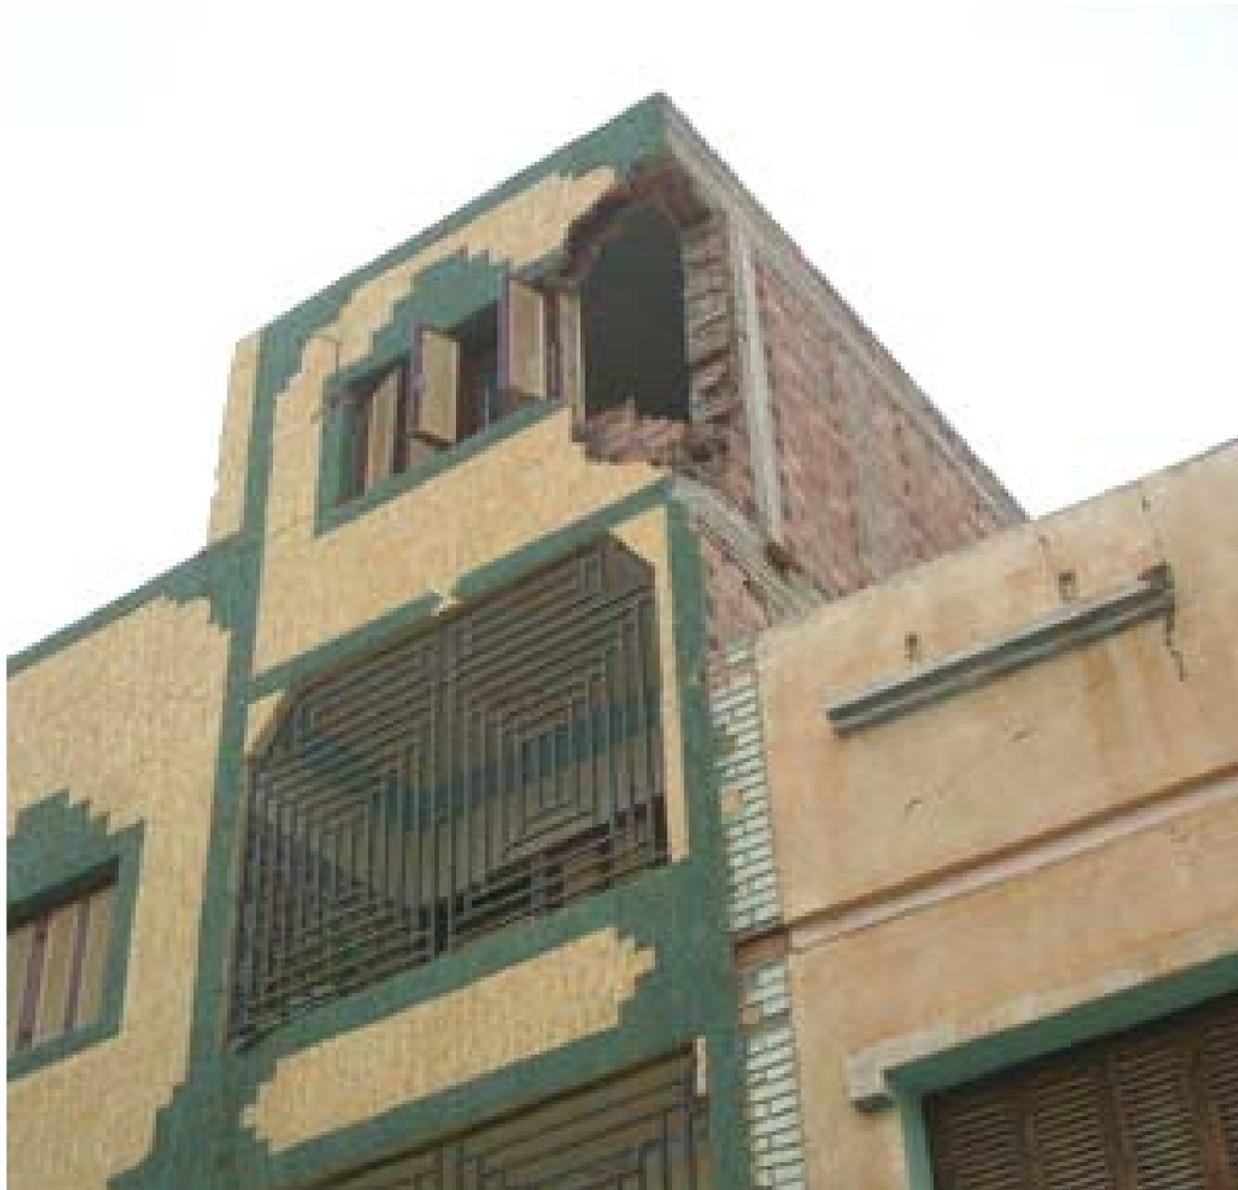
4.4.1 This loadbearing wall has failed in a characteristic corner failure as observed in loadbearing masonry construction, resulting from being horizontally loaded by a very unstiff RC frame in this building in Imzuren. (*grade 2 vulnerability C*)

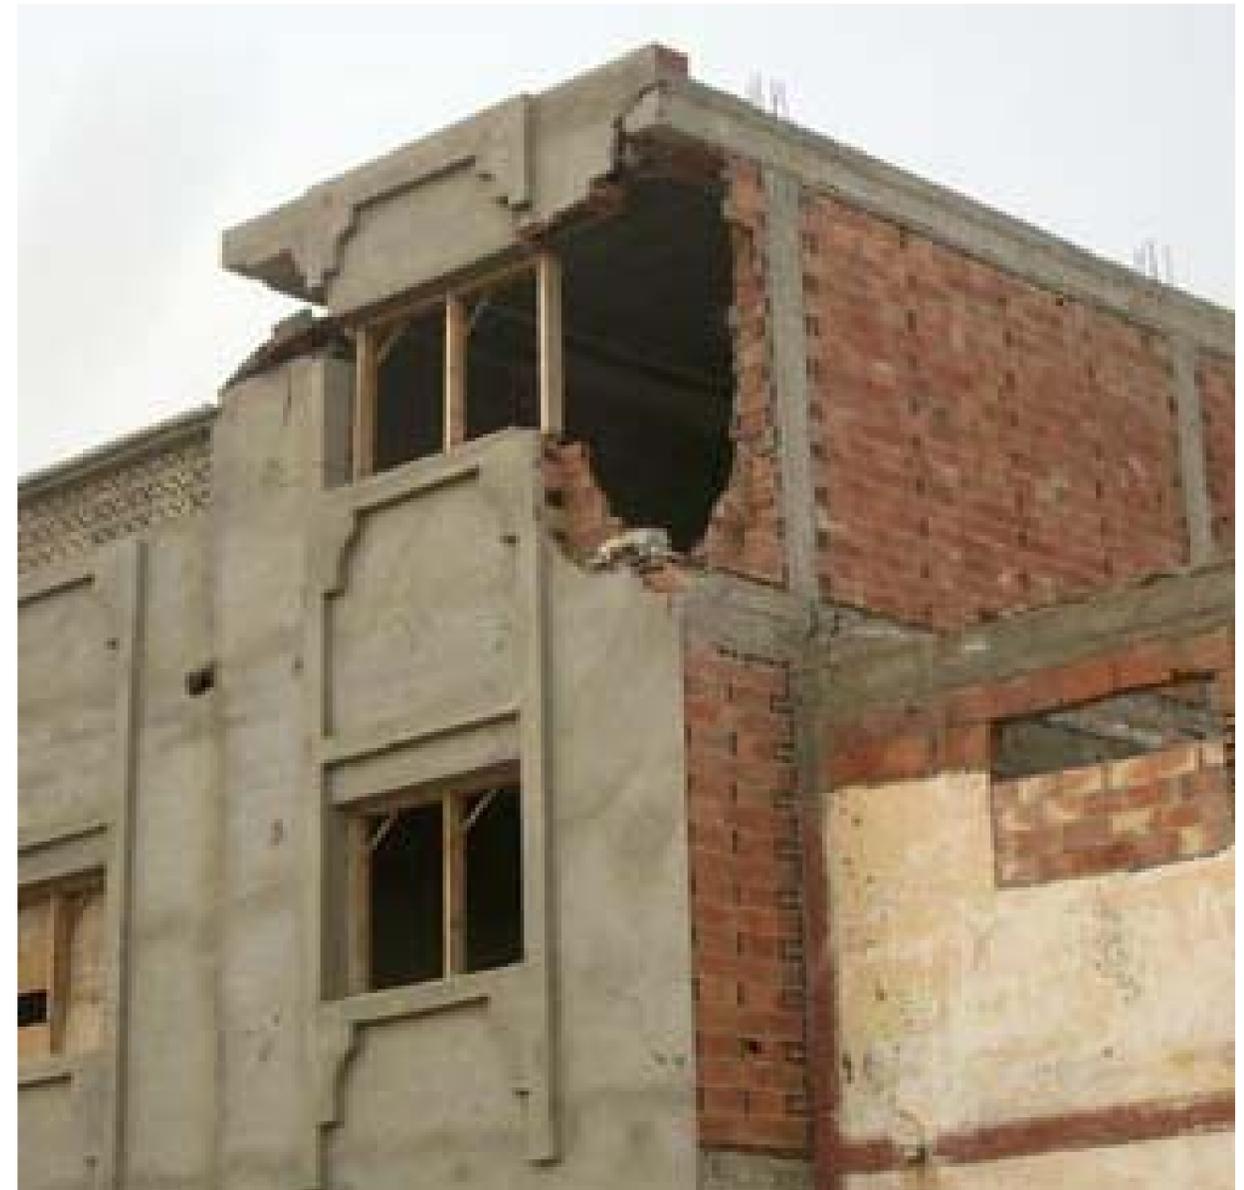
4.4.2 Similar damaged corner. Imzuren. (*grade 2 vulnerability C*)

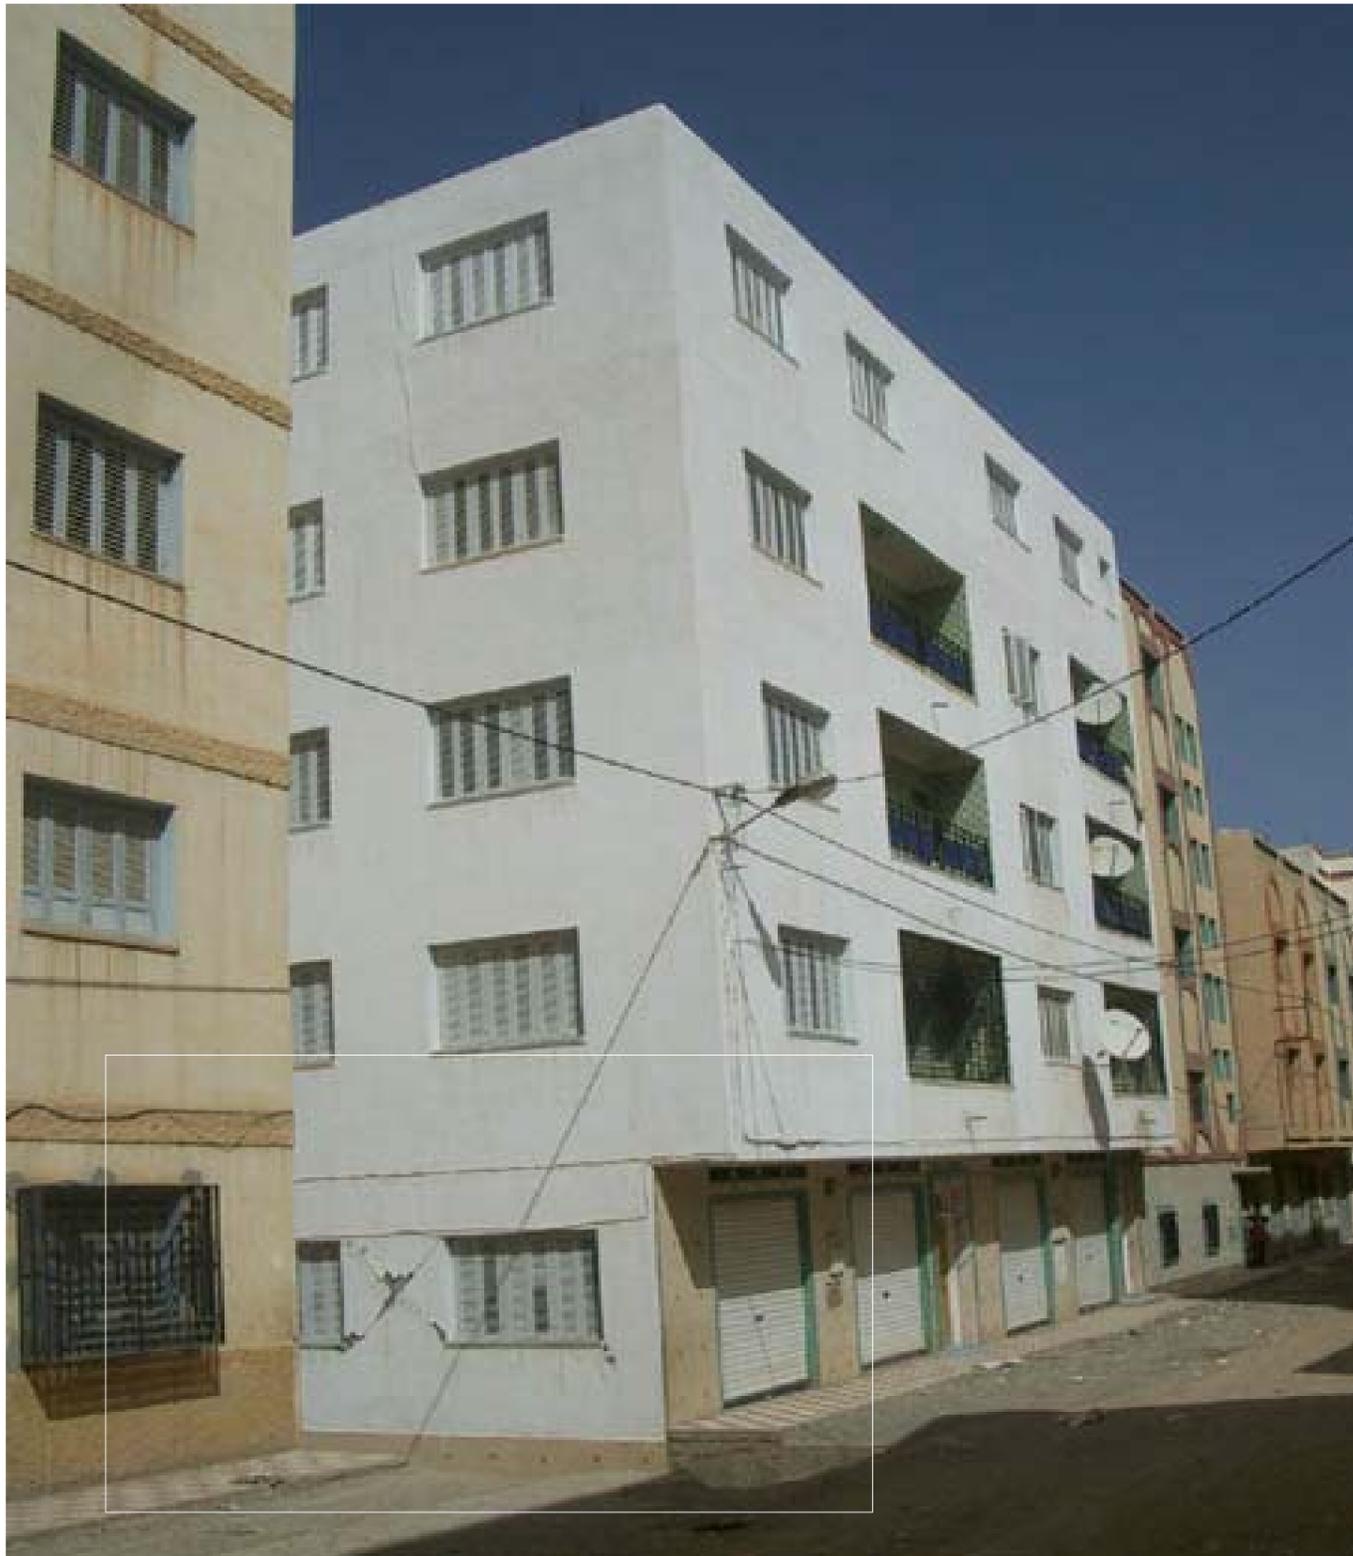
4.5.1 This non structural partition wall has been damaged by shear after being loaded by the movement of the RC structure of the building. Imzuren. (grade 2 Vulnerability C)

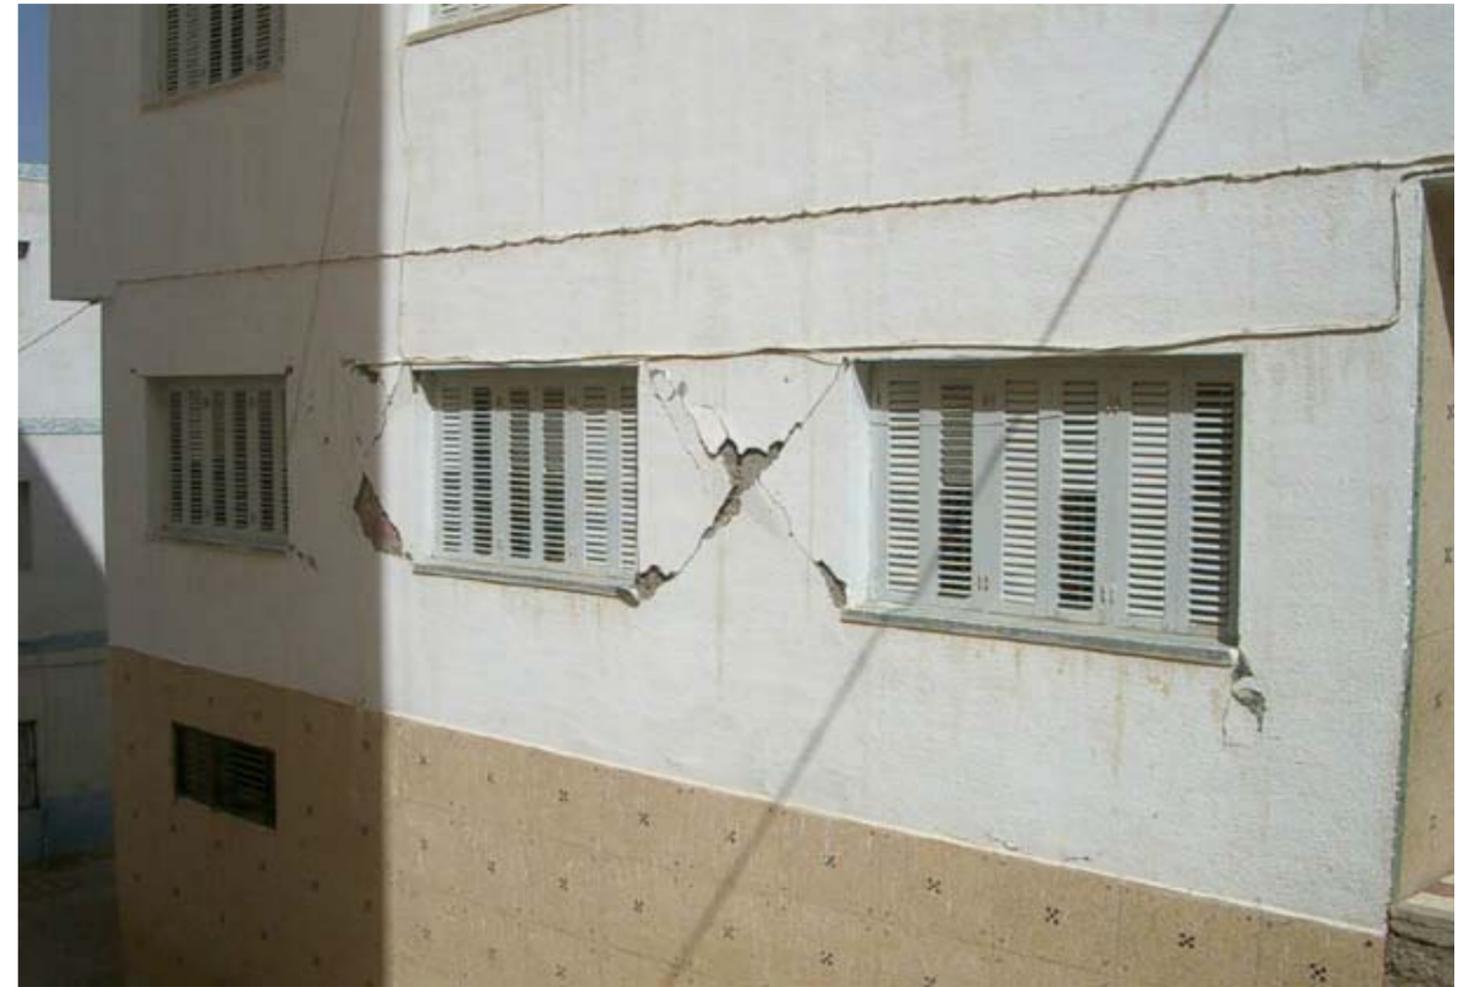
4.5.2 Close-up of the damaged non-structural piers.
