AL-HOCEIMA EARTHQUAKE 24 02 2004

FIELD REPORT

Patrick Murphy Corella *Architect* June 2004

The Al-Hoceima earthquake

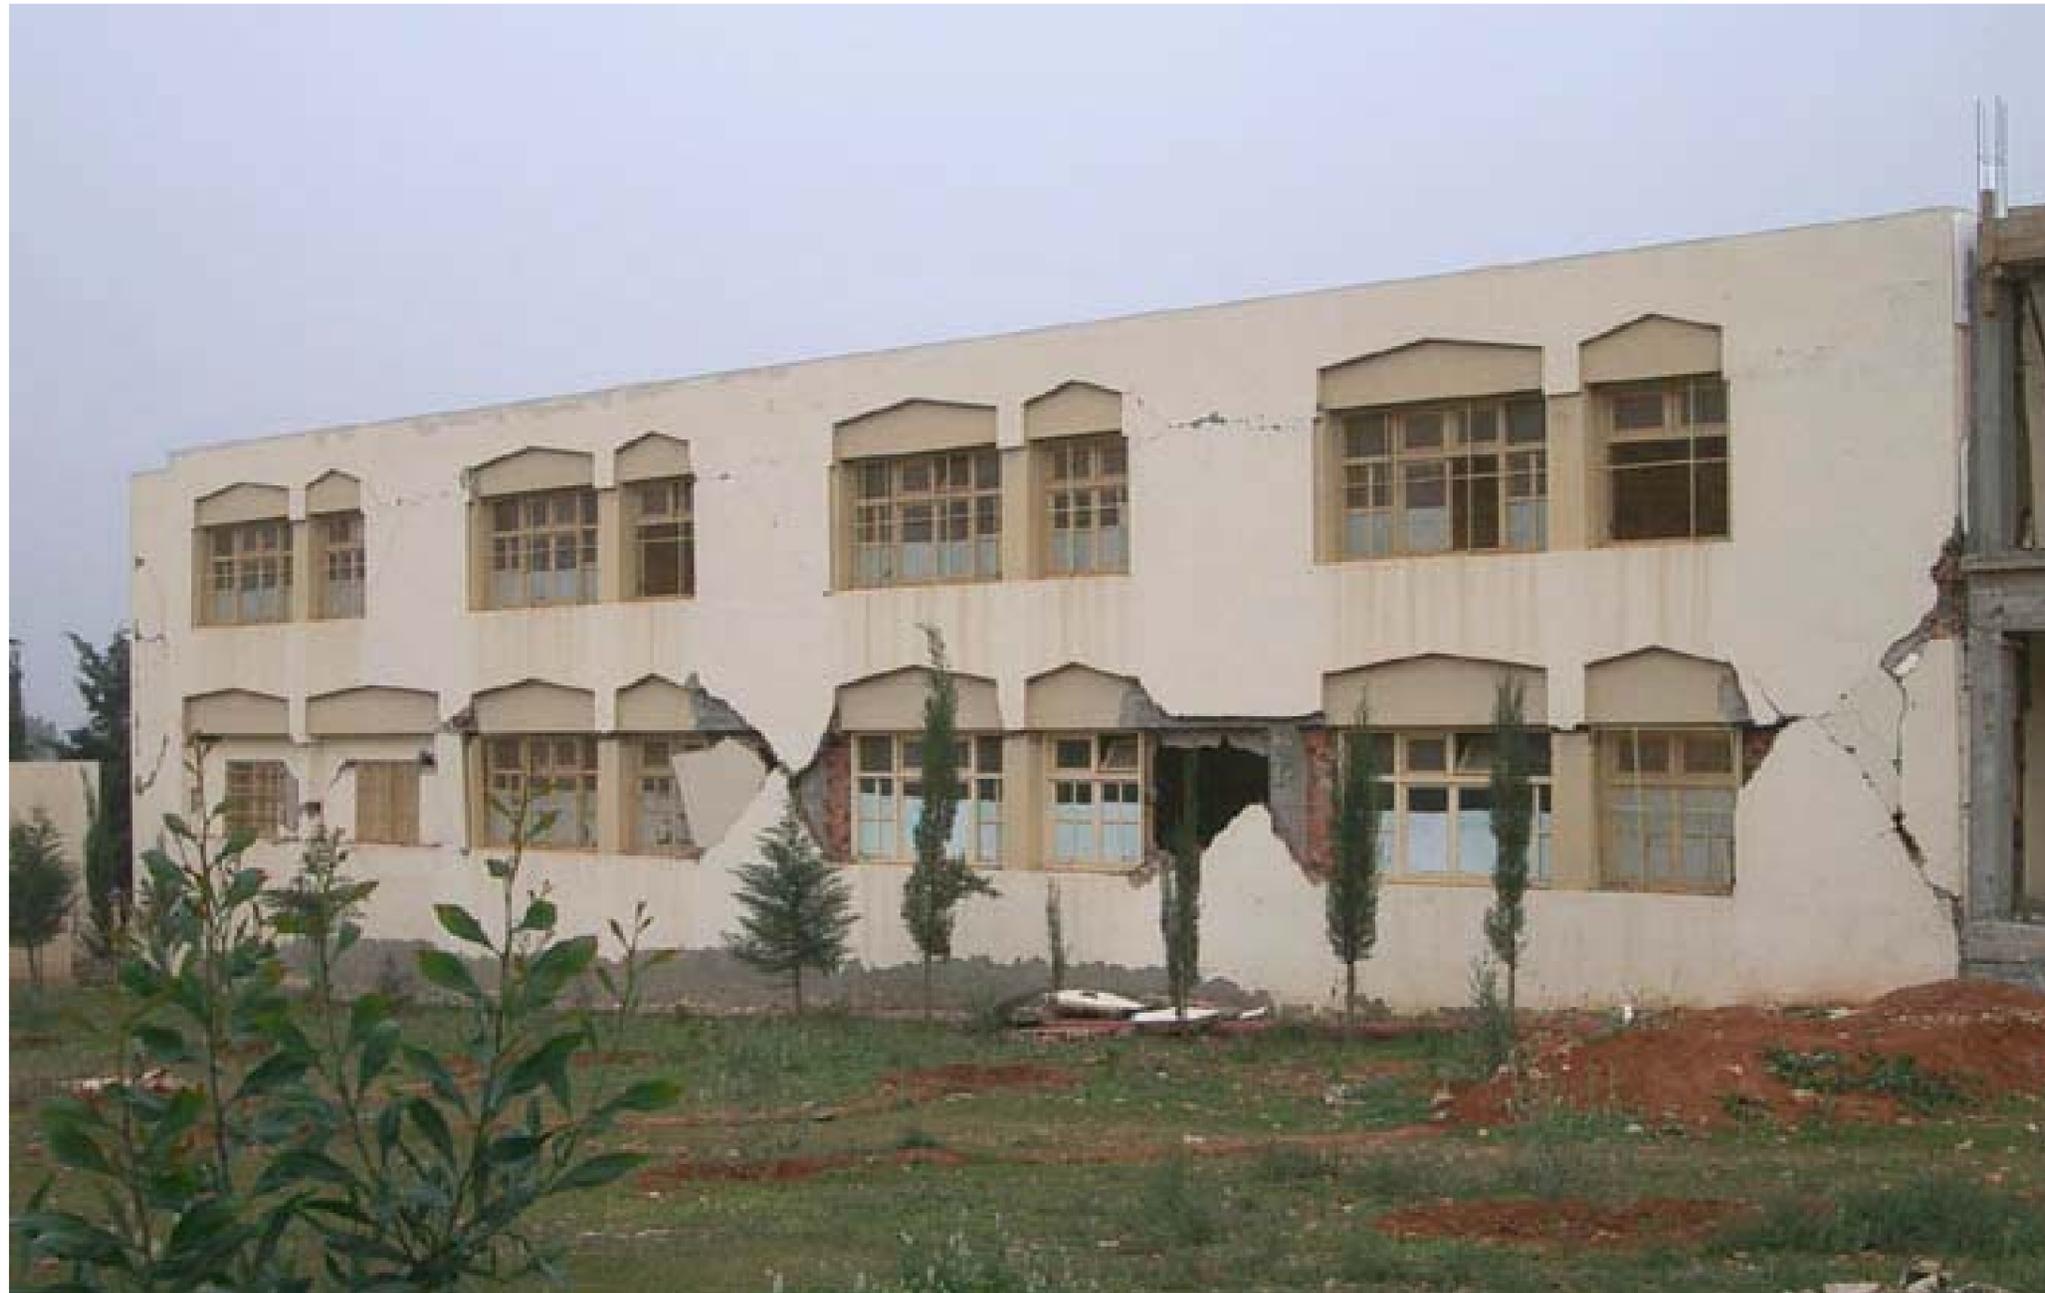
4.6.1 Extensive shear damage to non-loadbearing external walls in this RC school in Imzuren. (grade 3 vulnerability C)

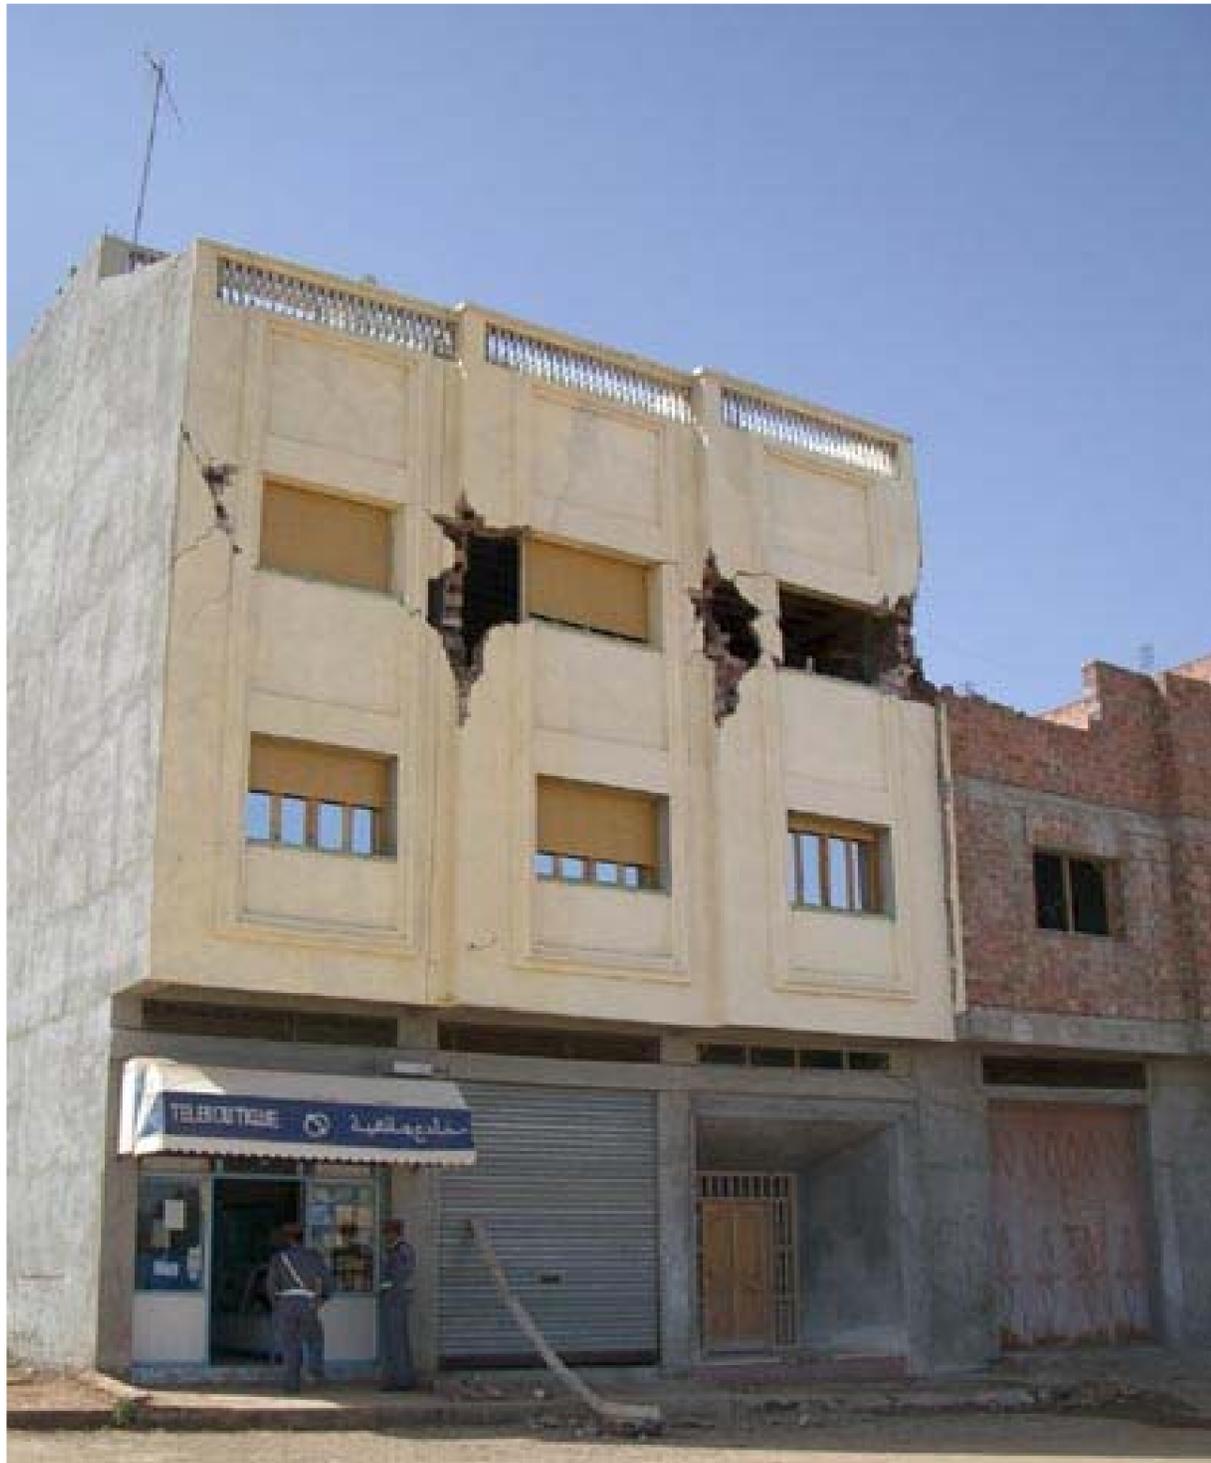
4.7.1 Pounding from the shorter stiffer building on the right has caused localised damage at the level of impact in this building in Imzuren. (*grade 3 vulnerability C*)

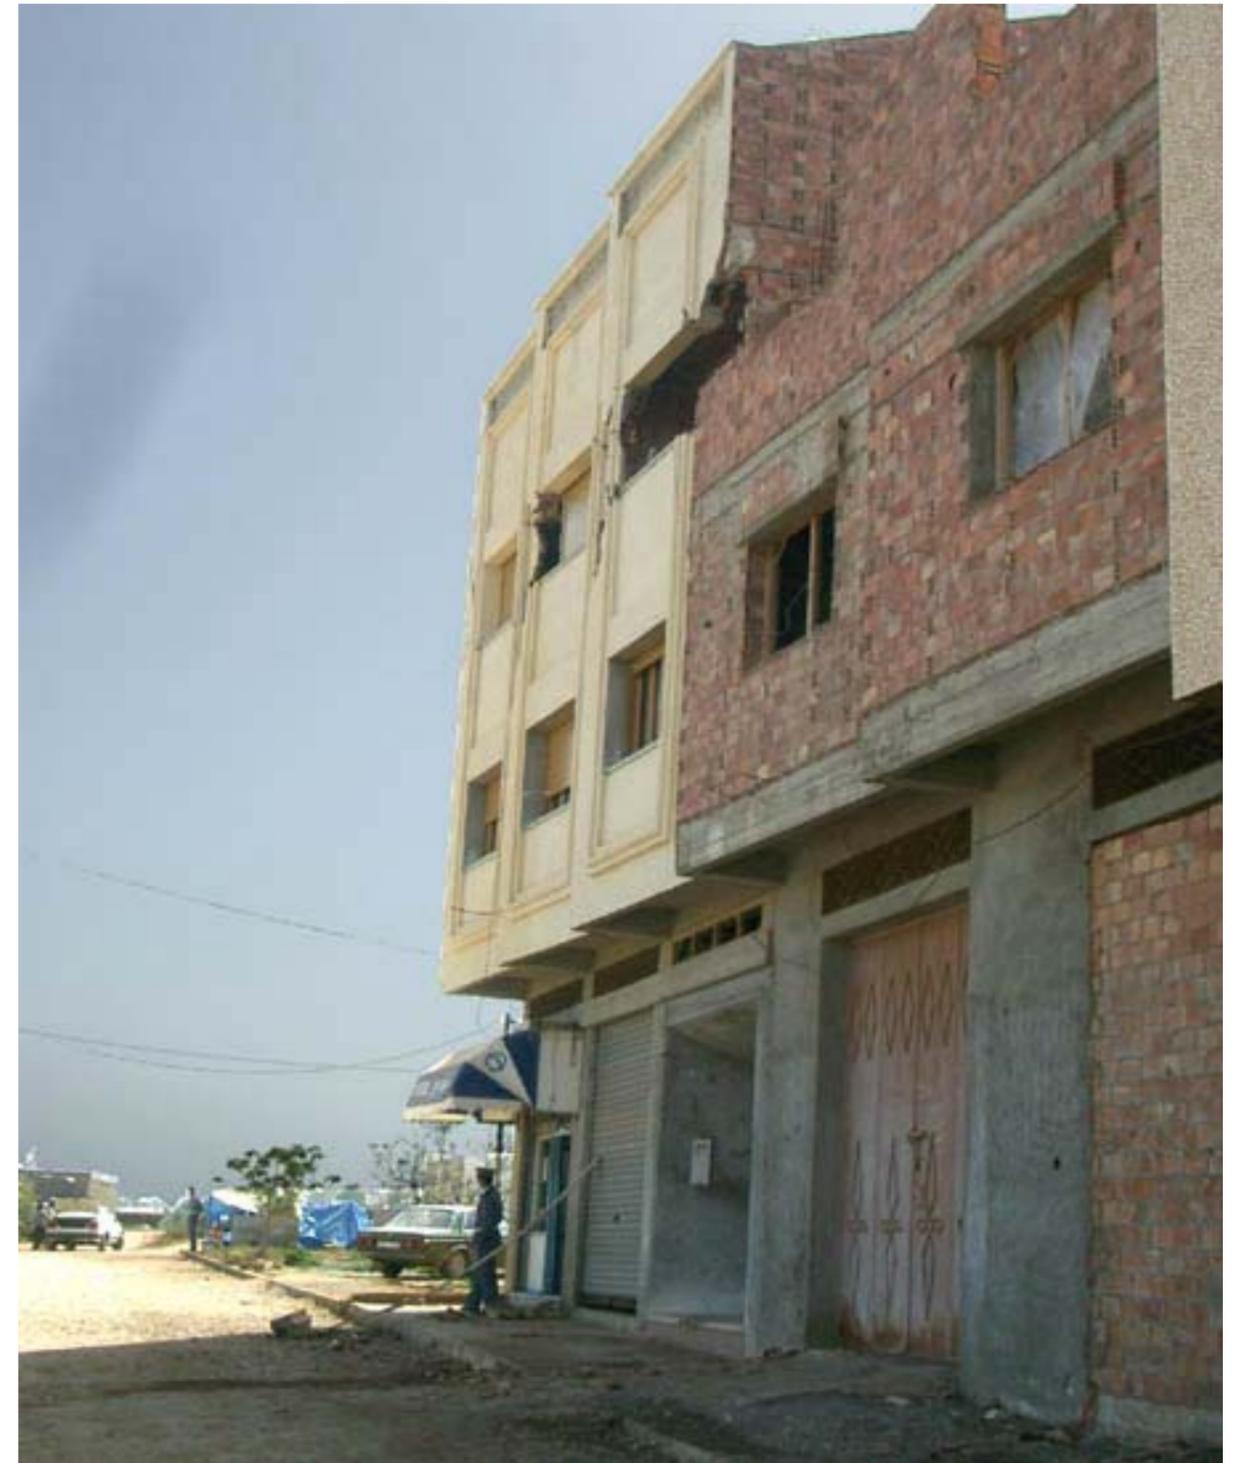
4.7.2 Side view of same building.

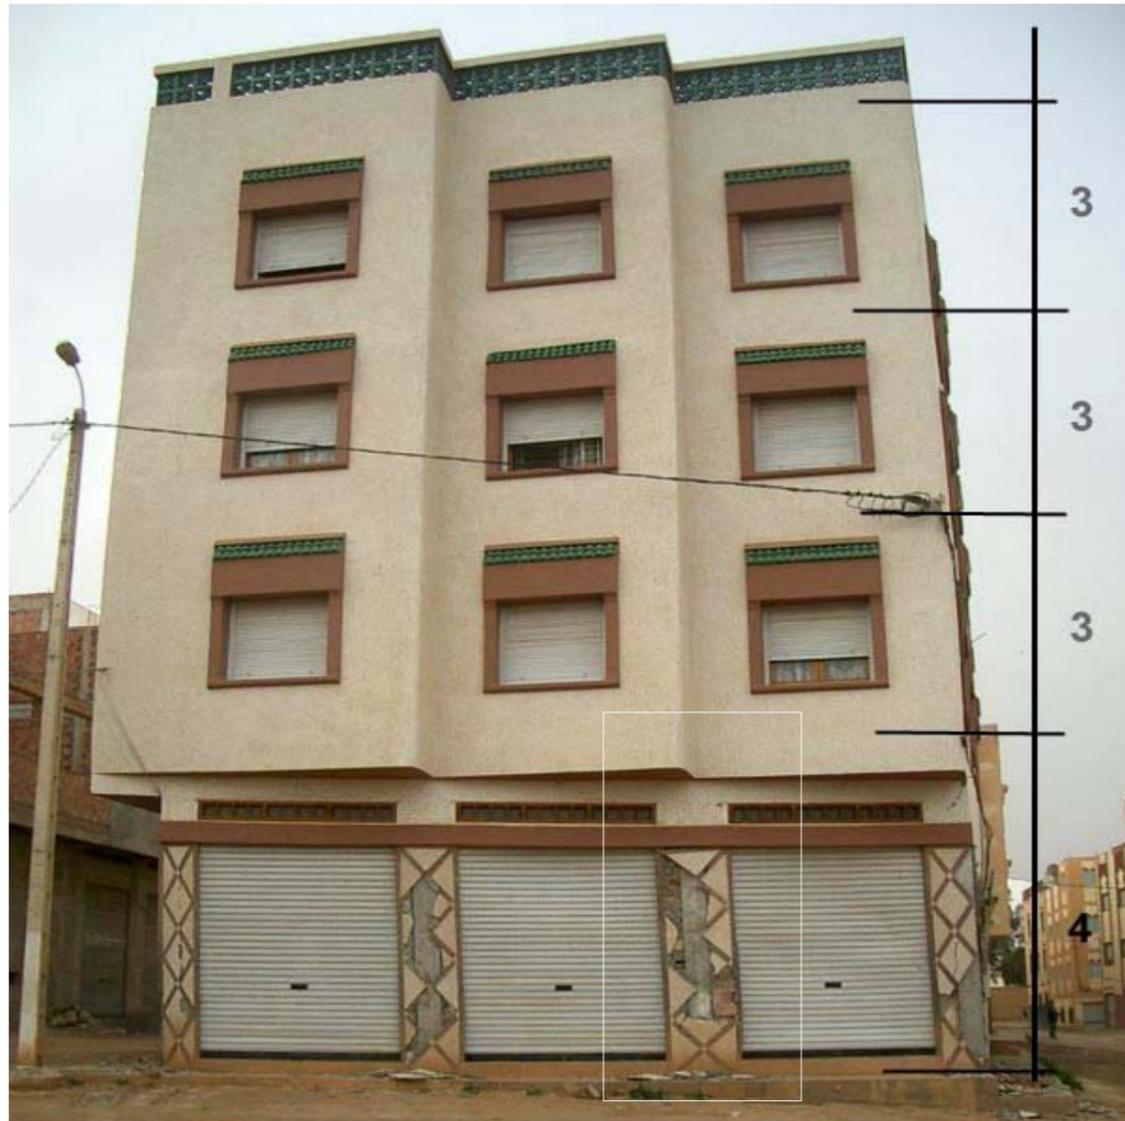
4.9.1 Open plan shops on ground floor with densely compartmented housing above. This was a classic candidate for soft storey damage. In this building in Imzuren the upper floors have drifted over the ground floor causing plastic hinges and permanent deformations. (grade 4 vulnerability C)

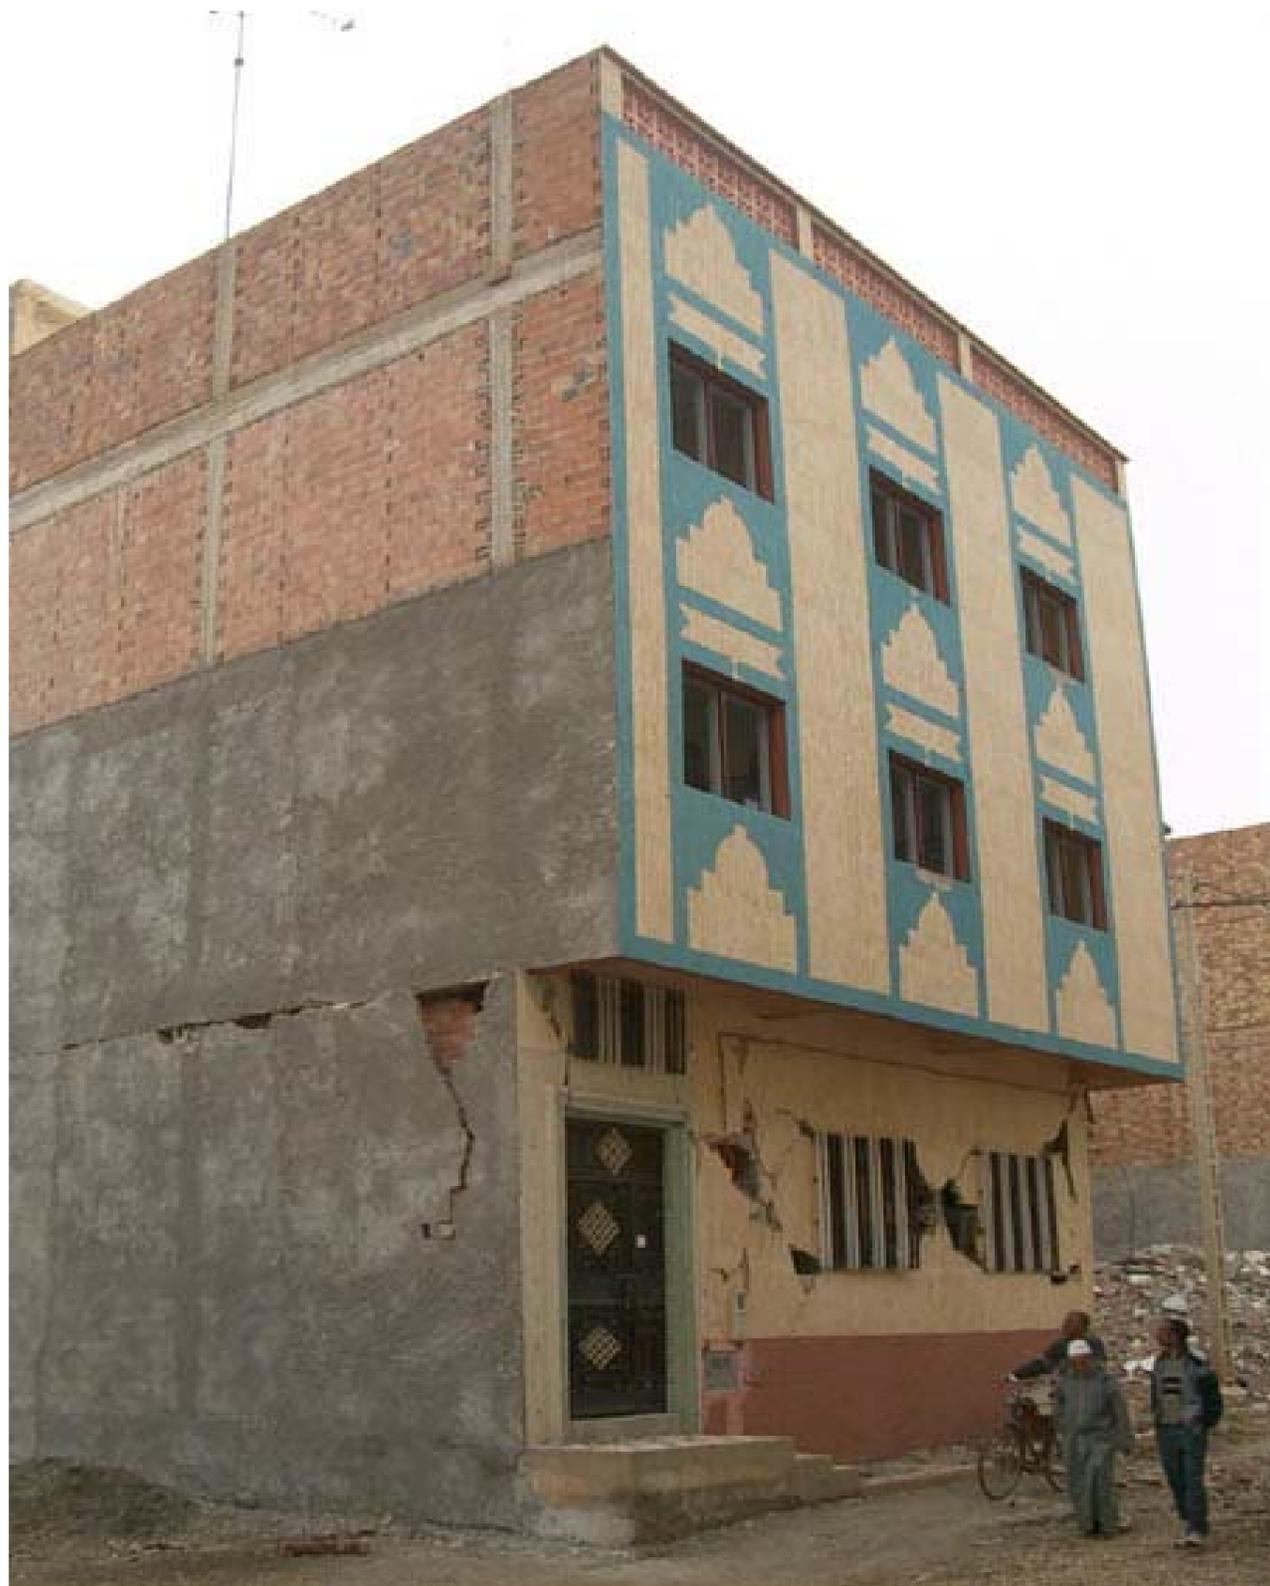
4.10.1 Soft storey damage in Imzuren. (*grade 3 vulnerability C*)

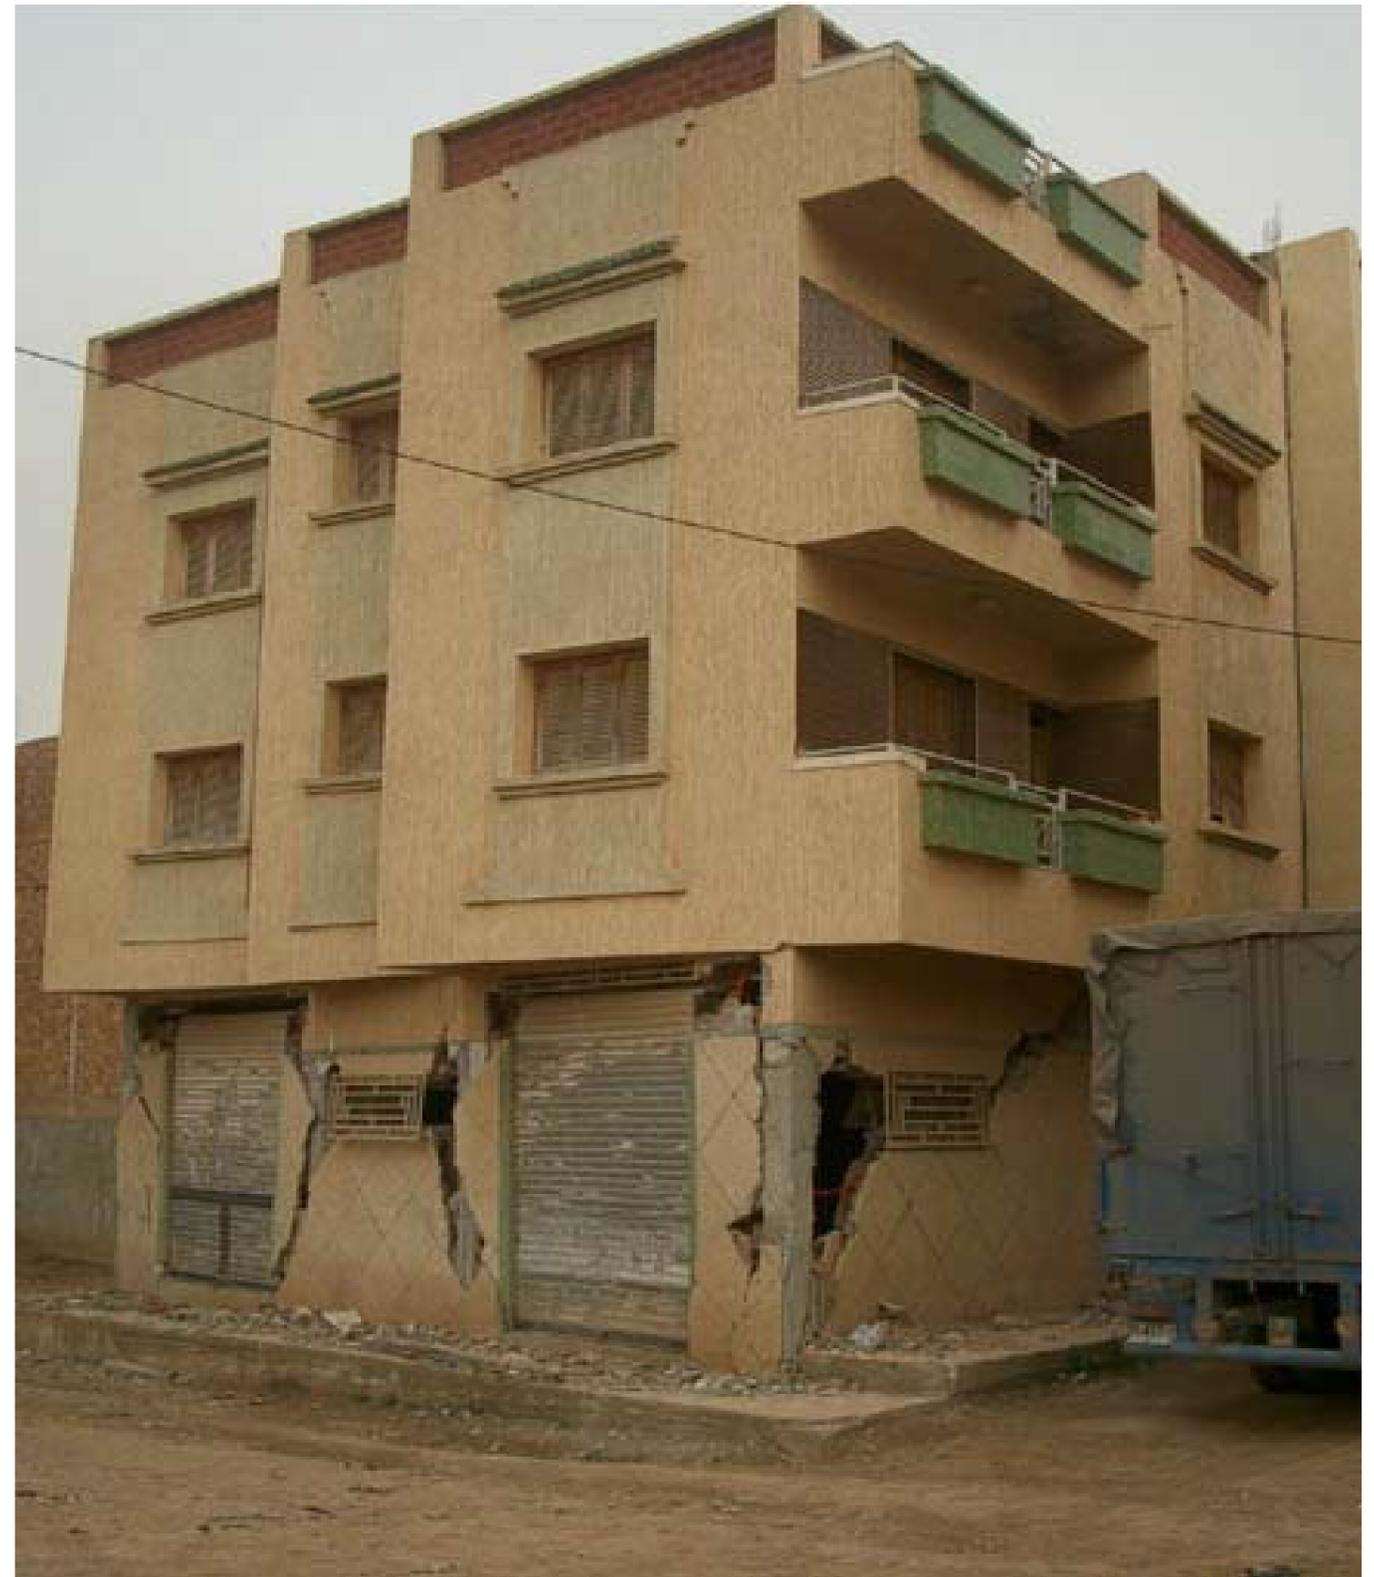
4.10.2 Soft storey damage in Imzuren. (*grade 3 vulnerability C*)

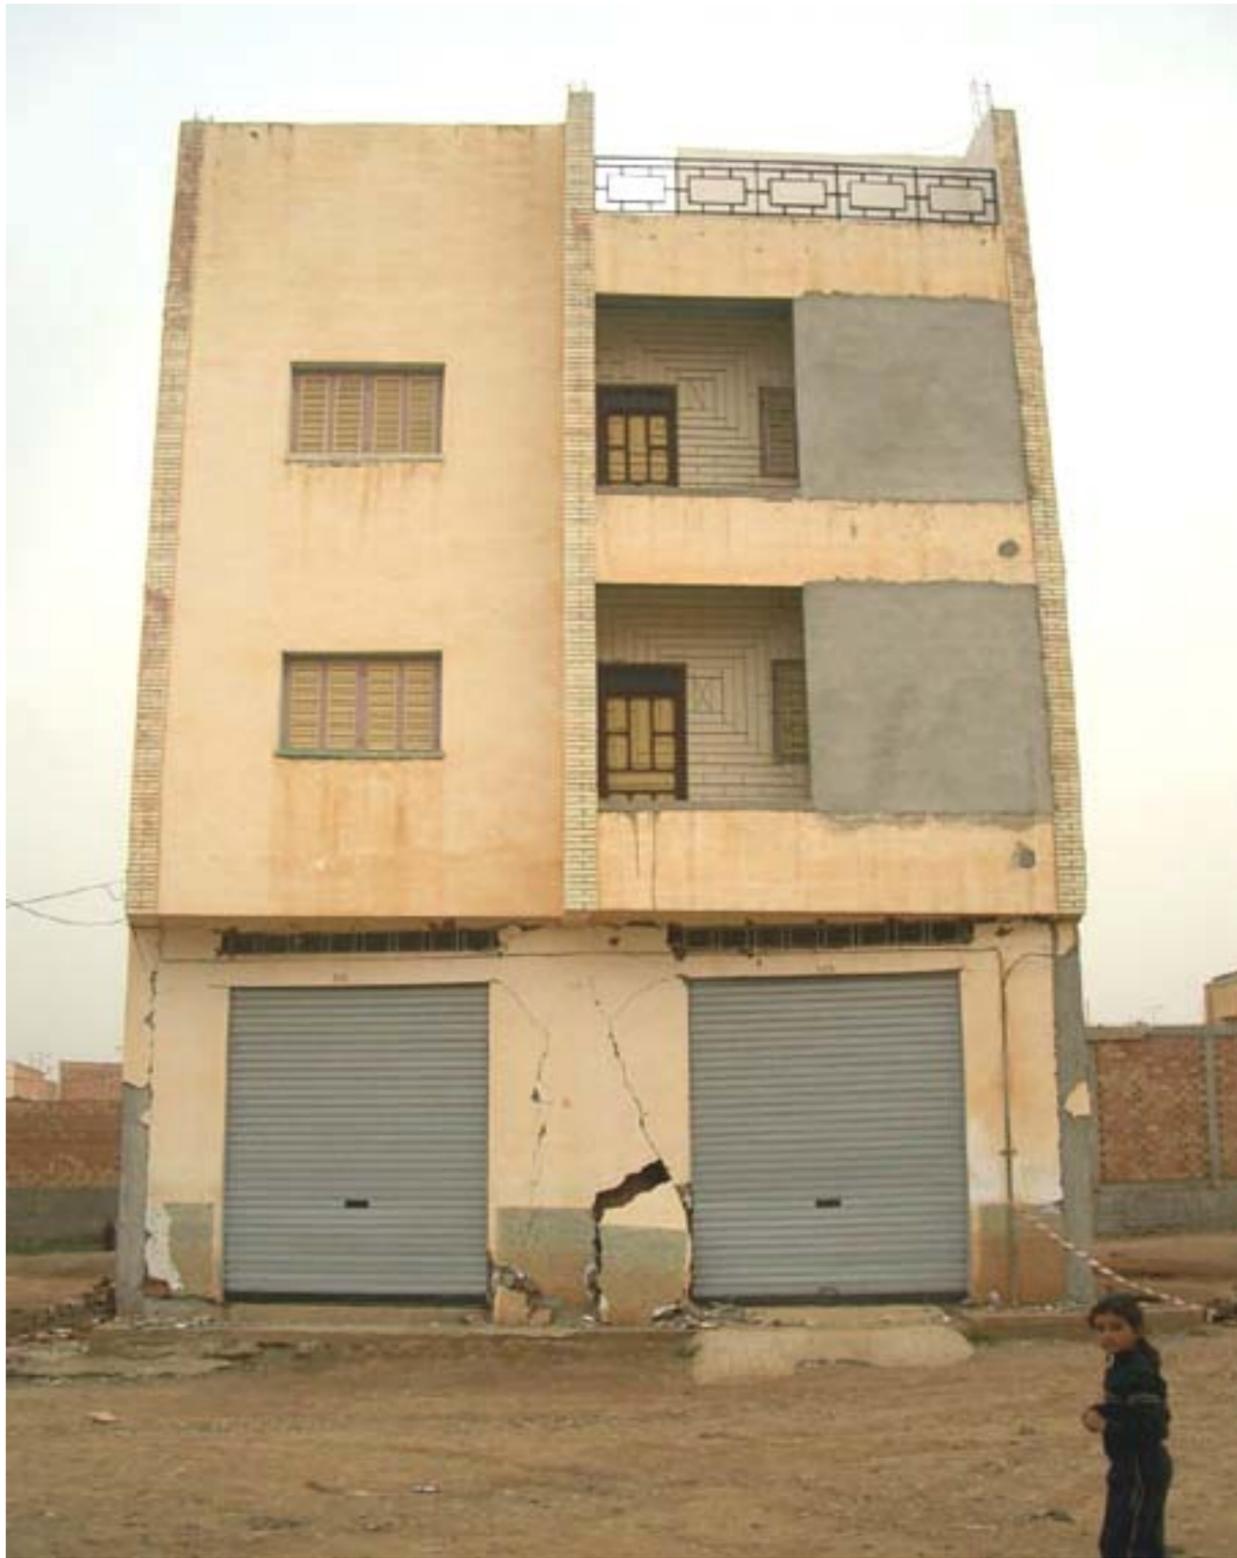
4.11.1 Soft storey damage in Imzuren. (*grade 2 vulnerability C*)

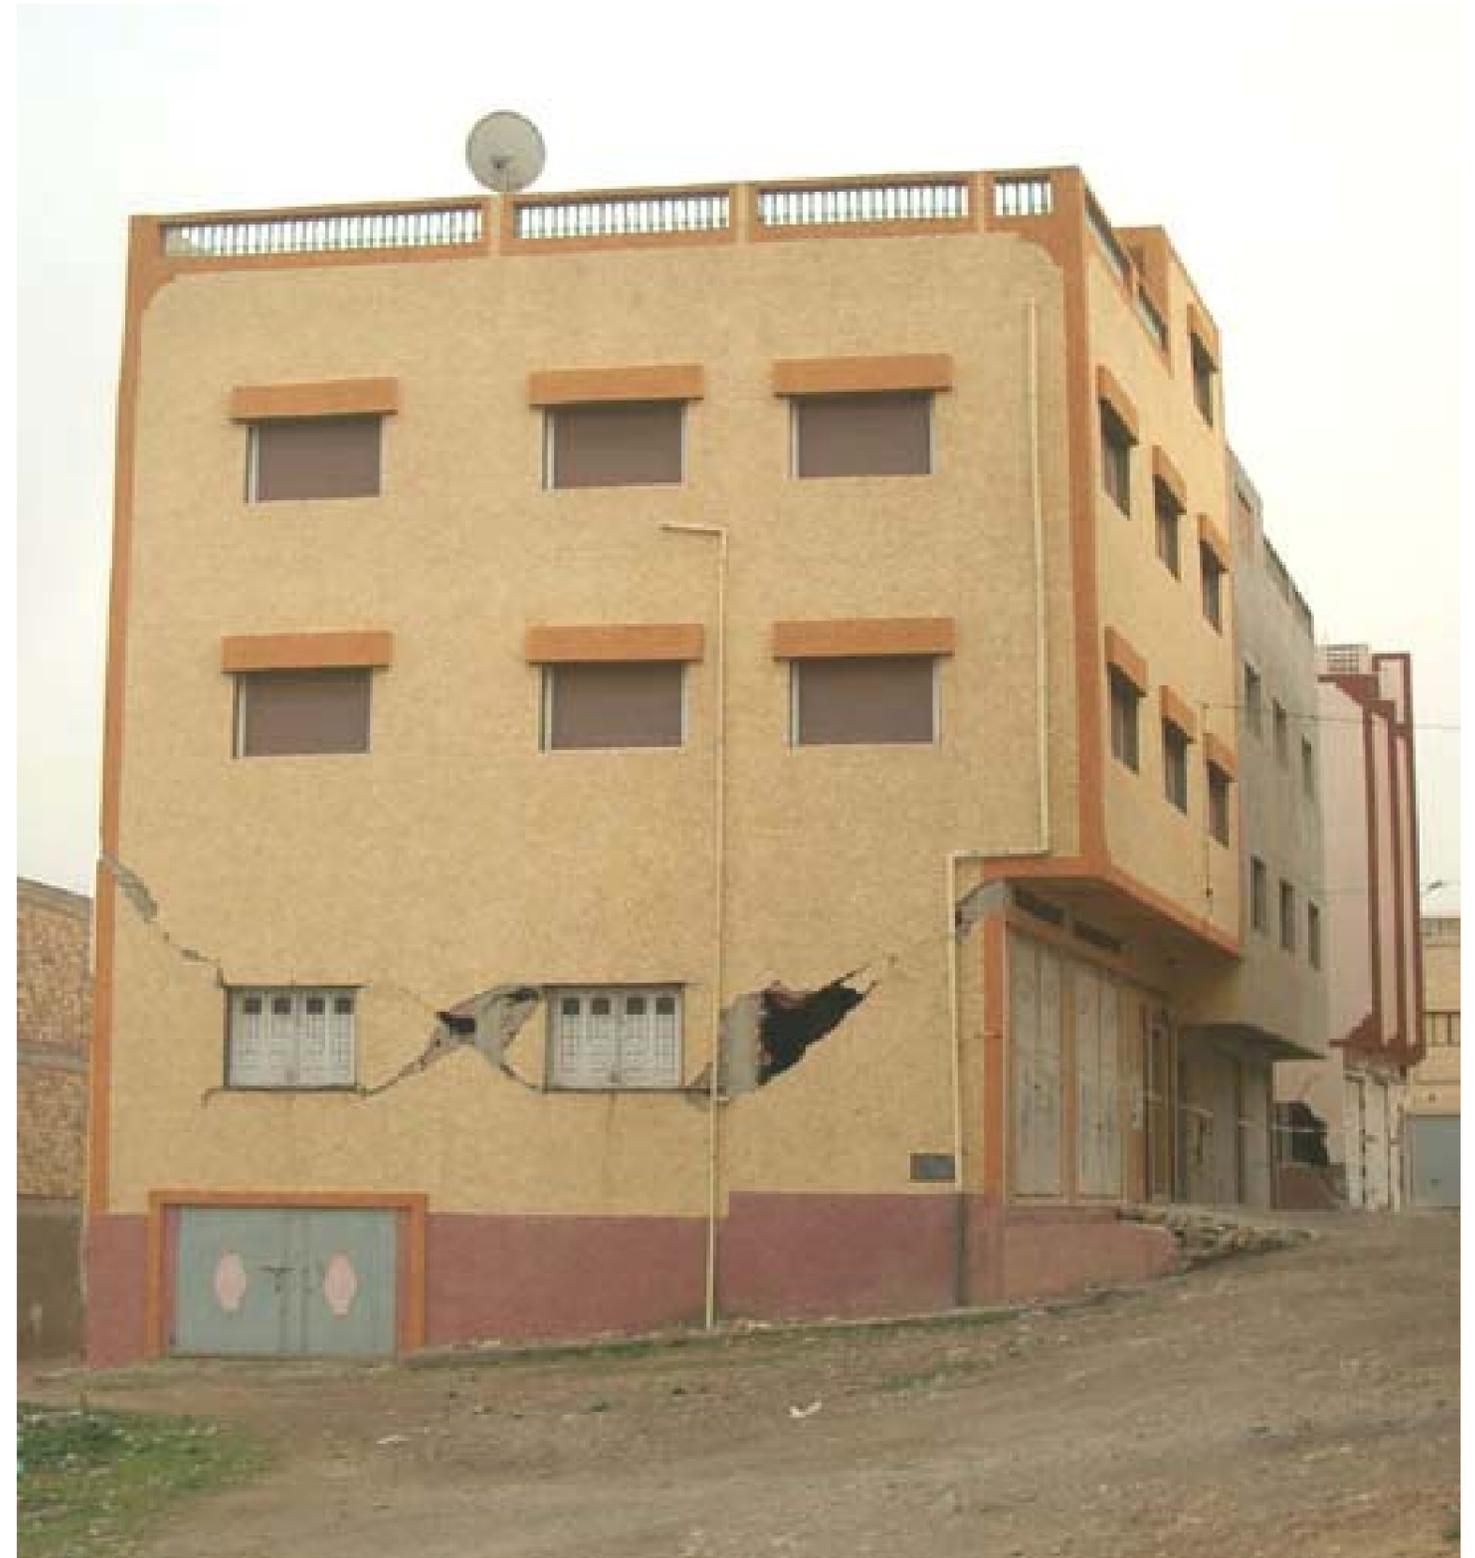
4.11.2 Soft storey damage in Imzuren. (*grade 2 vulnerability C*)

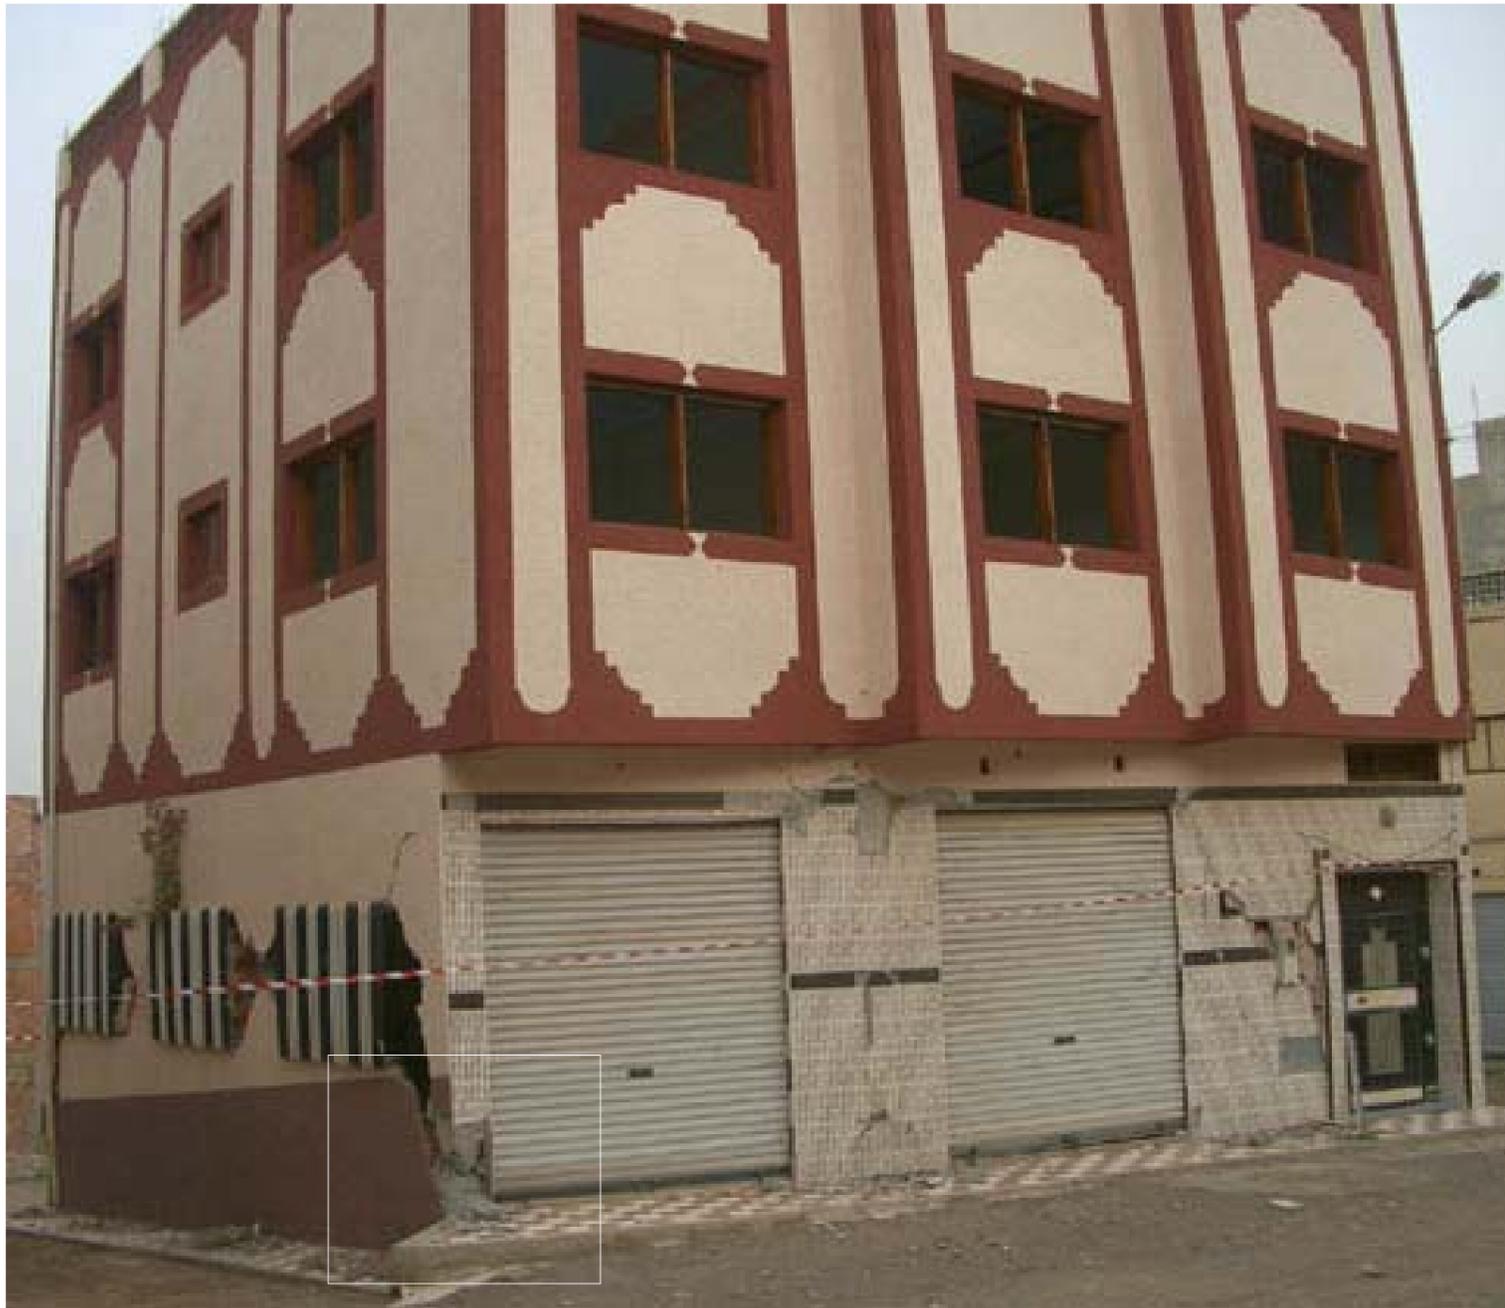
4.12.1 Soft storey damage in Imzuren. (*grade 3 vulnerability C*) Note plastic hinge on base of column on a building which appears undamaged at first glance.

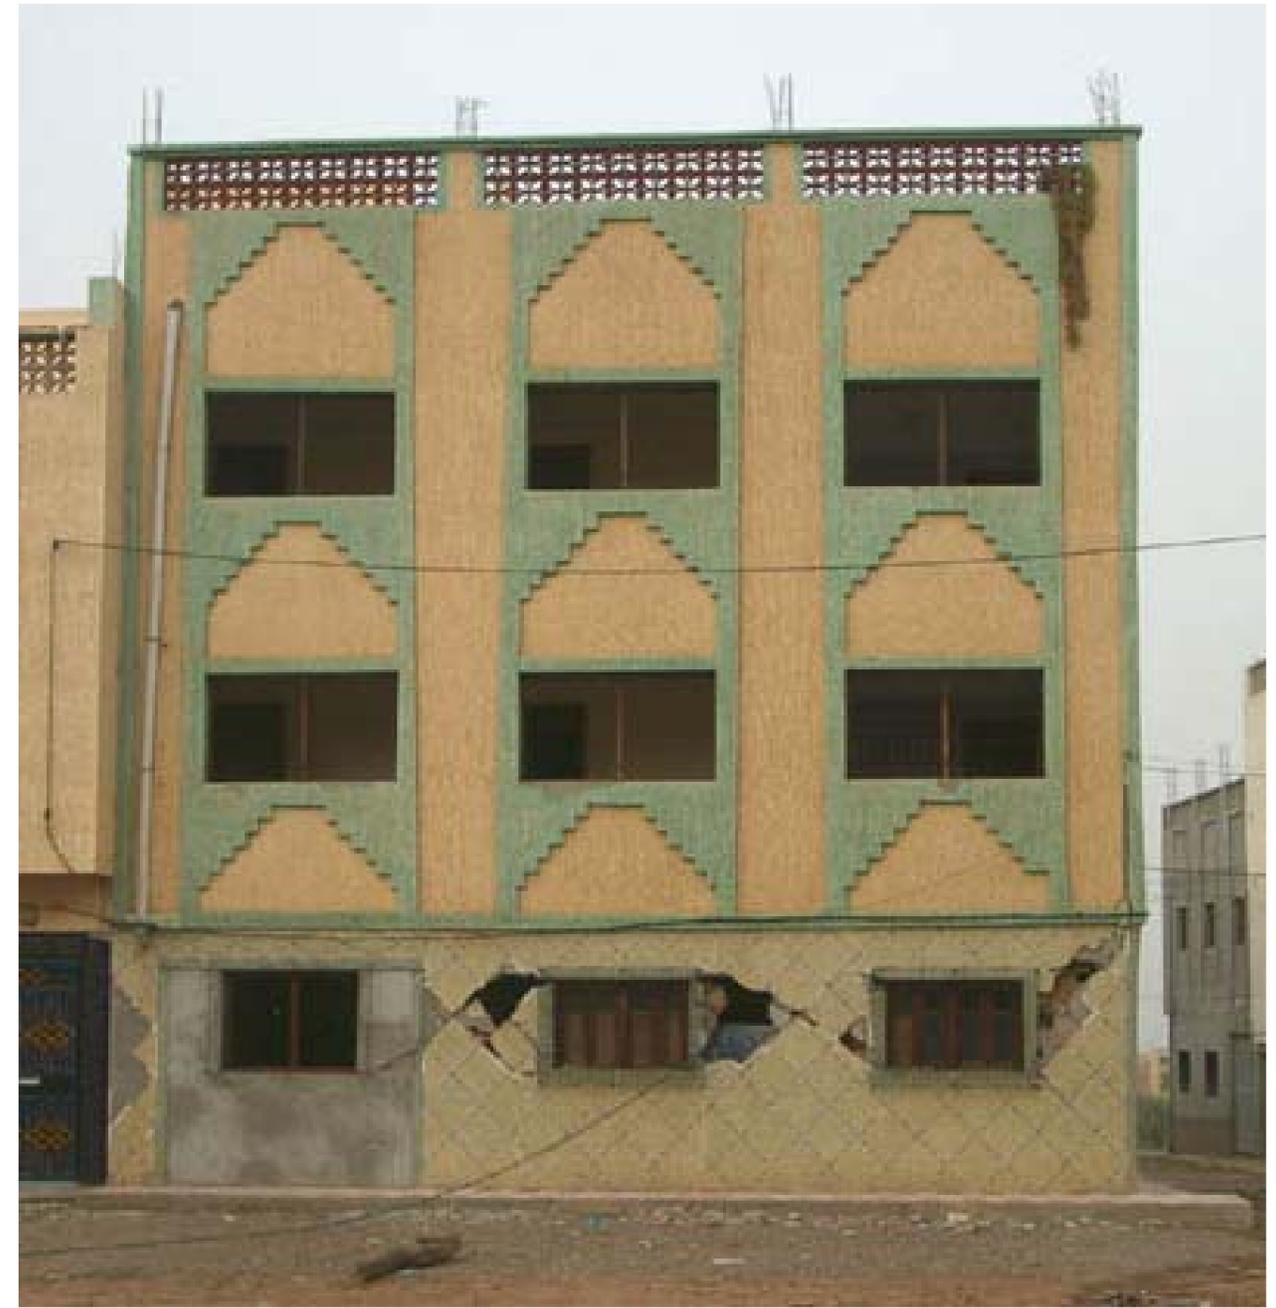
4.12.2 Soft storey damage in Imzuren. (*grade 2 vulnerability C*)

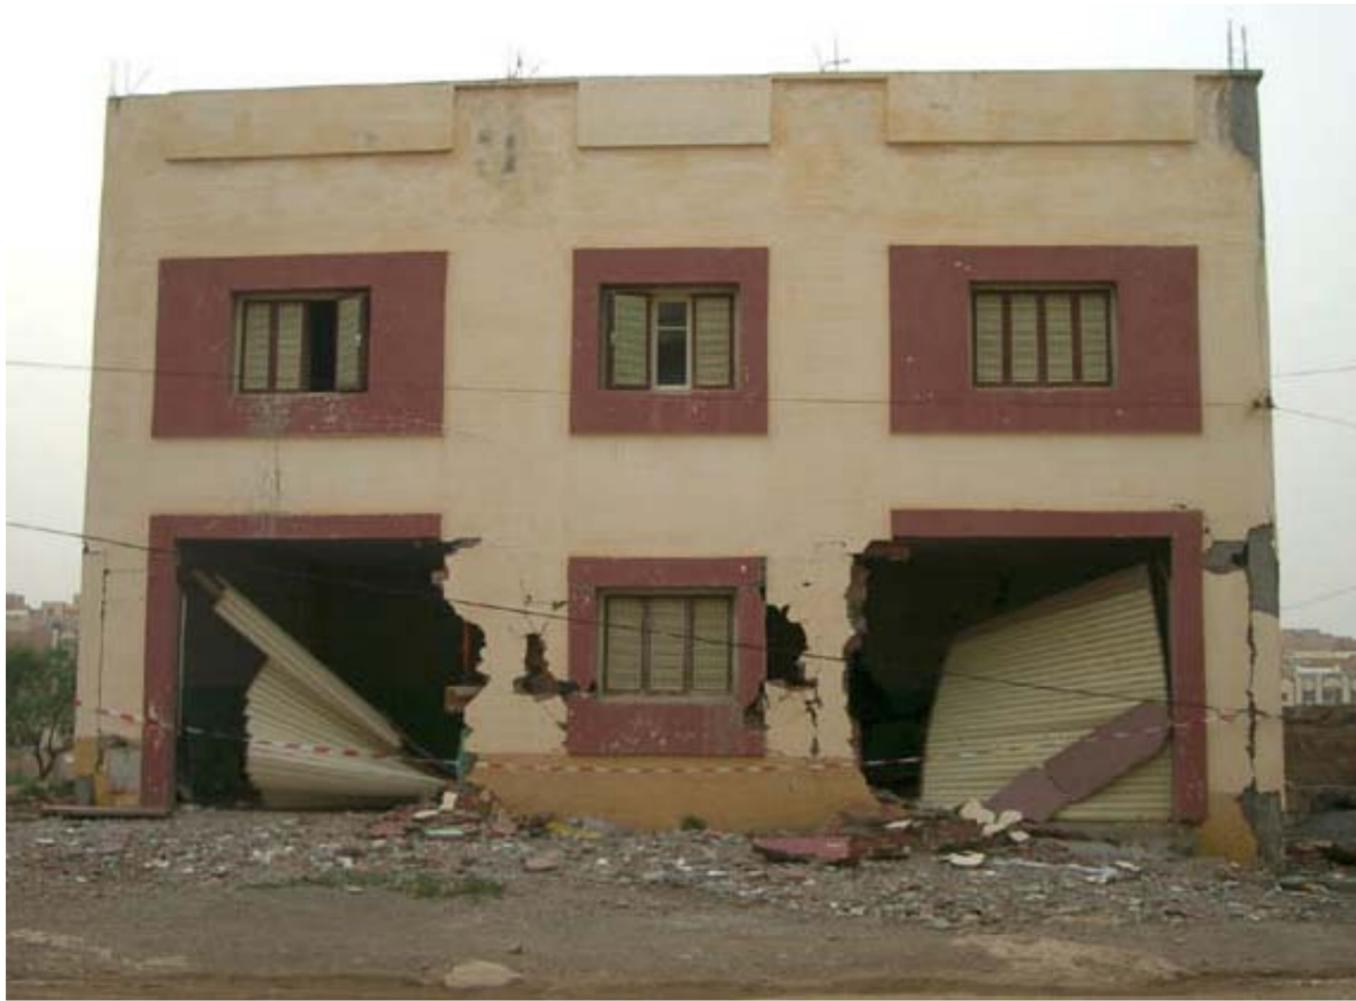
4.13.1 Soft storey damage in Imzuren. (*grade 3 vulnerability C*)

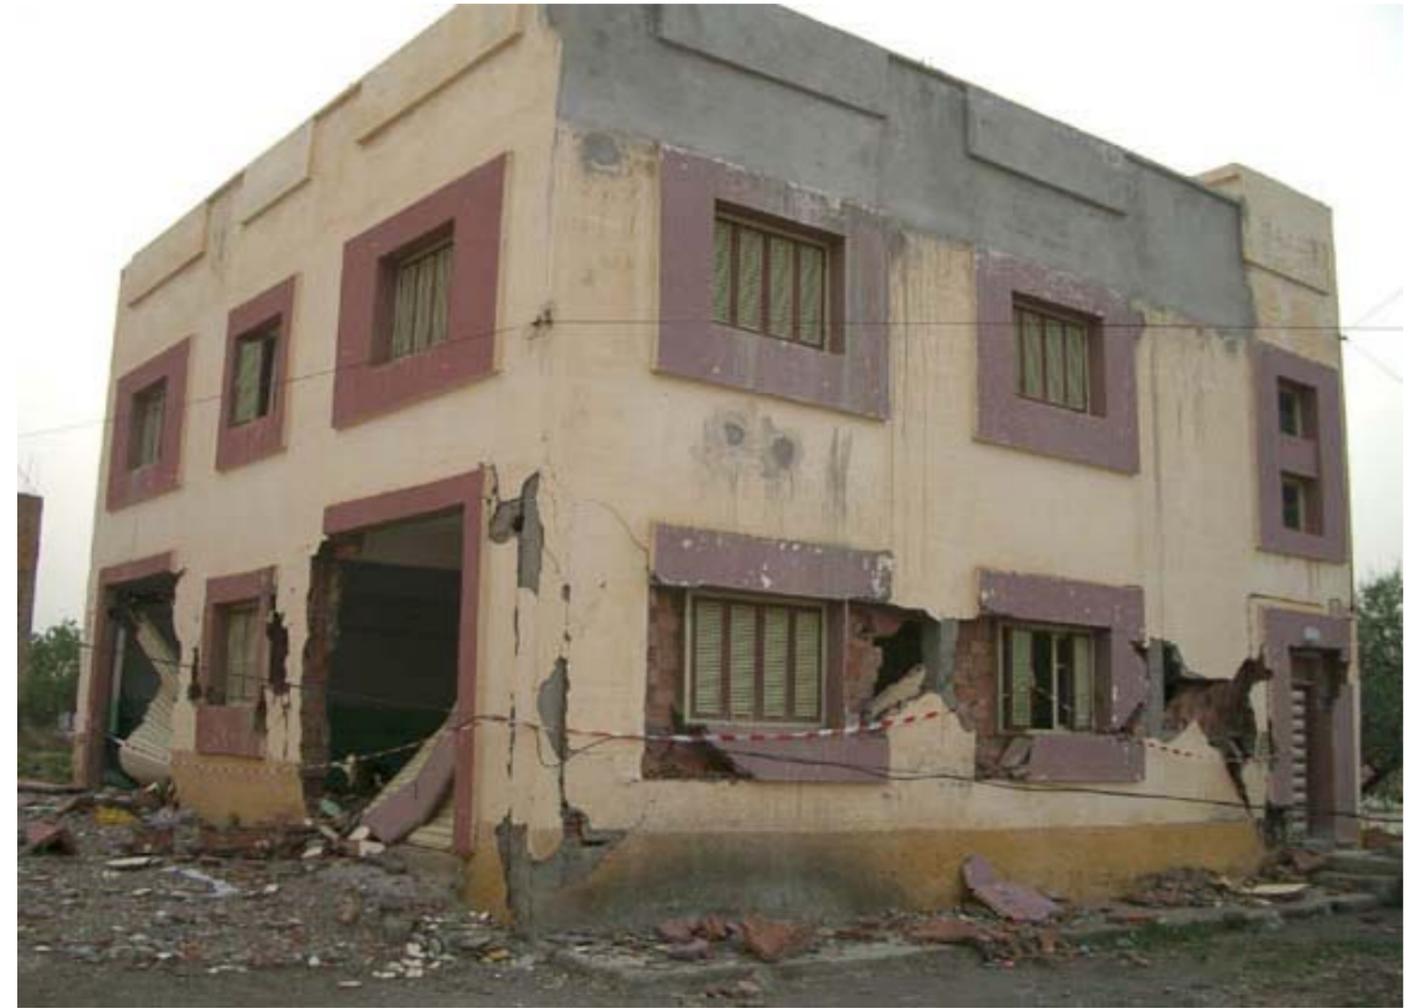
4.13.2 Side view.
