AL-HOCEIMA EARTHQUAKE 24 02 2004

FIELD REPORT

Patrick Murphy Corella *Architect* June 2004

The Al-Hoceima earthquake

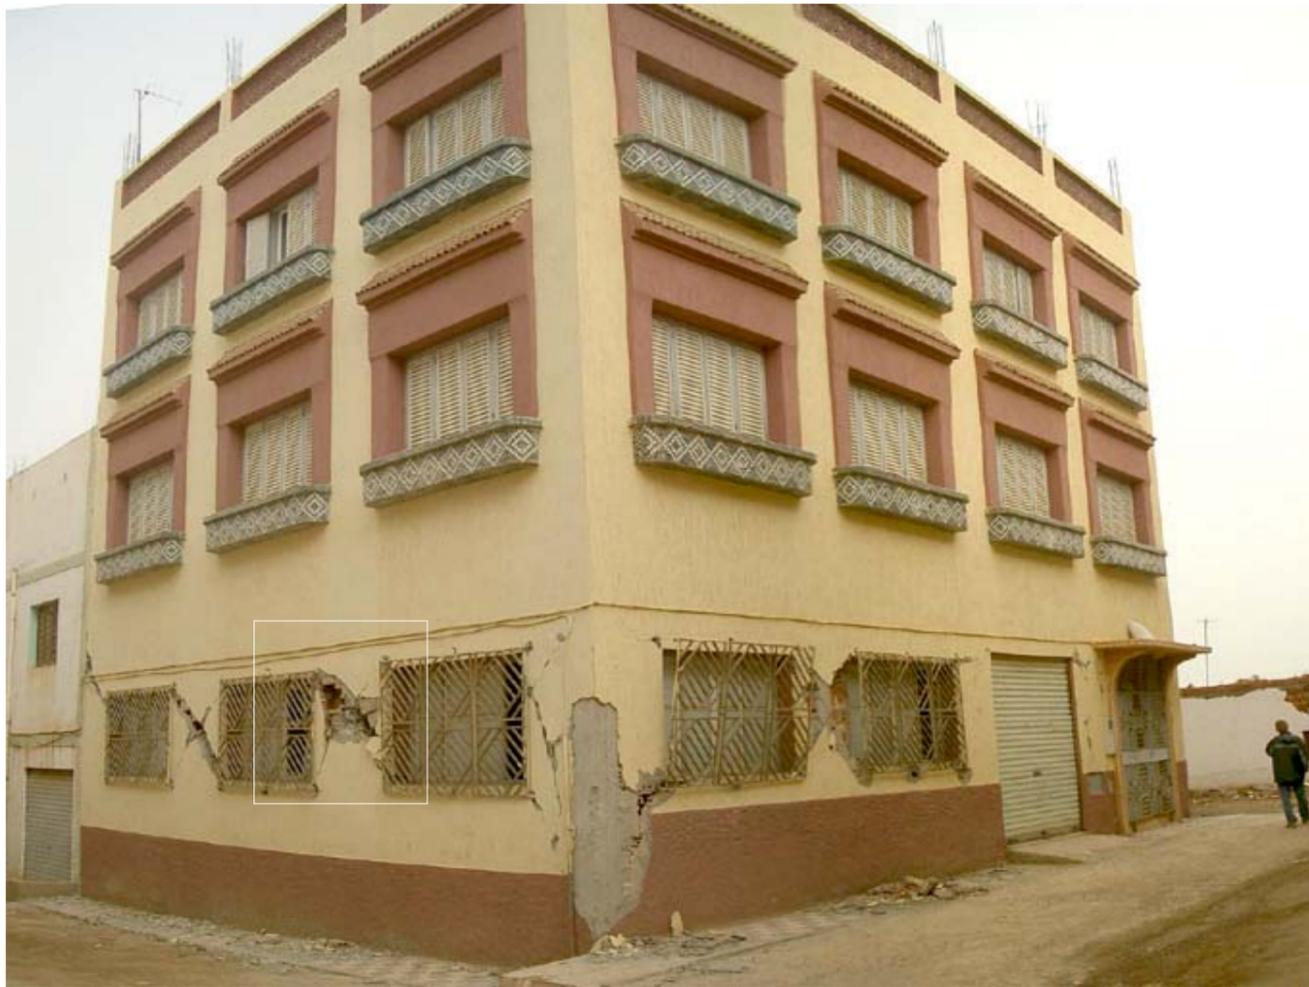
5.1.1 Short column damage in Imzuren. (grade 4 vulnerability C)

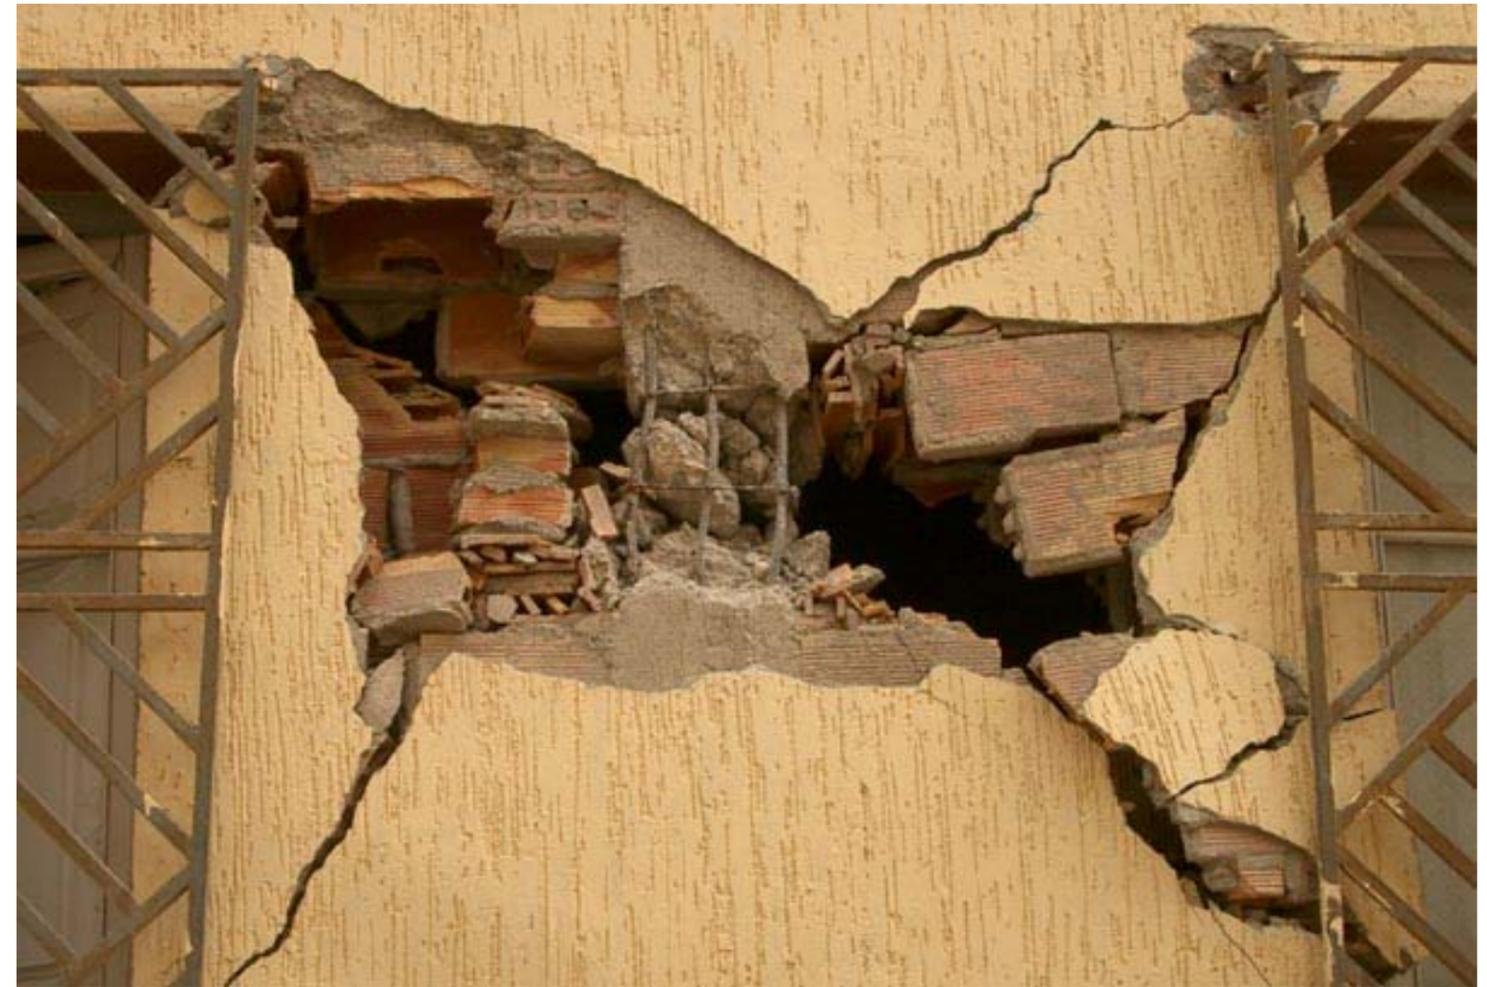
5.1.2 Detail of damaged column.

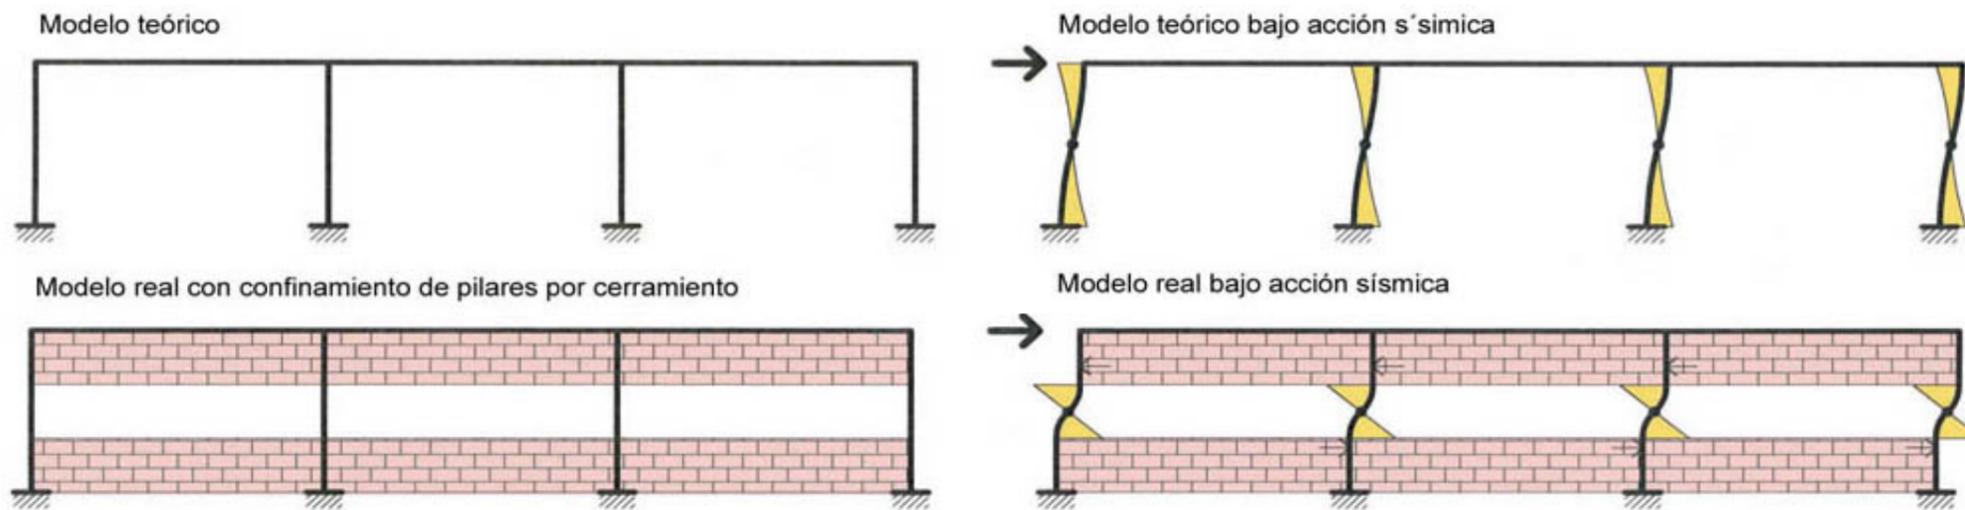
5.1.3 Captured column; the expected performance of a column as foreseen on top is compromised by the restraining action of the partitioning brickwork, resulting in a 'shorter' column taking on all the shear force.

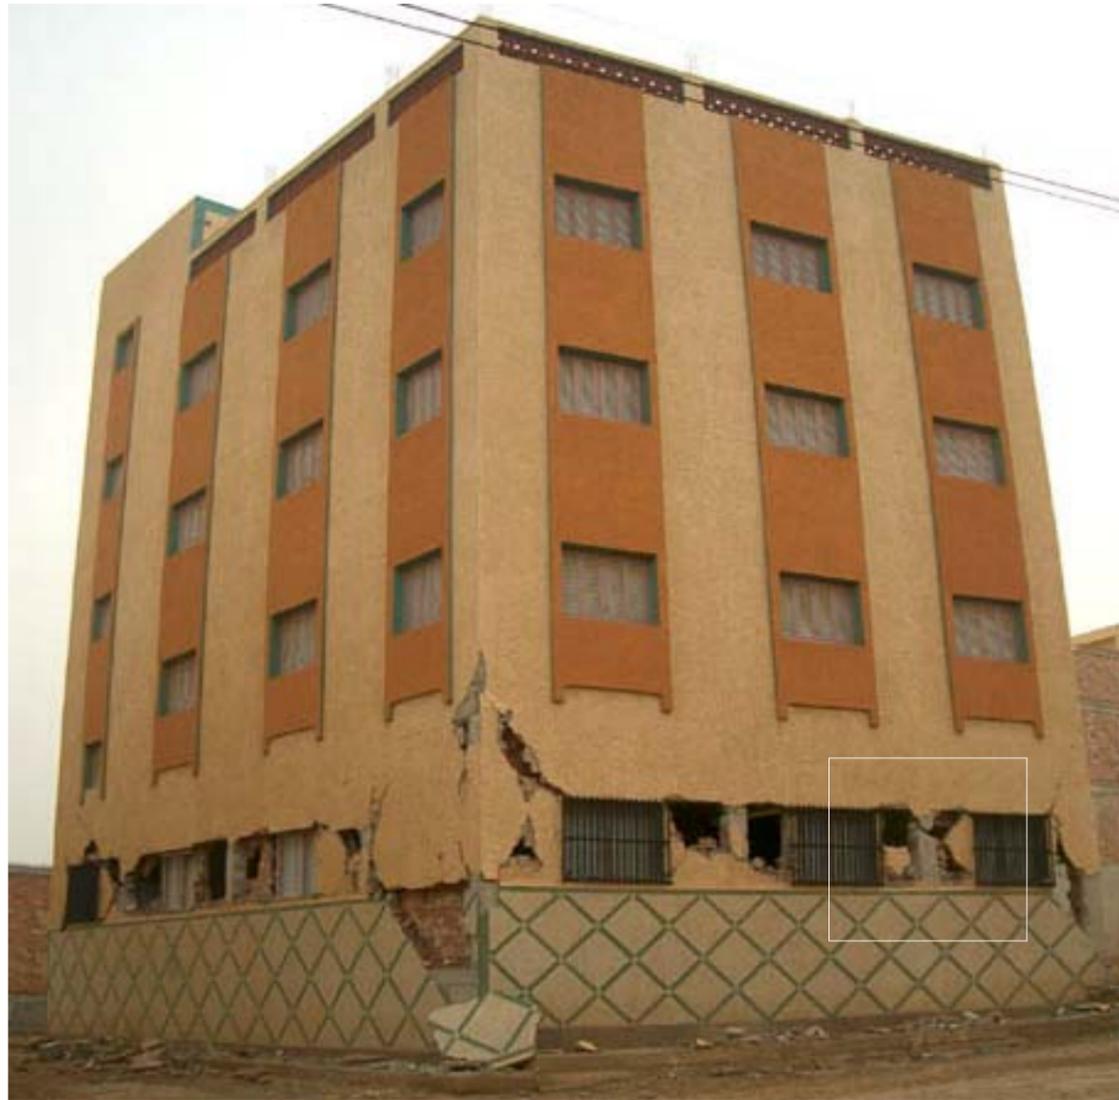
5.2.1 Short column damage in Imzuren. (grade 4 vulnerability C)

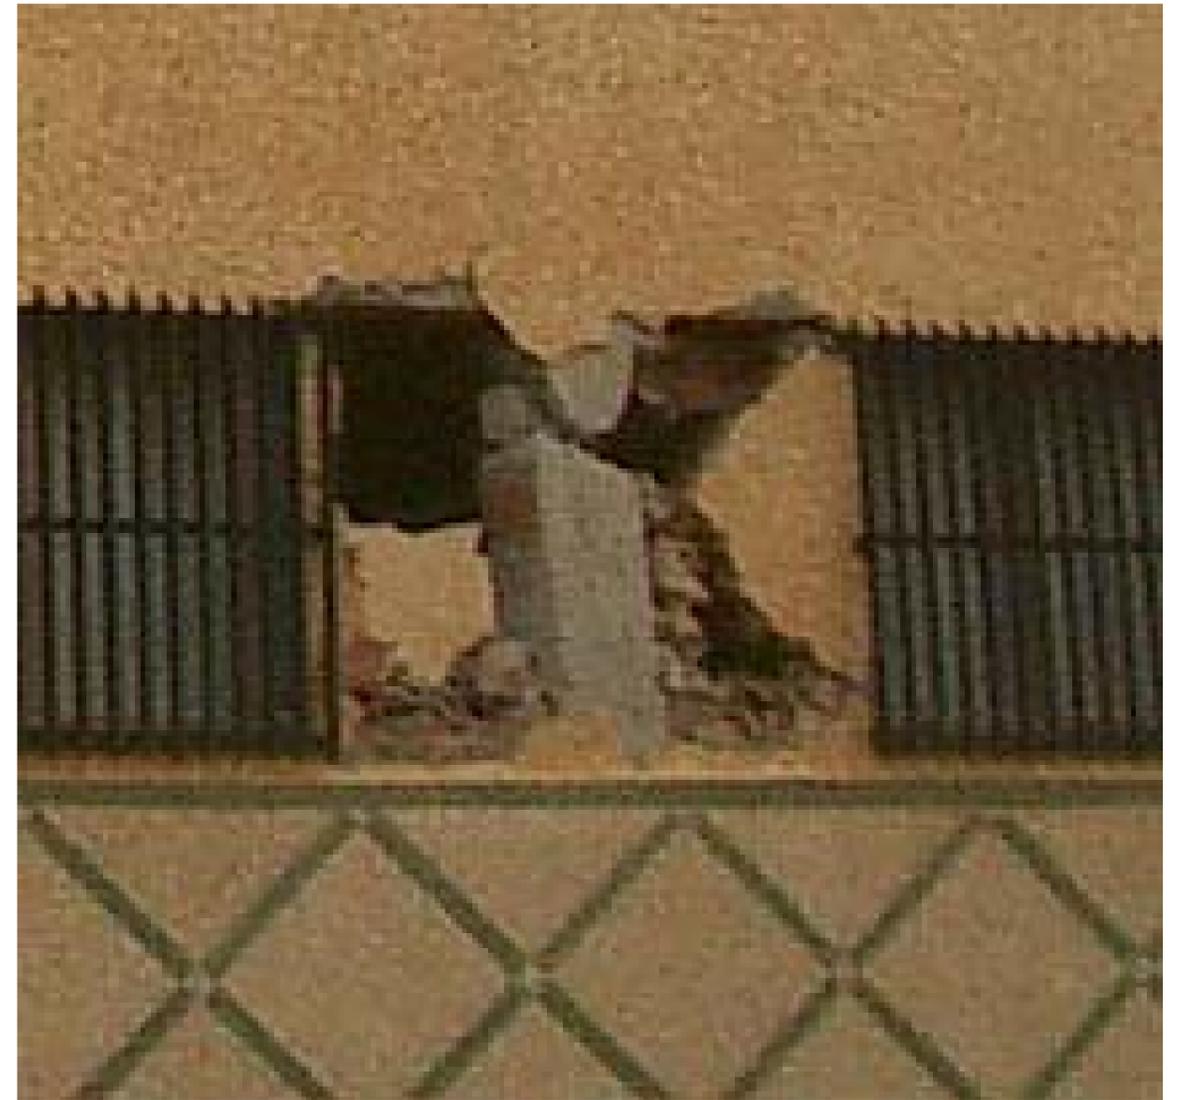
5.2.2 Detail of damaged column.

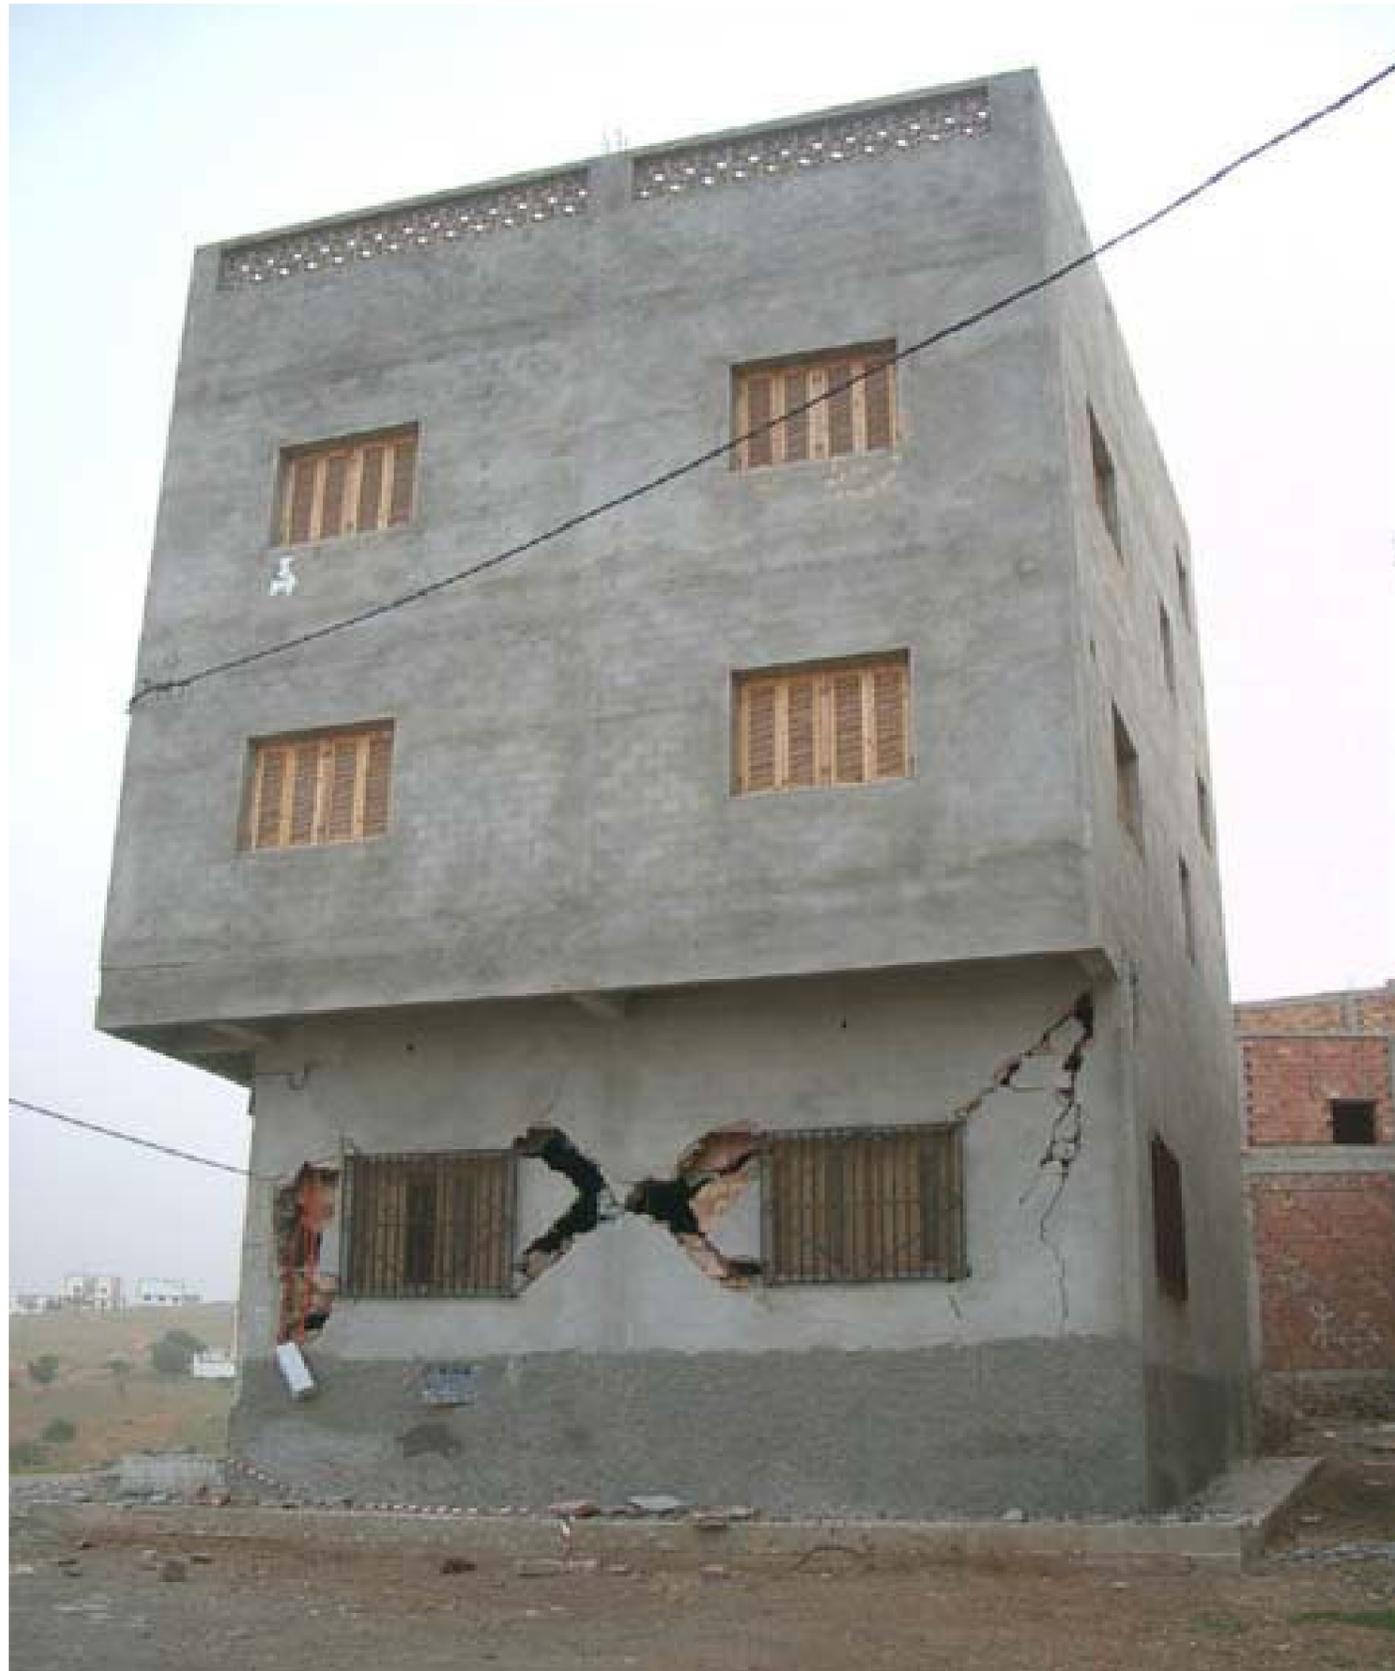
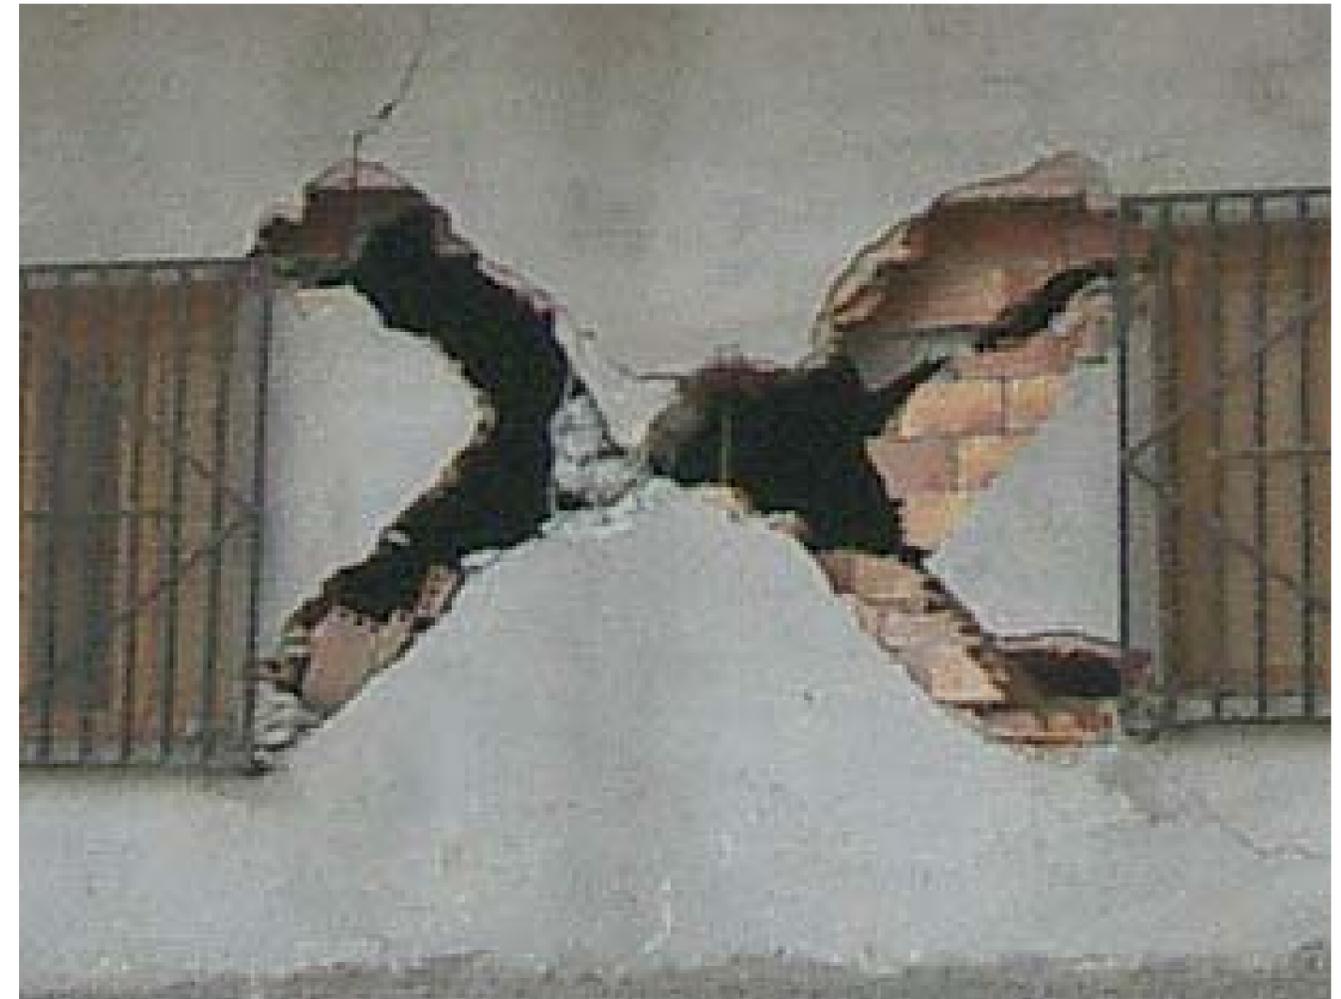
6.1.2 Detail of damaged column.

6.1.1 Short column and soft storey damage in Imzuren.
(*grade 4 vulnerability C*)

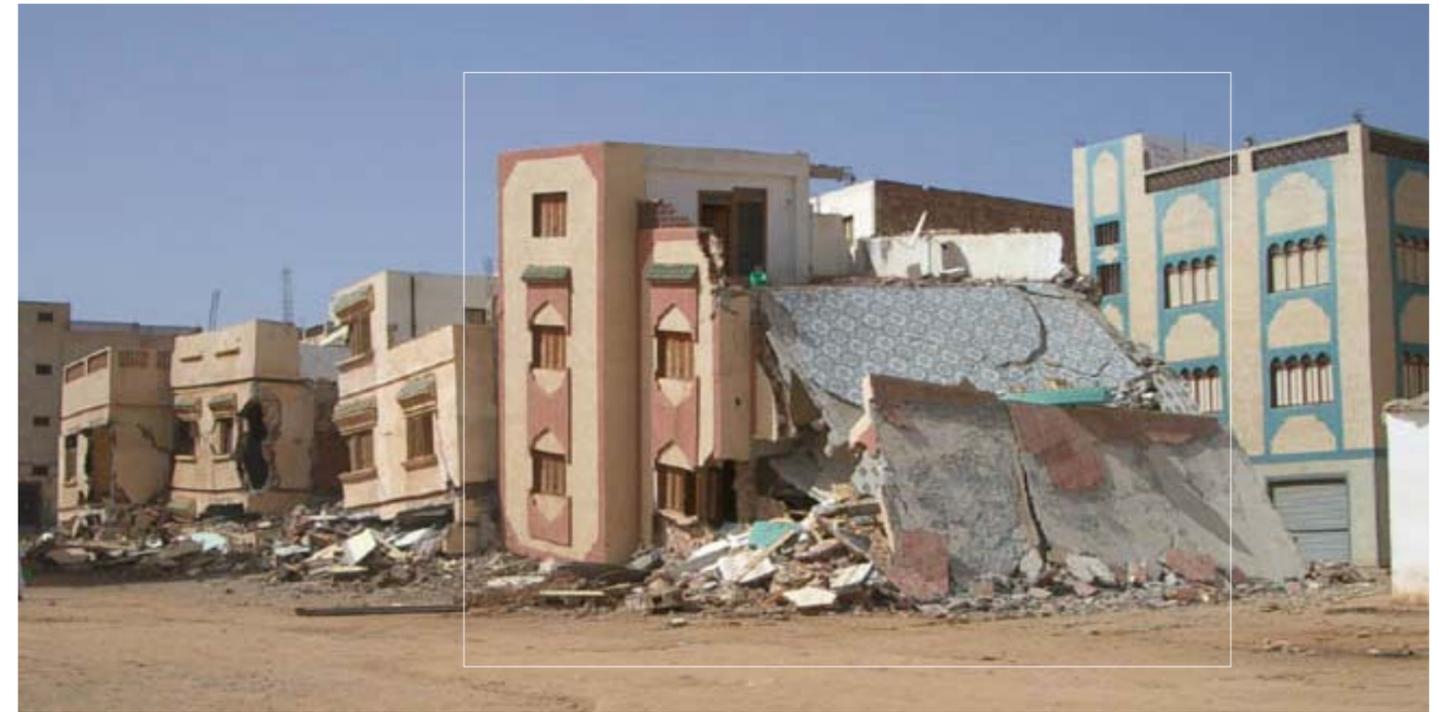
7.1.2 This building will be studied as an example of soft storey ground floor failure.

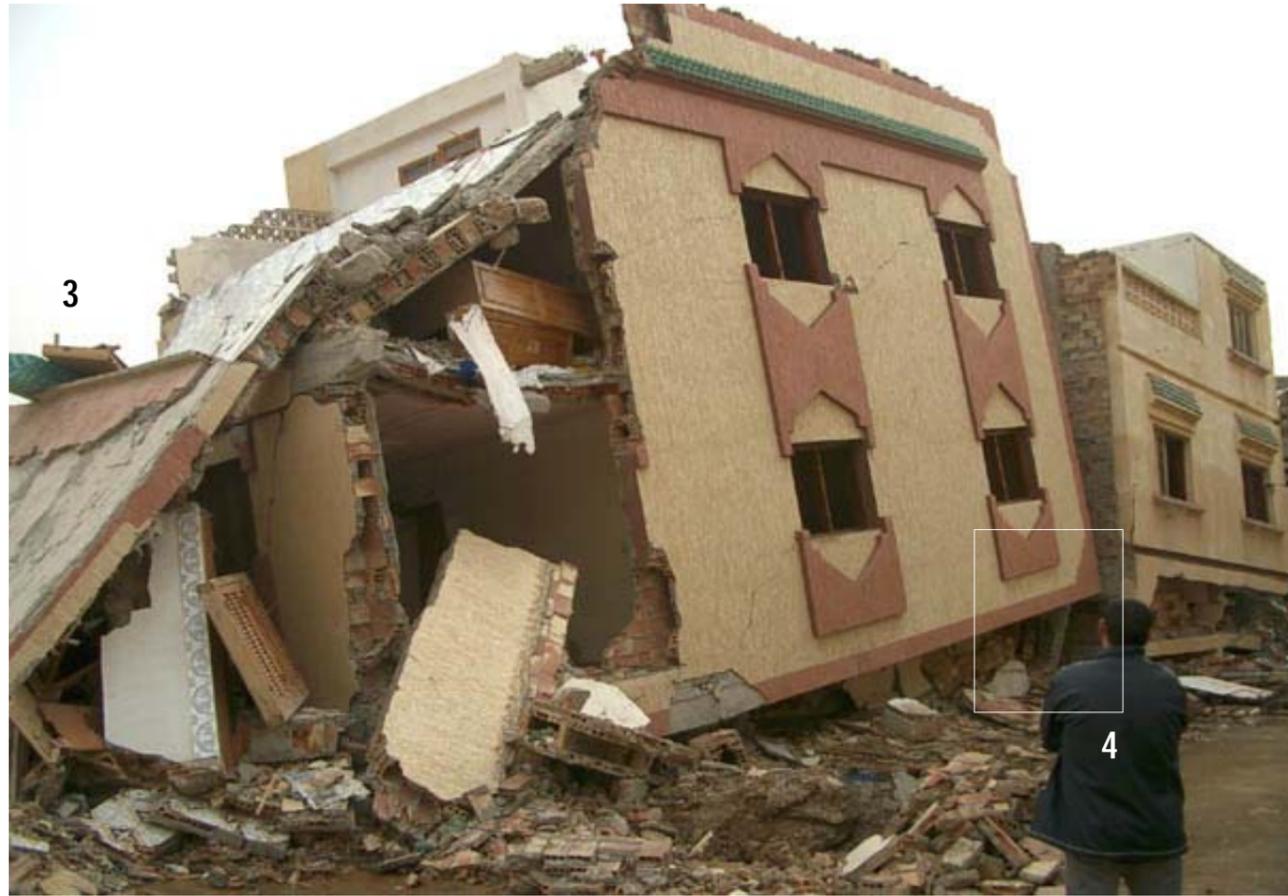
7.2.1 Back view of the building with failed tower.

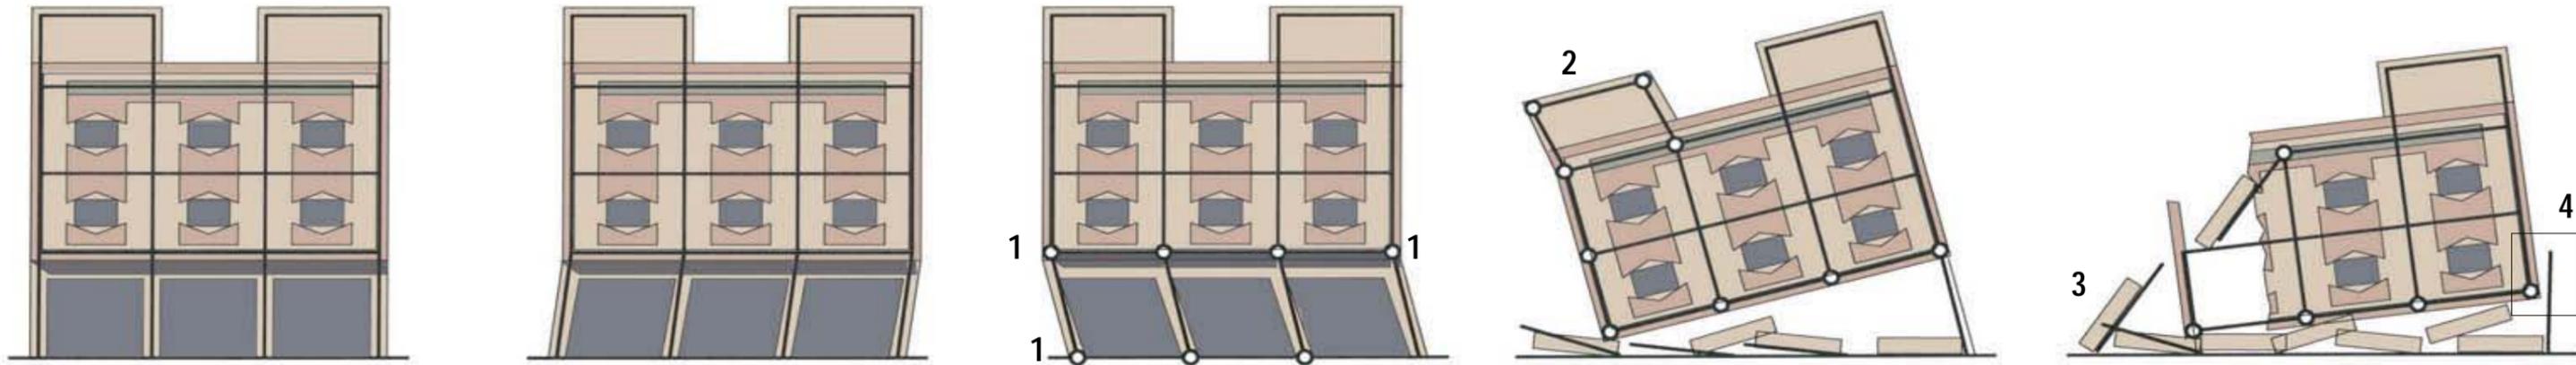
7.2.4 *Failure model*, Open plan shops and densely compartmented flats above result in a soft storey situation. Beyond the limited elastic range of the column to slab connections, plastic hinges are formed. (1) With reduced stiffness, plasticated connections fail, throwing the building to the ground left side first. (2) Impact with the ground probably causes the failure of the left tower and its roof falls to the road. (3) The last column to detach is n°4 (4) settling the building on its own scree.

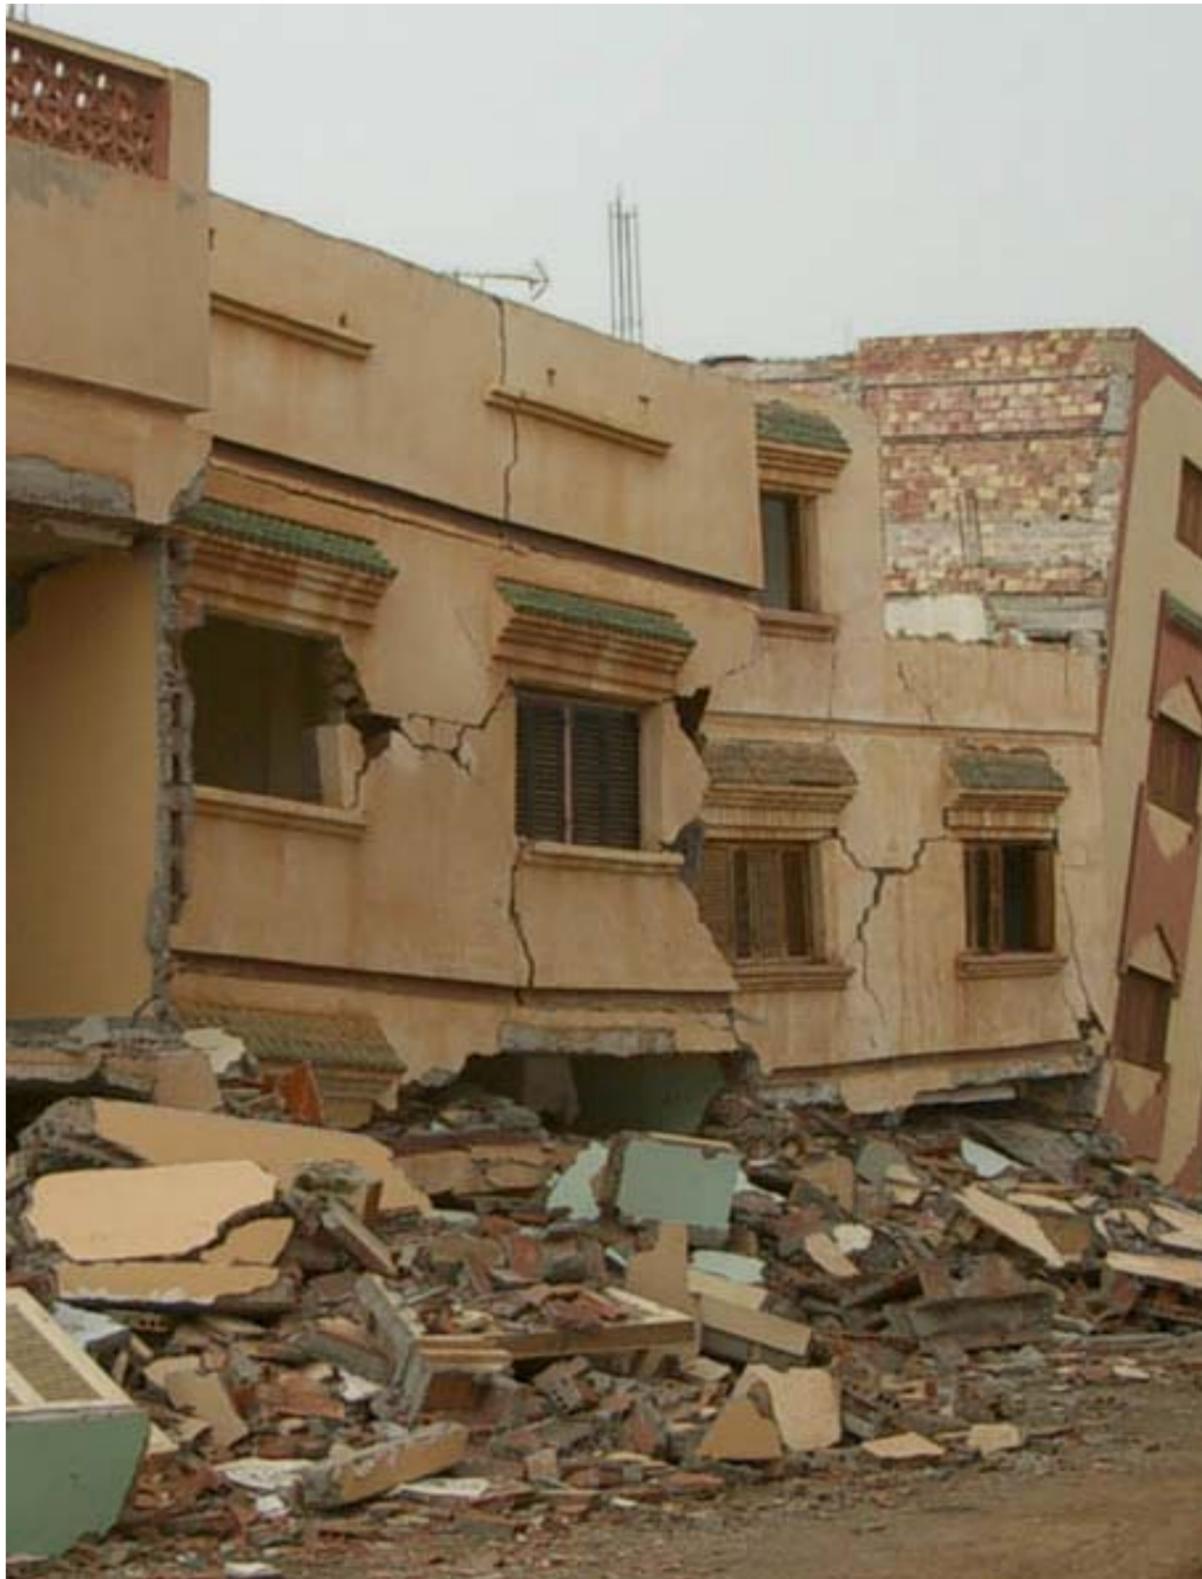
7.3.1 Both ground and first floors failed in this building in Imzuren. (*grade 5 vulnerability C*)

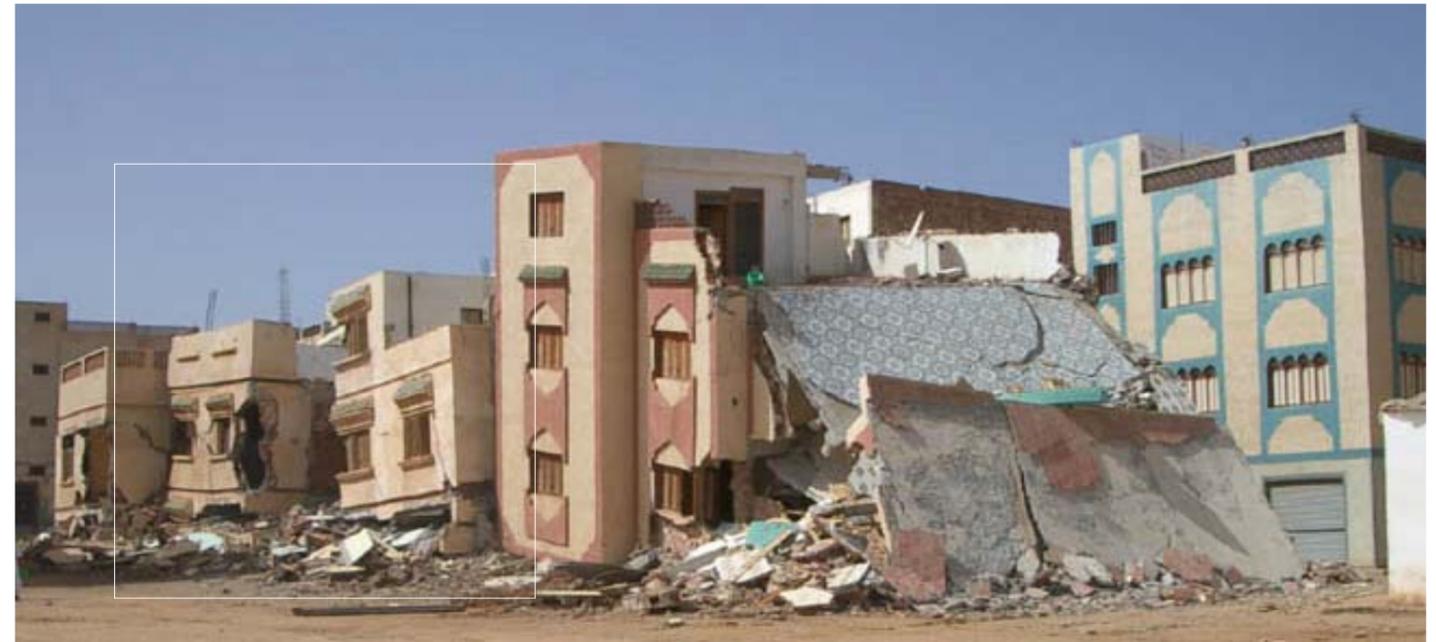
7.3.2 This building will be studied as another example of soft storey ground floor failure.

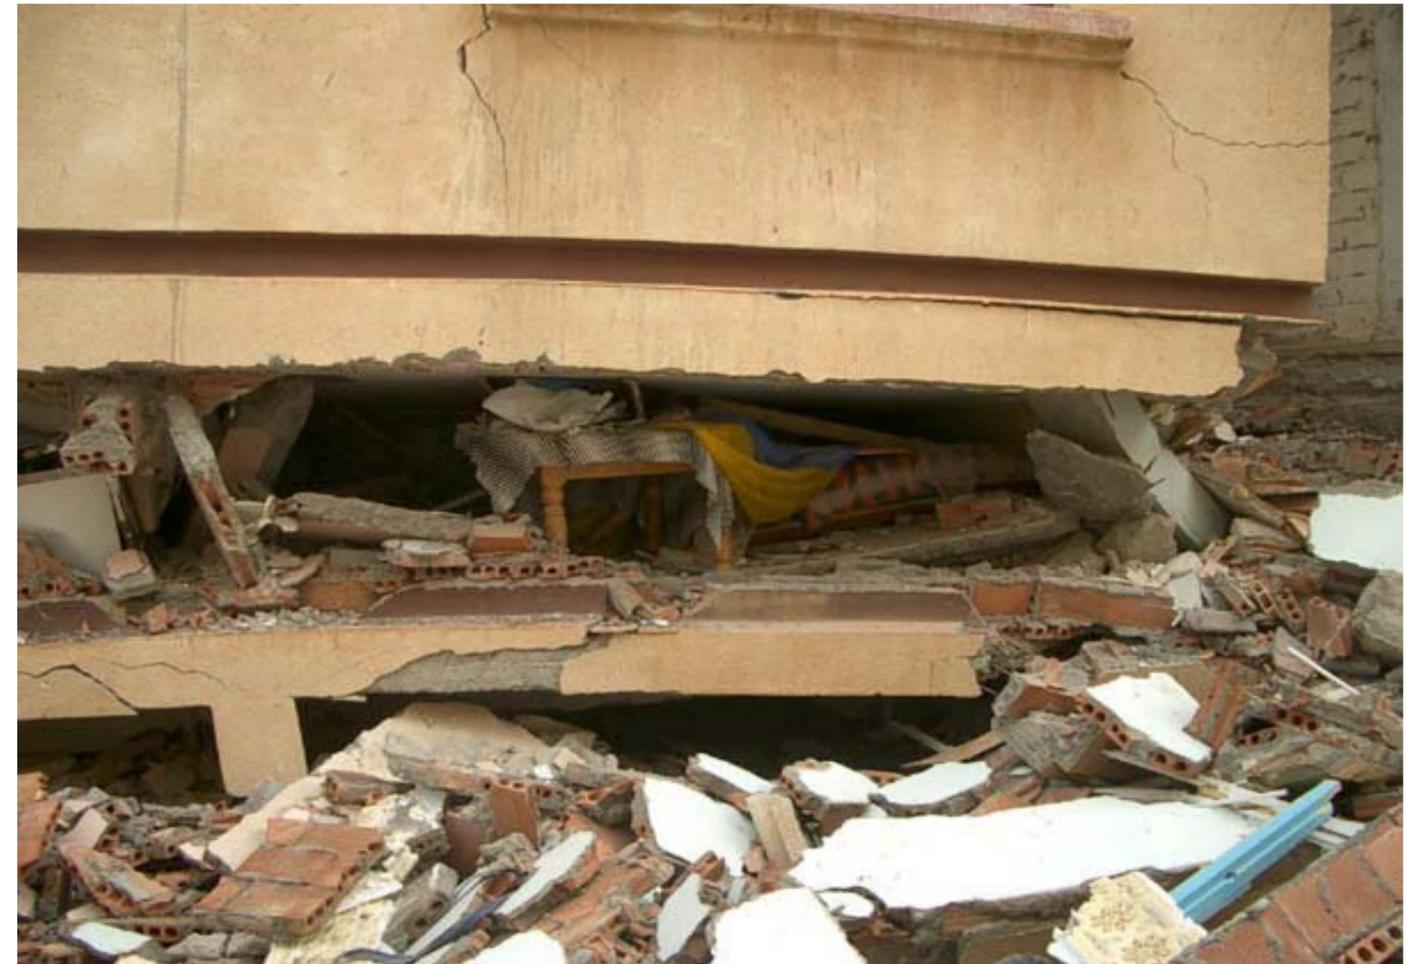
7.4.3 There is a ground and first floor here. A resident ducking under the table would have probably survived the failure unscathed.

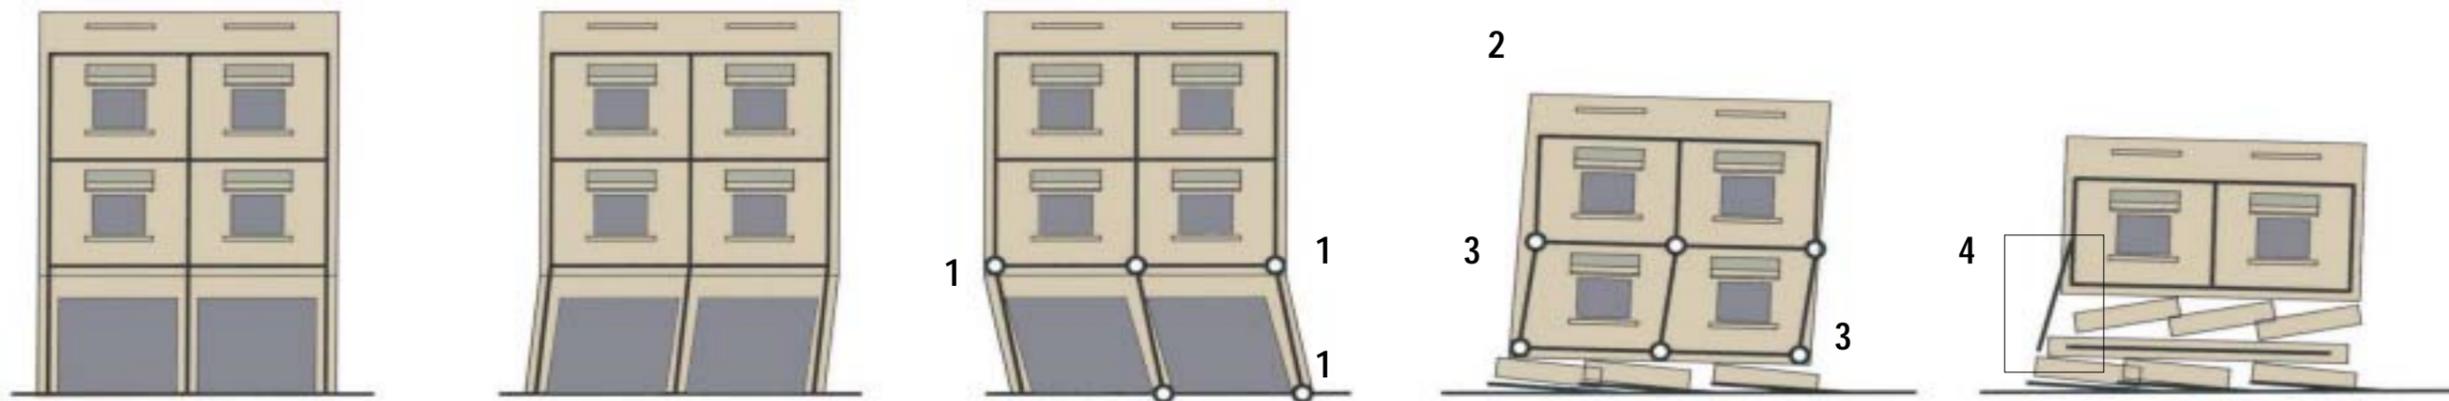
7.4.4 *Failure model*, Building with open plan shops and two floors of densely compartmented flats above. Past the elastic range the column to beam connections of the ground floor hinge (1) and the building drifts to one side and collapses. (2) Impact with the ground probably causes hinging in first floor connections and a new 'soft storey' is formed. (3) Note the column piercing the slab (4) suggesting the first floor failed drifting towards the left. It takes alot of cold blood, but this is why you should duck under furniture during an earthquake. (7.4.3)

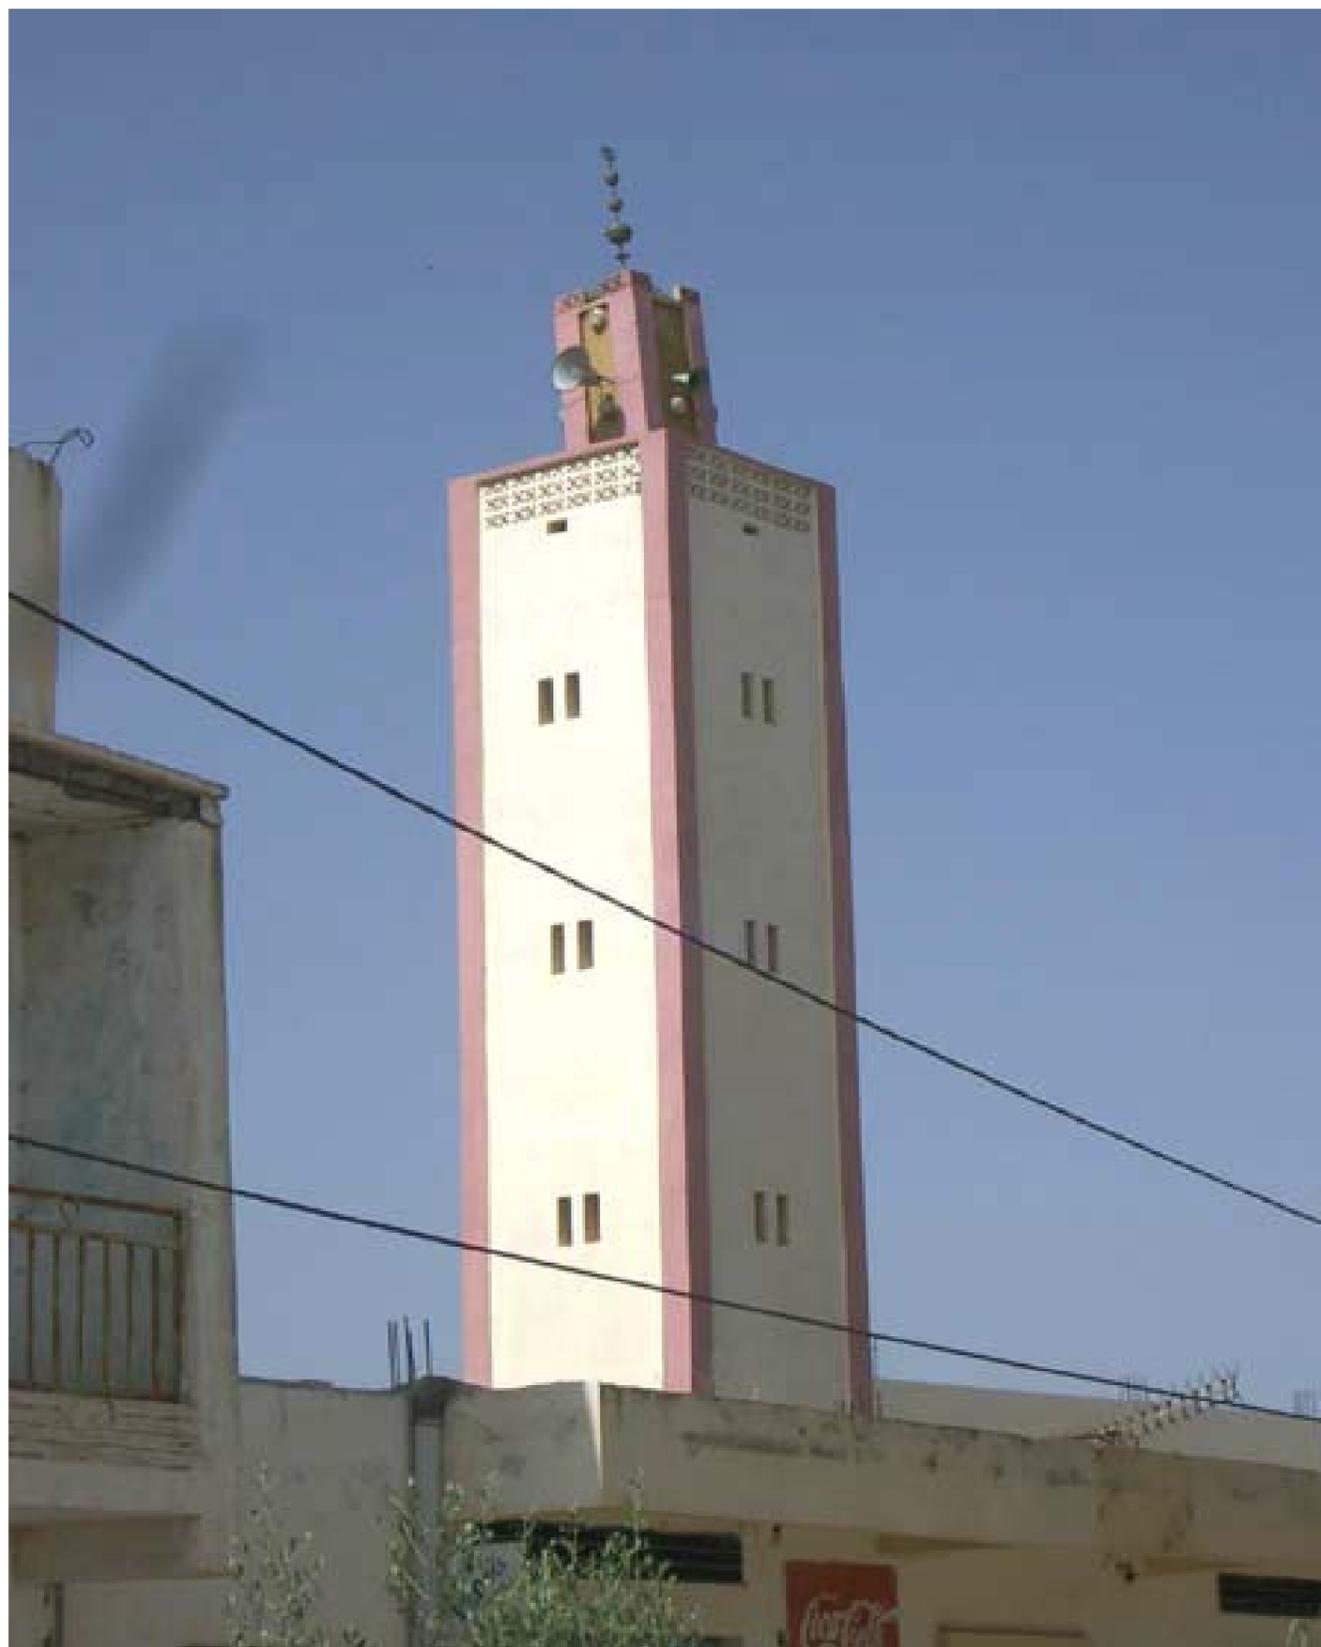
9.1.2 Damaged lantern in this mosque in Imzuren. (*grade 2 vulnerability C*)

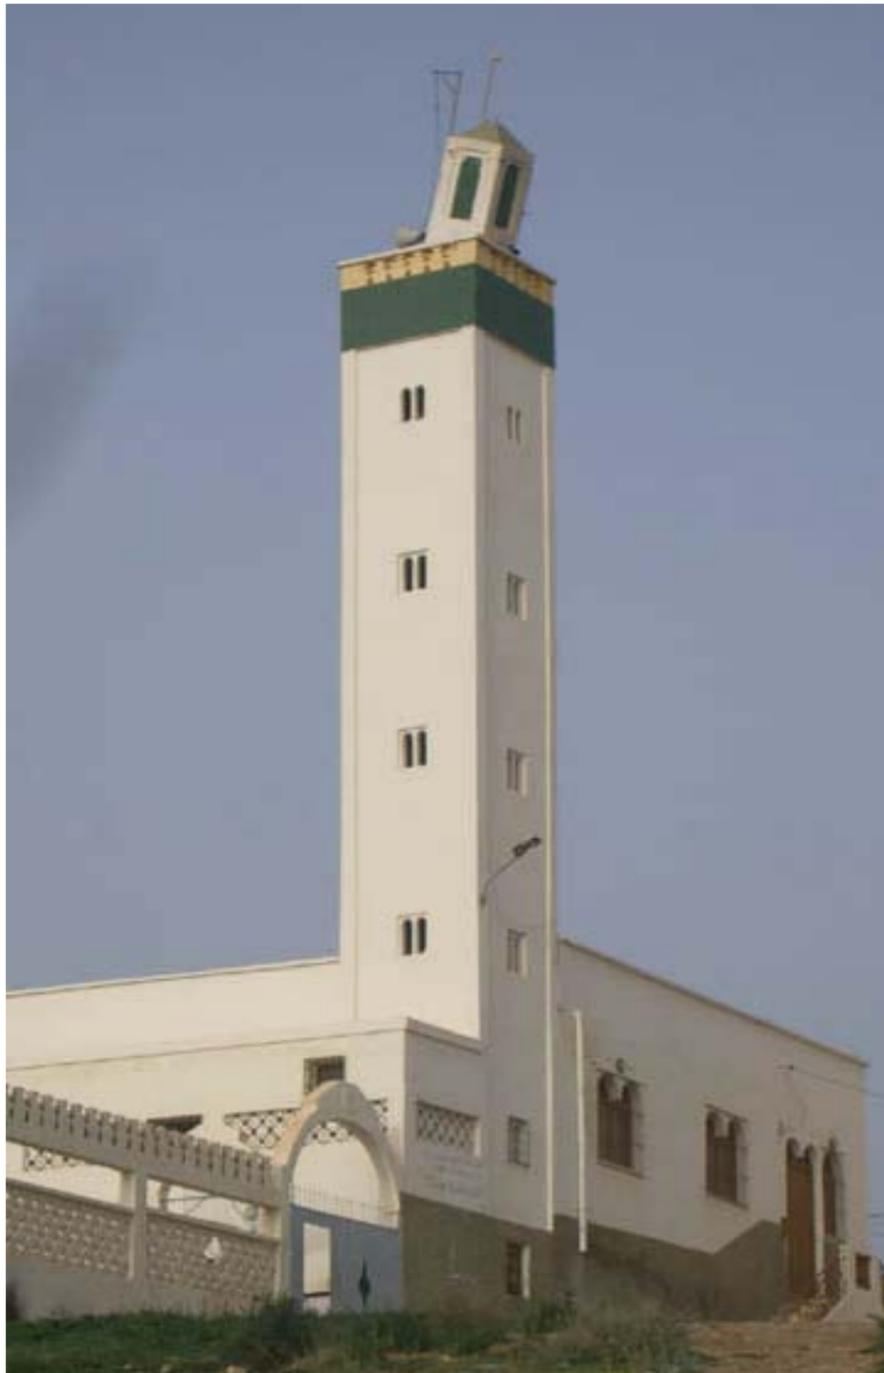
9.3.1 Lantern collapse in Imzuren. (*grade 2 vulnerability C*)
