AL-HOCEIMA EARTHQUAKE 24 02 2004

FIELD REPORT

Patrick Murphy Corella *Architect* June 2004

The Al-Hoceima earthquake

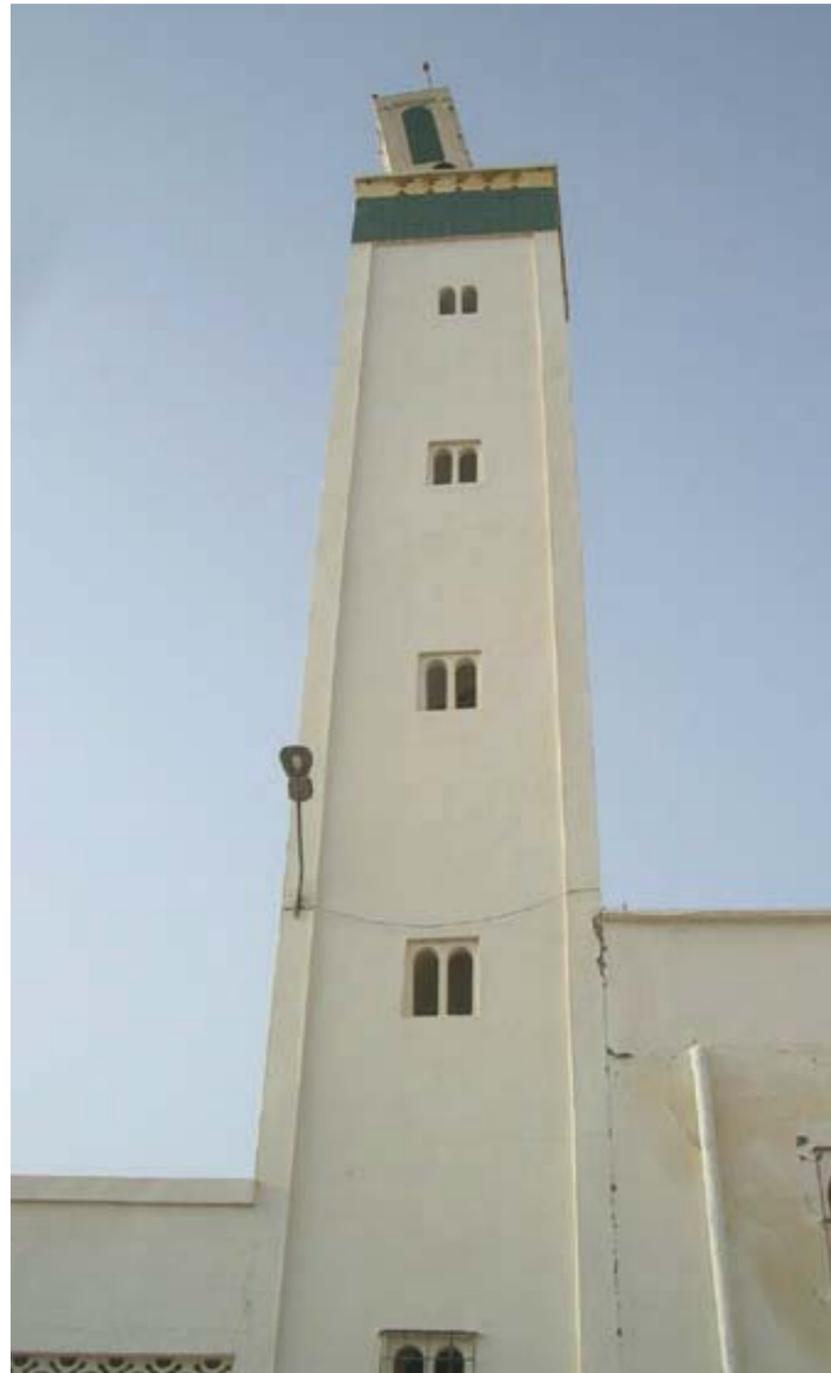
9.3.2 Same minarette from different view. Note damage at contact between tower and wall.

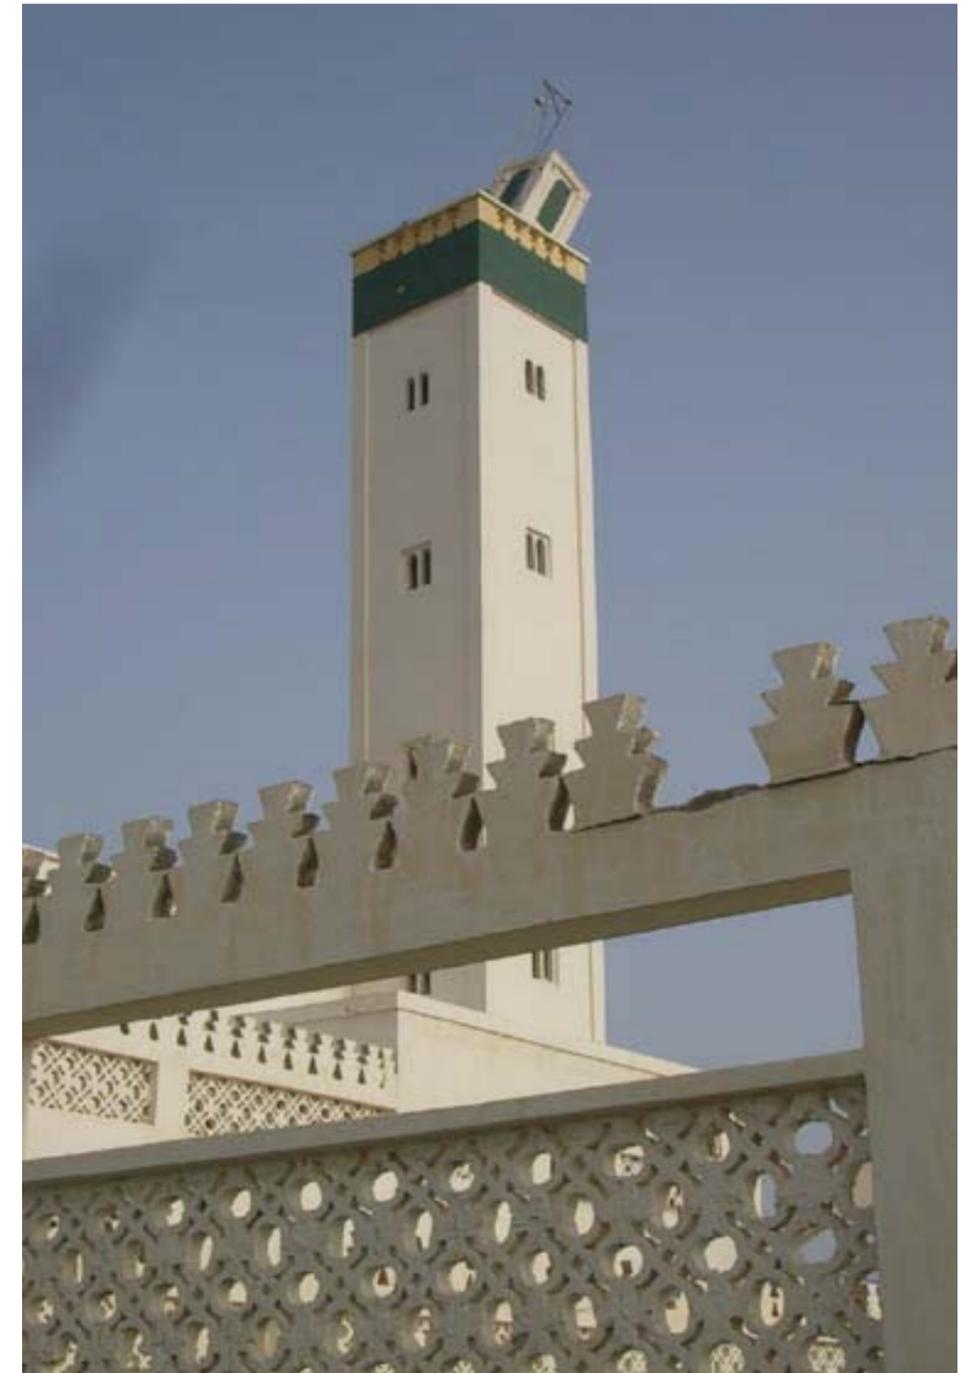
9.3.3 Different view, note damage to castellations

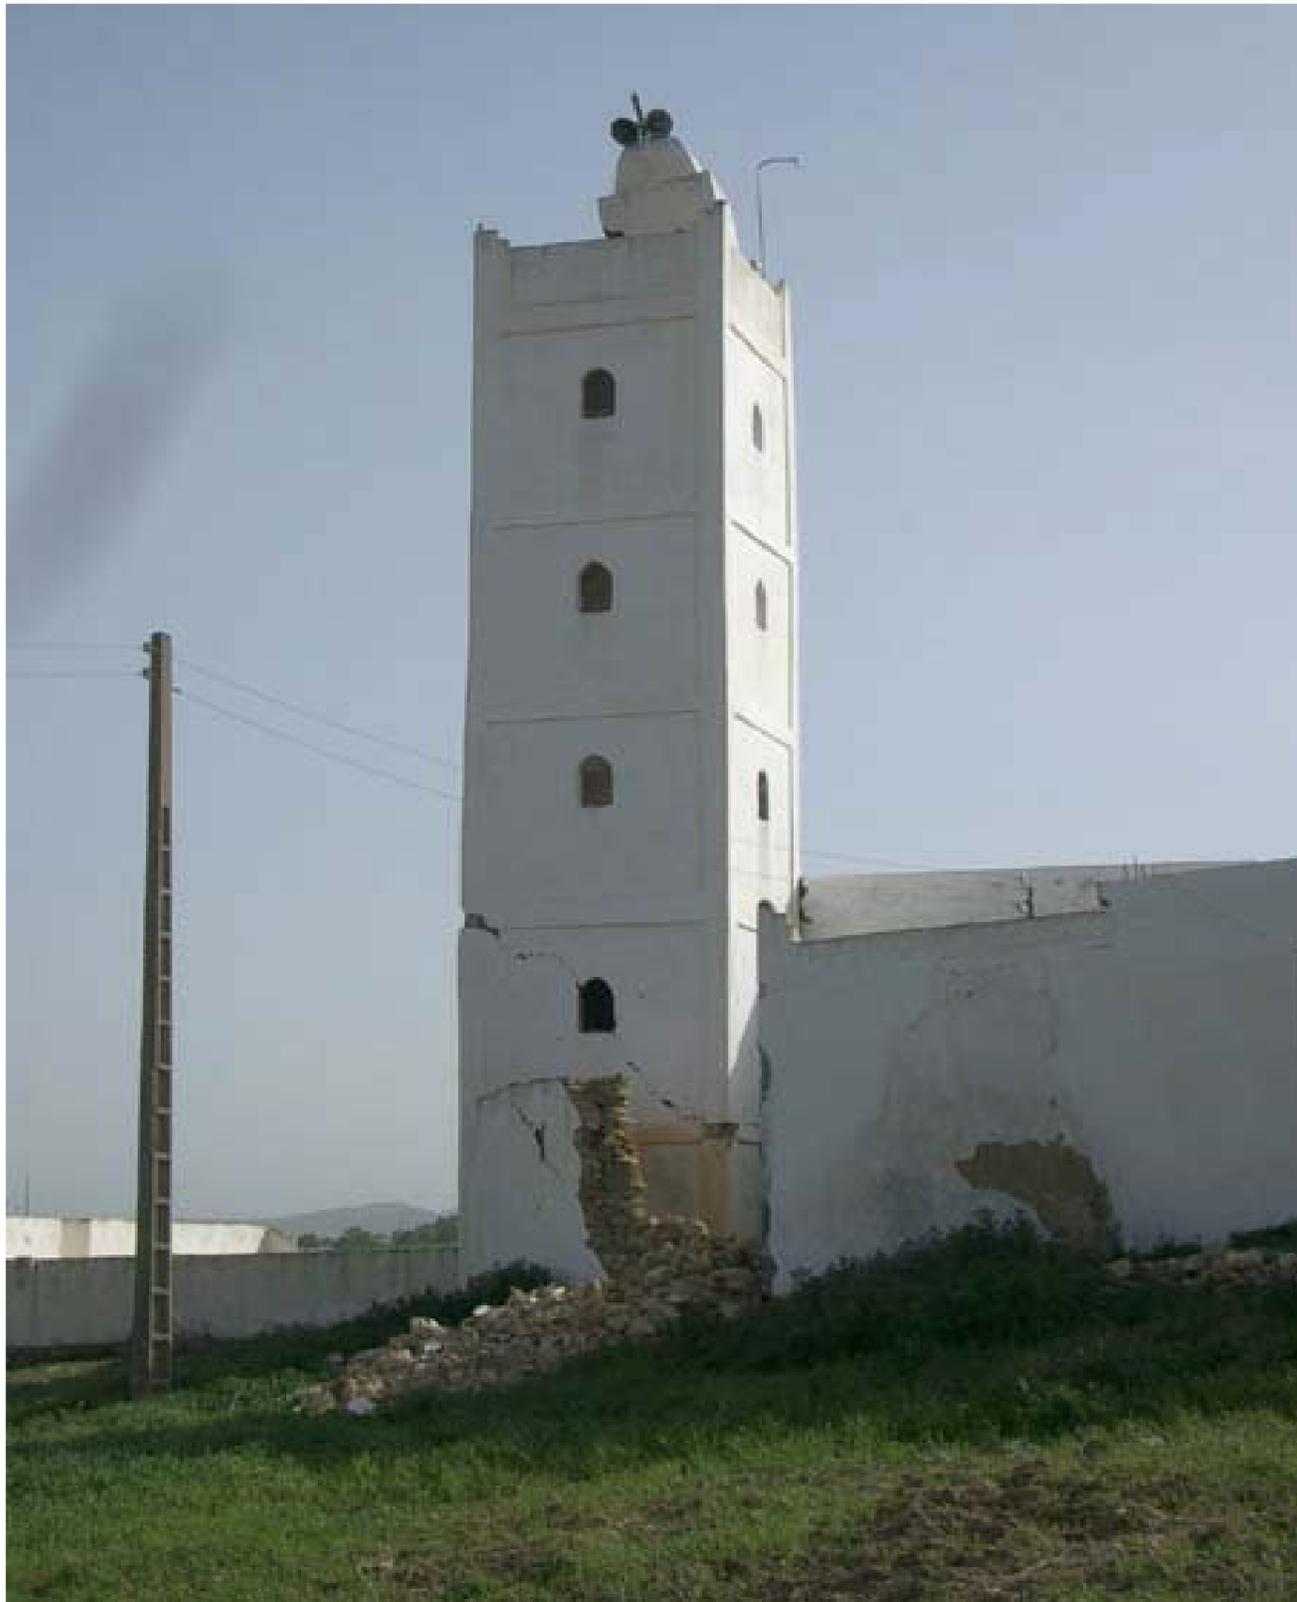
9.4.1 Lantern collapse and shear damage to base of tower. Note simple toppling failure of closure wall. (*grade 3 mixed vulnerability A+C*)

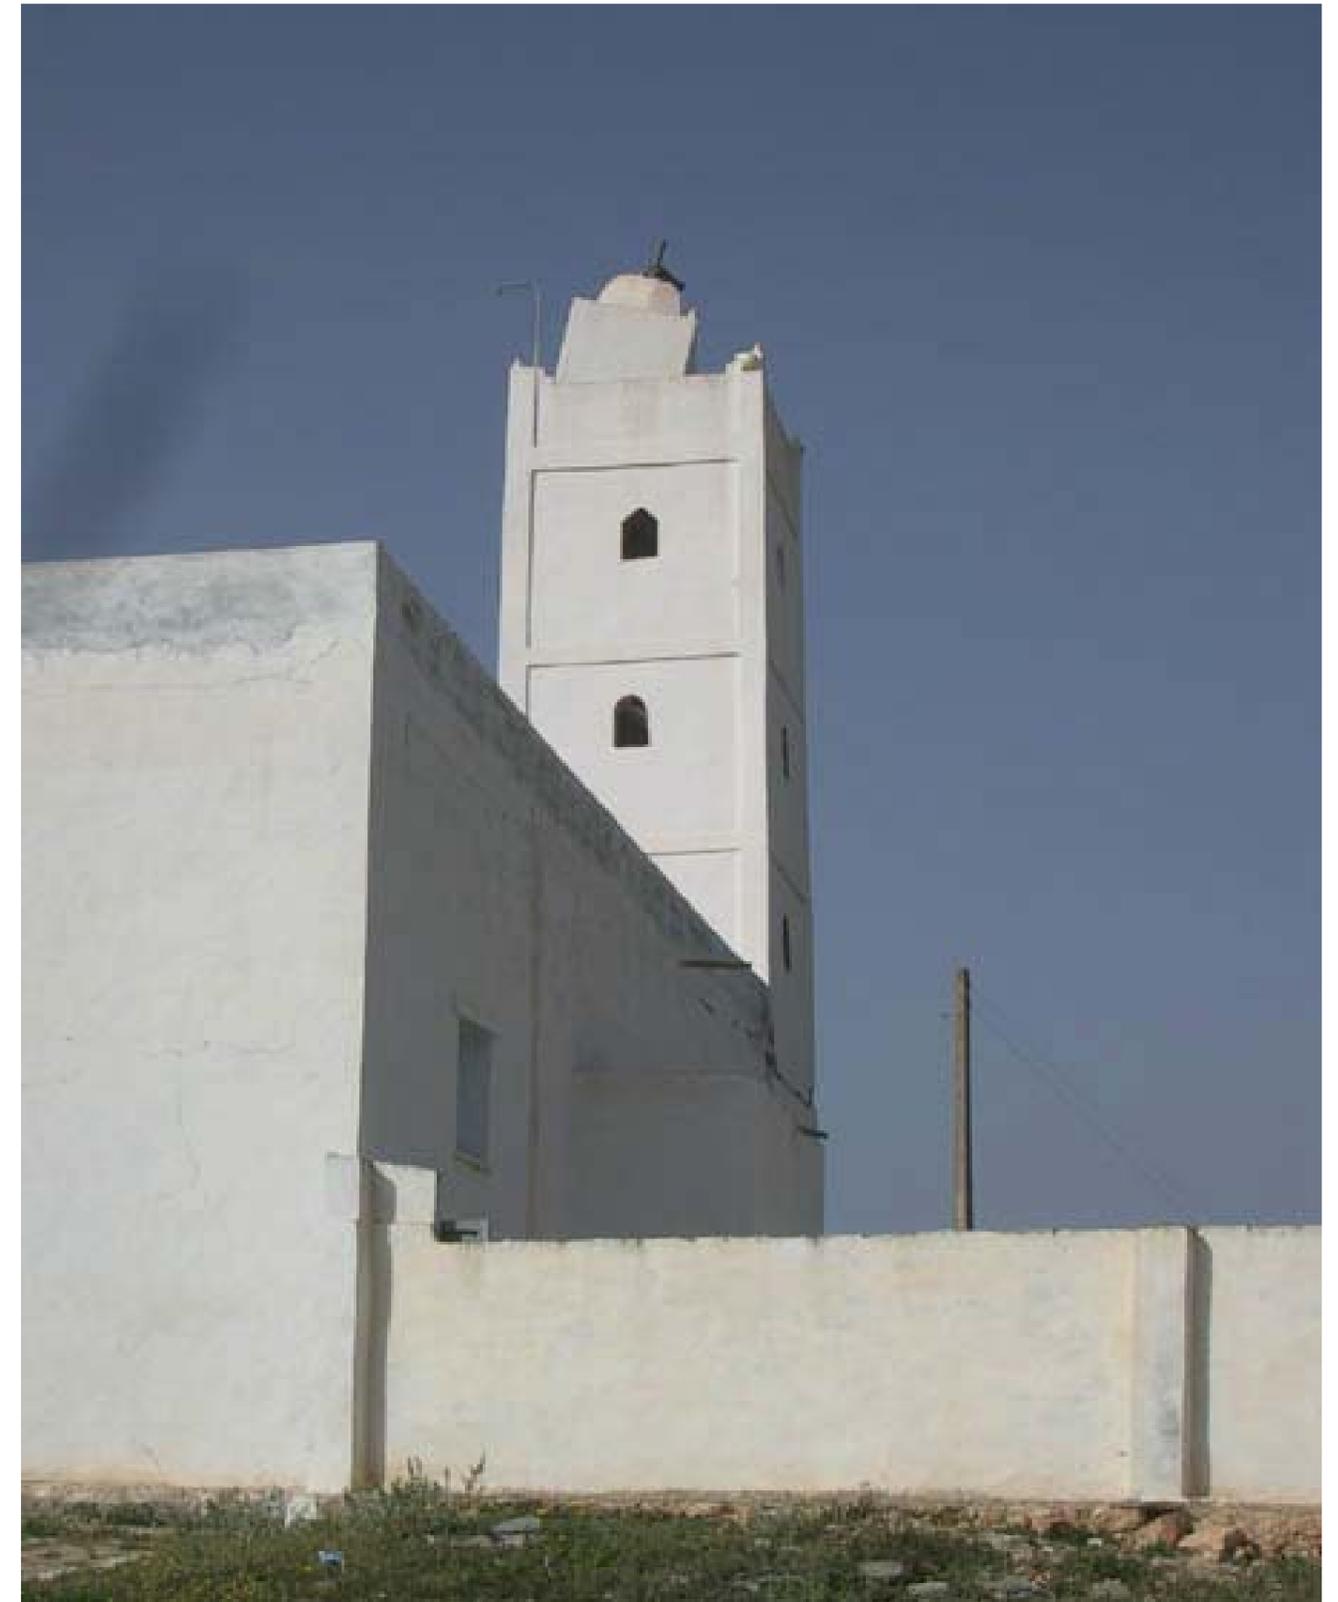
9.4.2 Back view of damaged lantern.

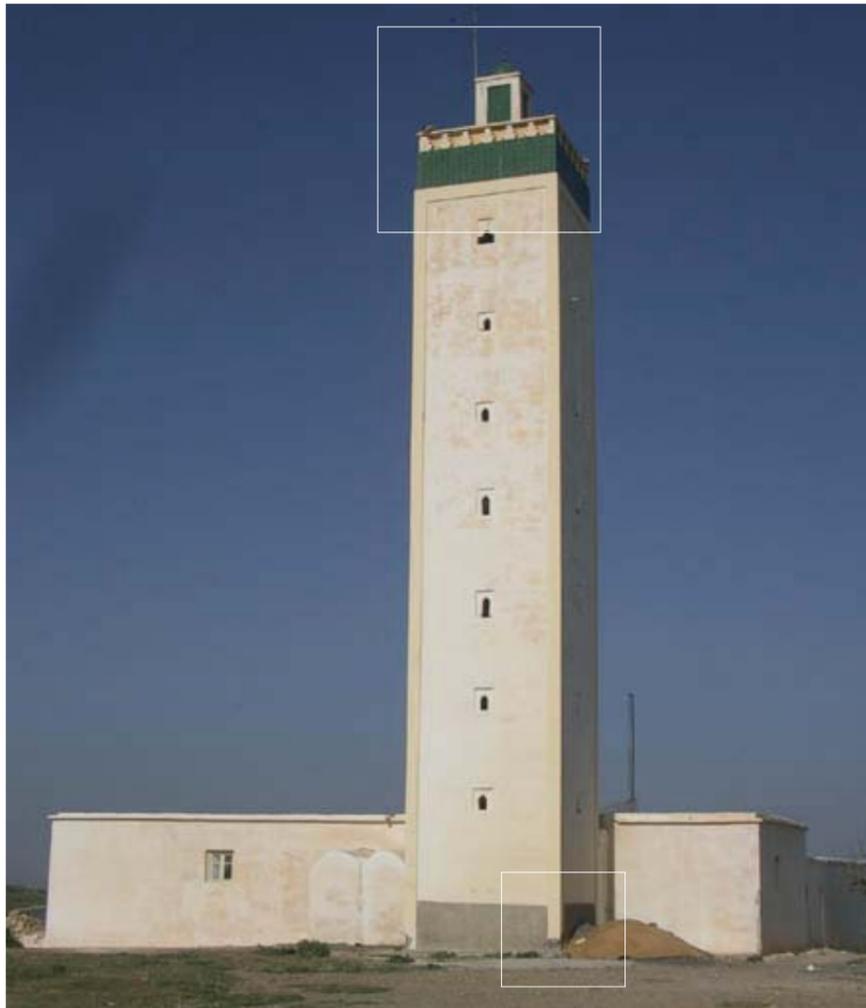
9.6.1 Mosque minarette in Ait Jamra. Twisting of lantern and early plastic hinging at base of tower is observed. (grade 3 vulnerability C)

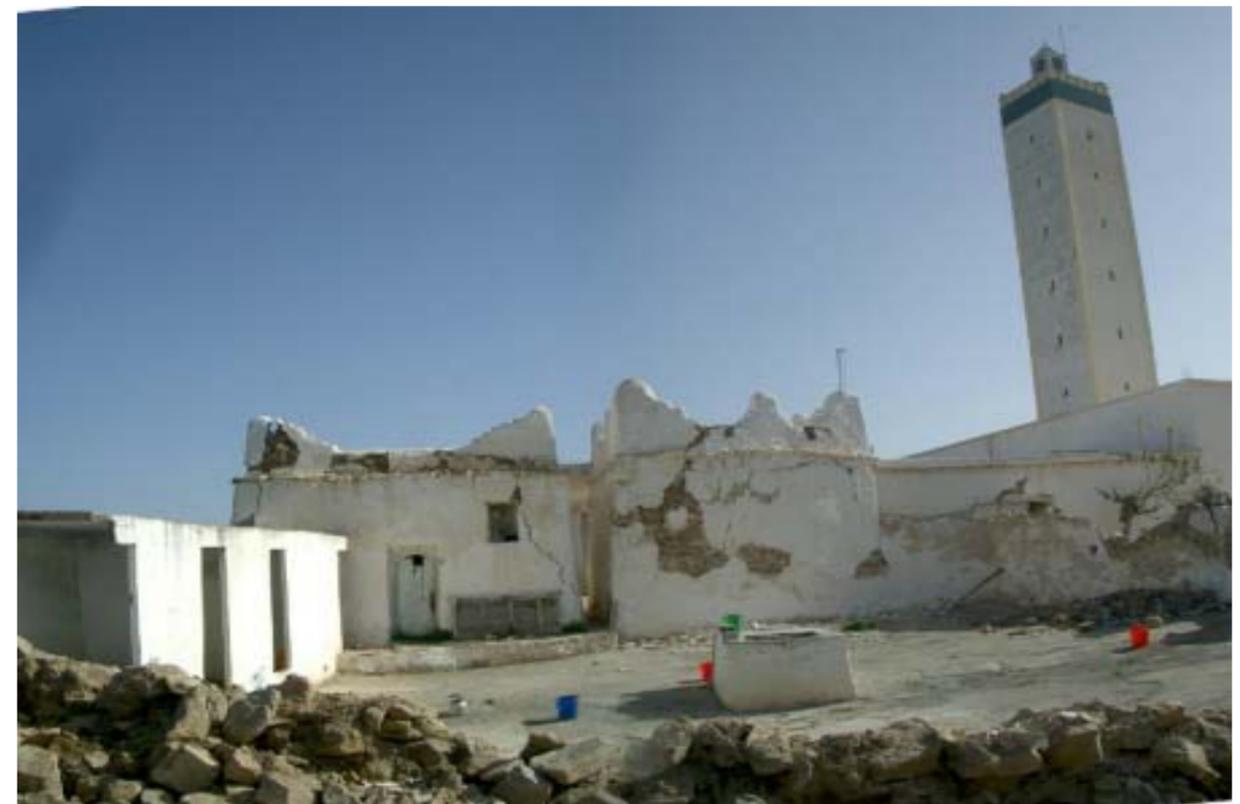
9.6.4 General view of the mosque complex, Vulnerability C is assigned to the tower only. The prayer hall is vulnerability A and shows damage of grade 3.

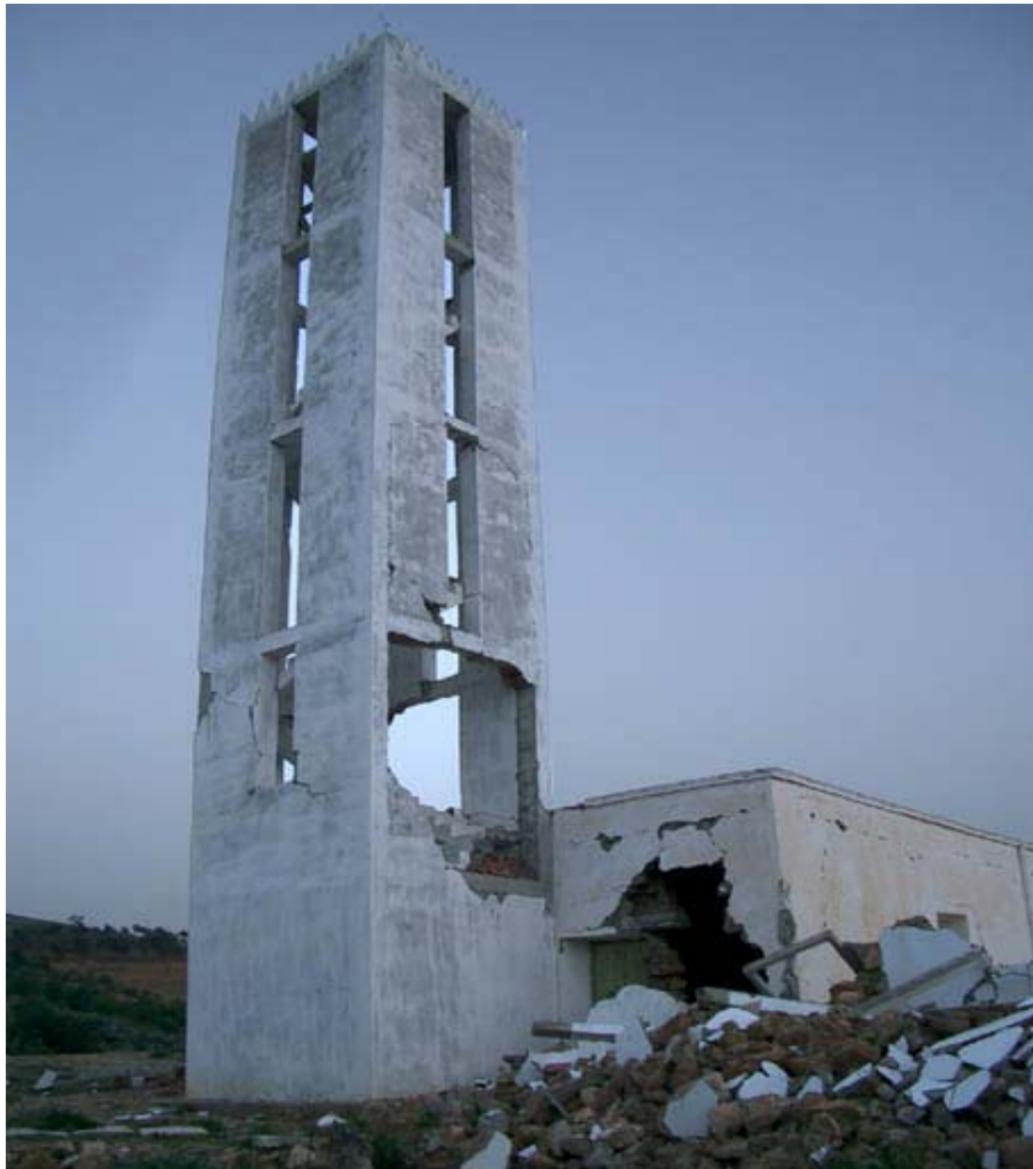
9.7.1 Pounding damage from the prayer hall to this minarette which is hinging at its 'first floor' level. (grade 3 vulnerability C)

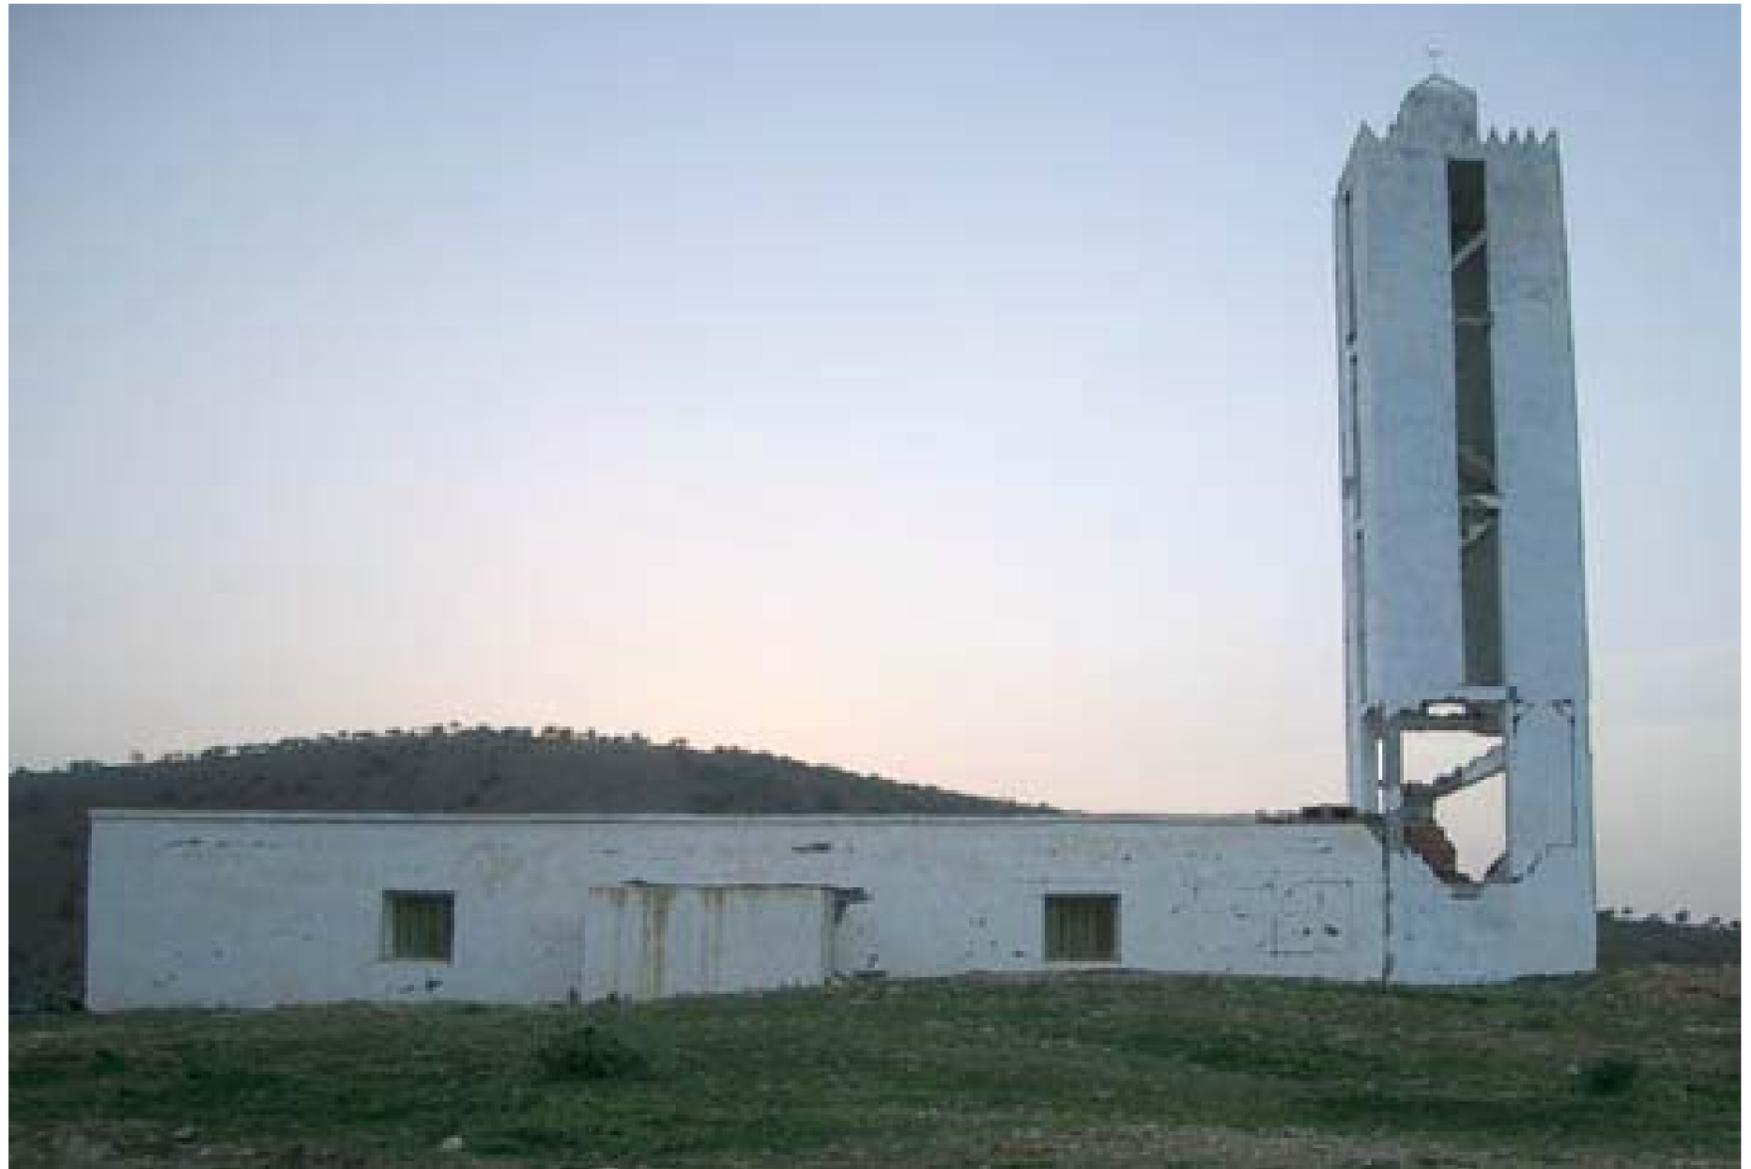
9.7.2 side view. Note the low long and stiff prayer hall's pounding damage to the diaphanous tower.

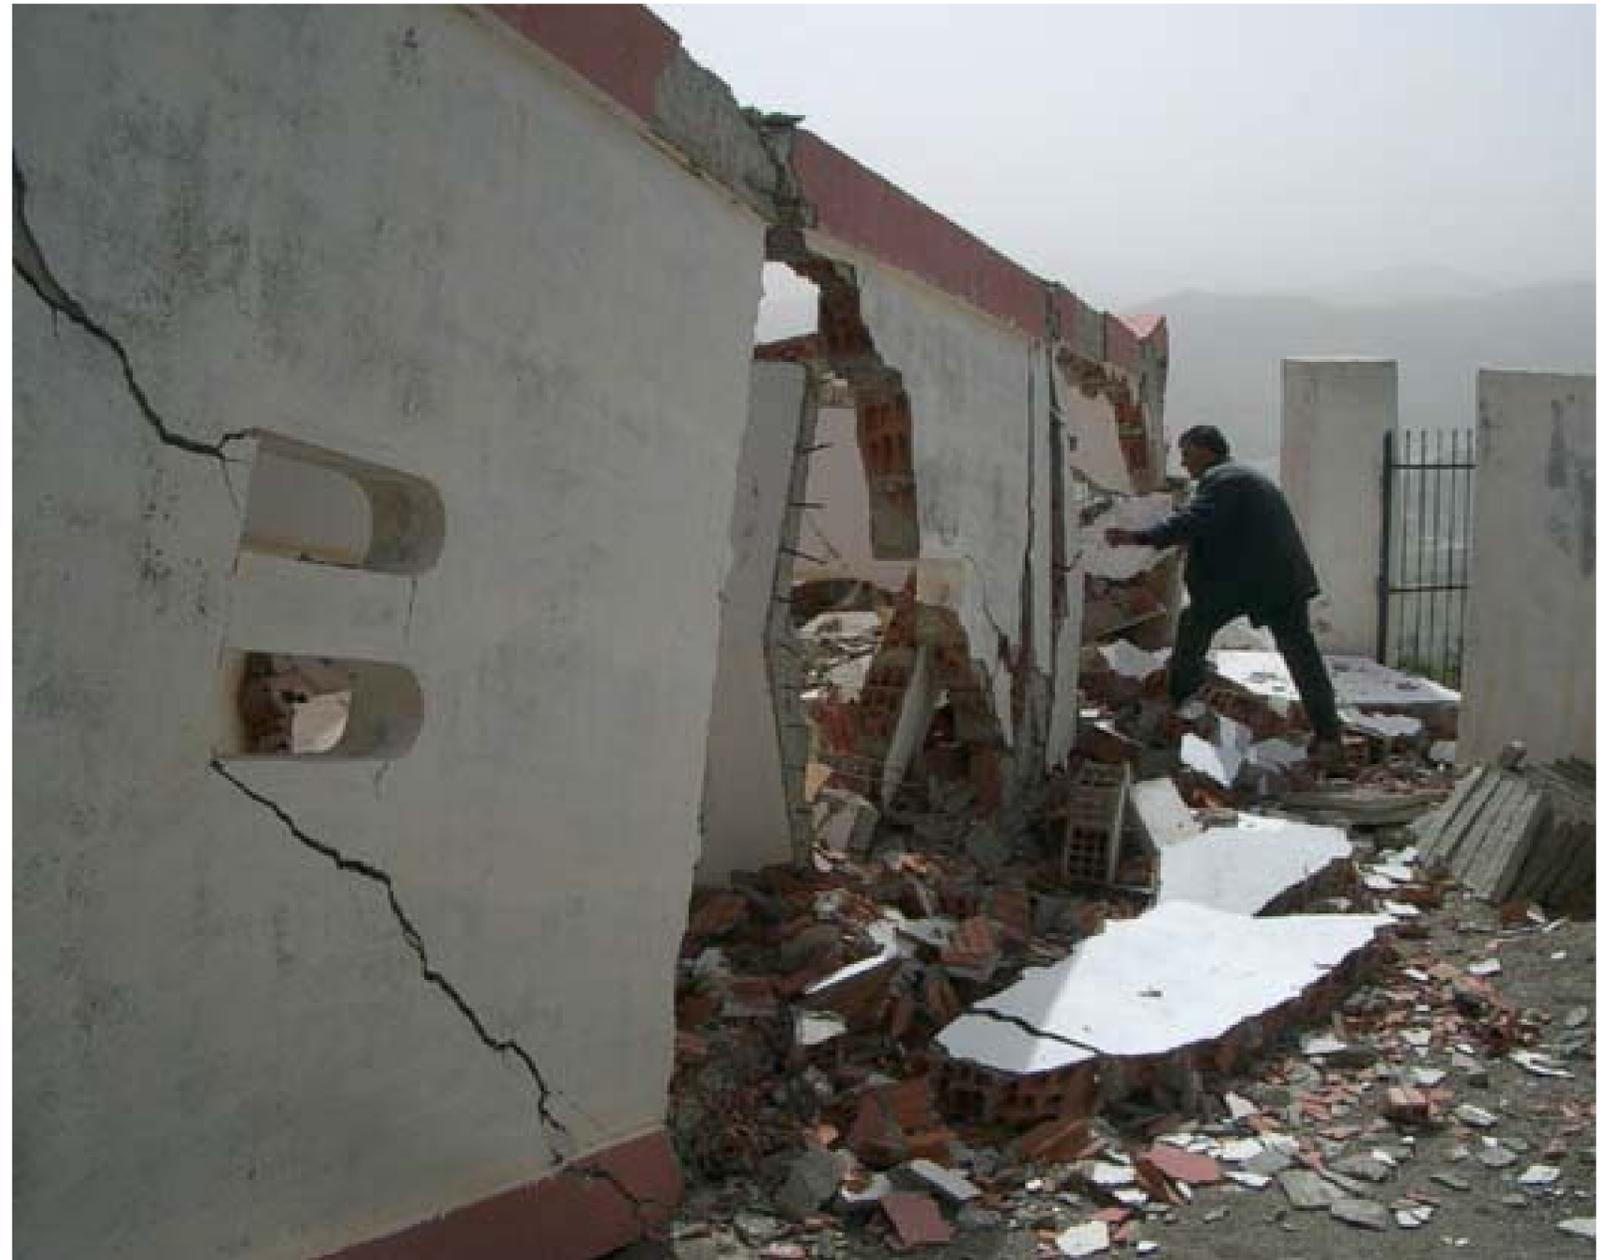
9.8.2 Side view of the toppled minarette.

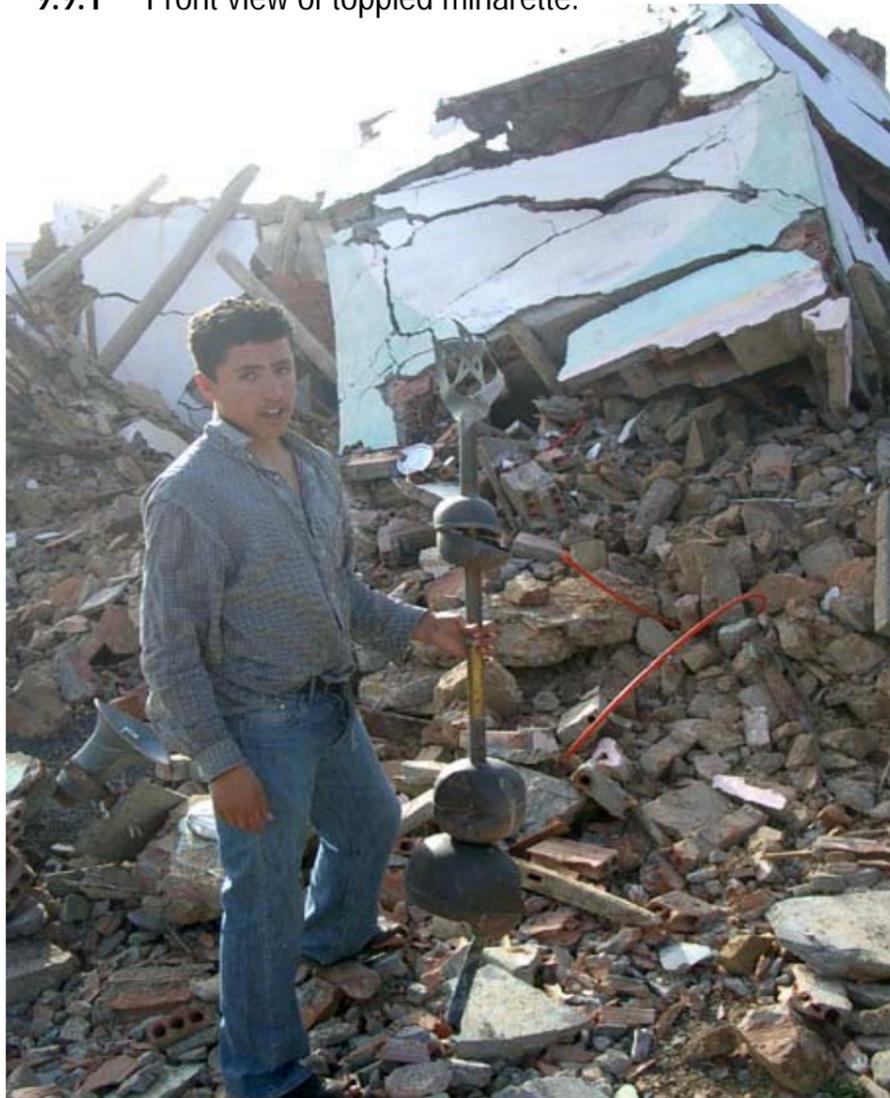
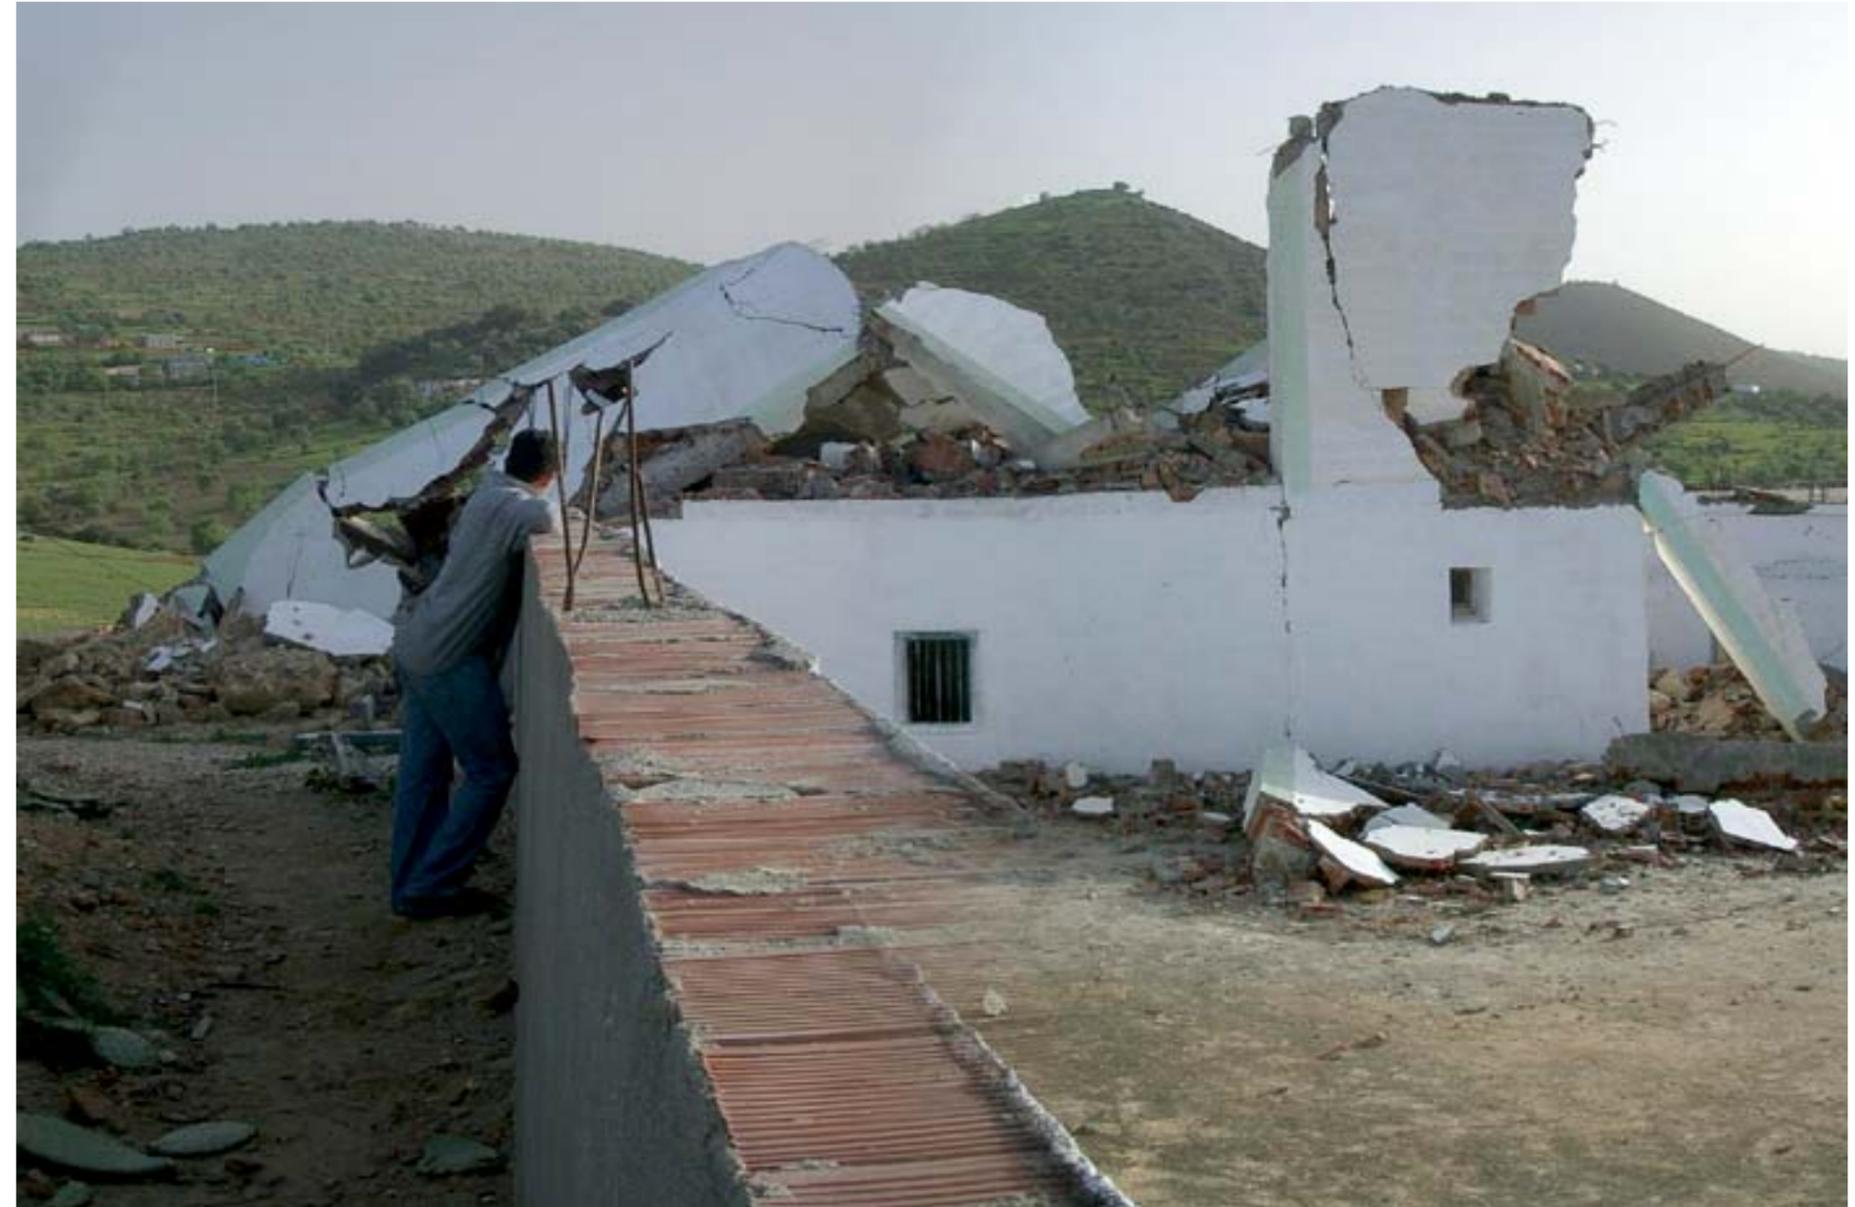
9.9.2 In this case the insertion of the prayer hall building at the base of the tower has caused plastic hinges to develop at the 'first floor' level, as in example 9.7 instead of the ground floor. Toppling therefore, has happened over the prayer hall level.

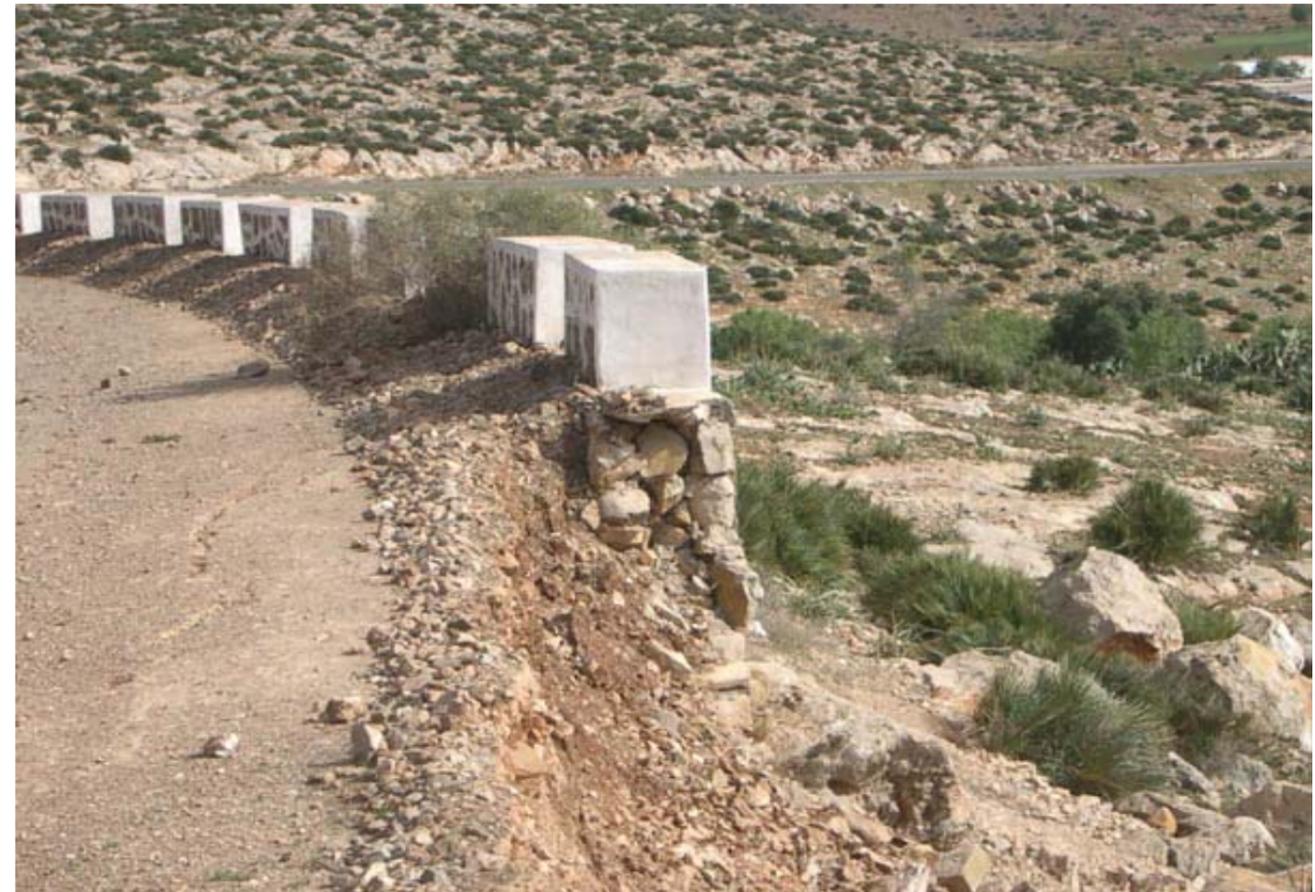
10.1.3 Collapsed road embankment- Izemurrenne
