AL-HOCEIMA EARTHQUAKE 24 02 2004

FIELD REPORT

Patrick Murphy Corella *Architect* June 2004

The Al-Hoceima earthquake

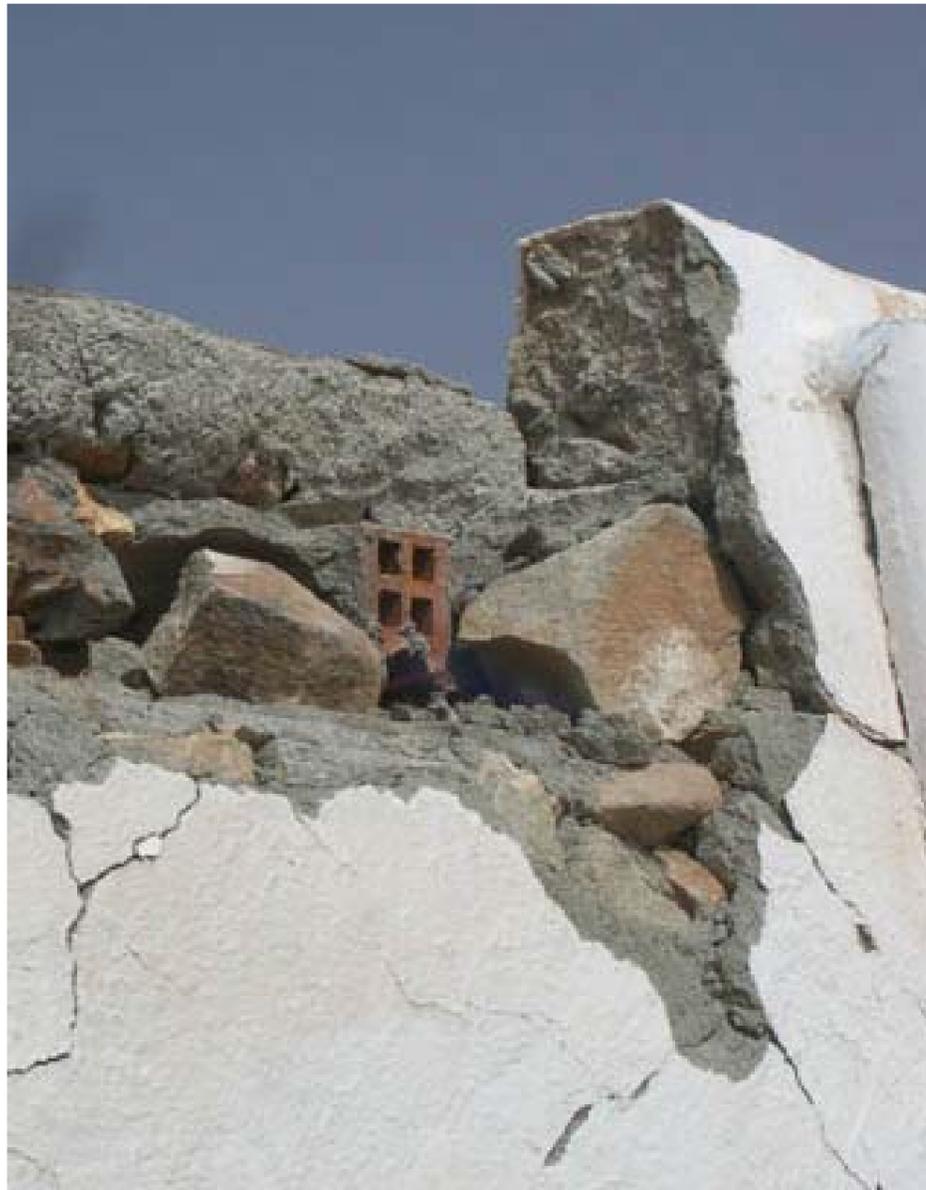
2.3.1 In today's traditional construction, small beams are cast using bricks as formwork, incorporating a single rebar for small spans in housing. Although hardly a moment resistant connection, there are shades of increased performance by the semi-diaphragm action resulting from this construction detail.

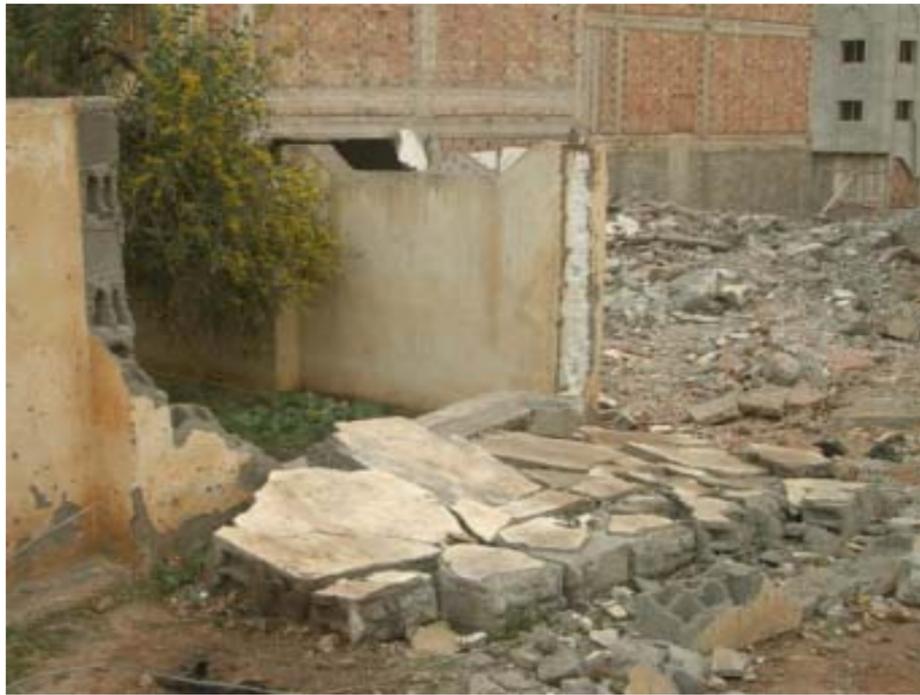
3.1.1 Block wall toppled over - Imzuren

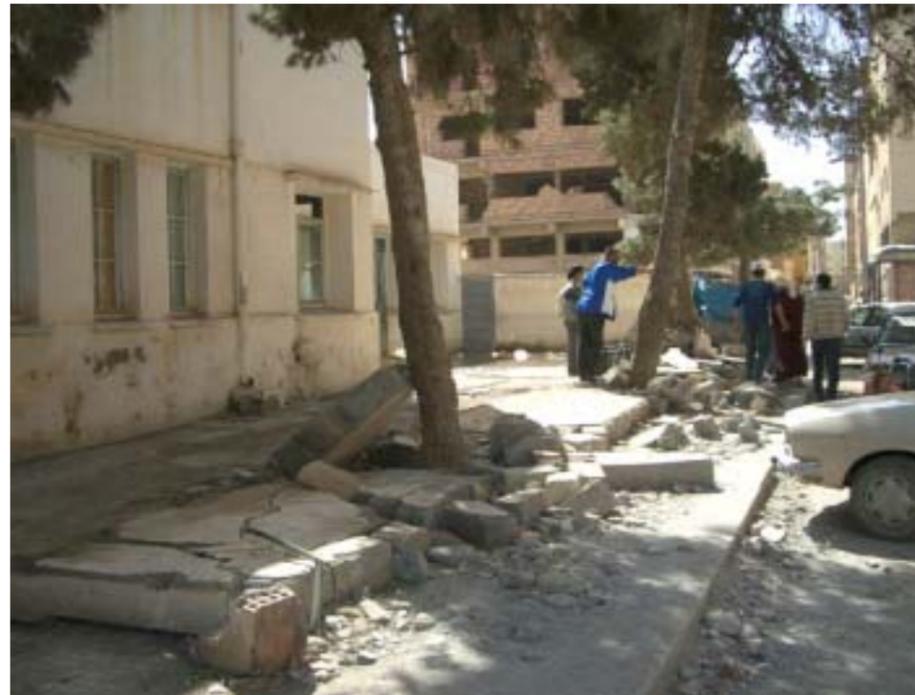
3.1.2 Block wall toppled over - Imzuren

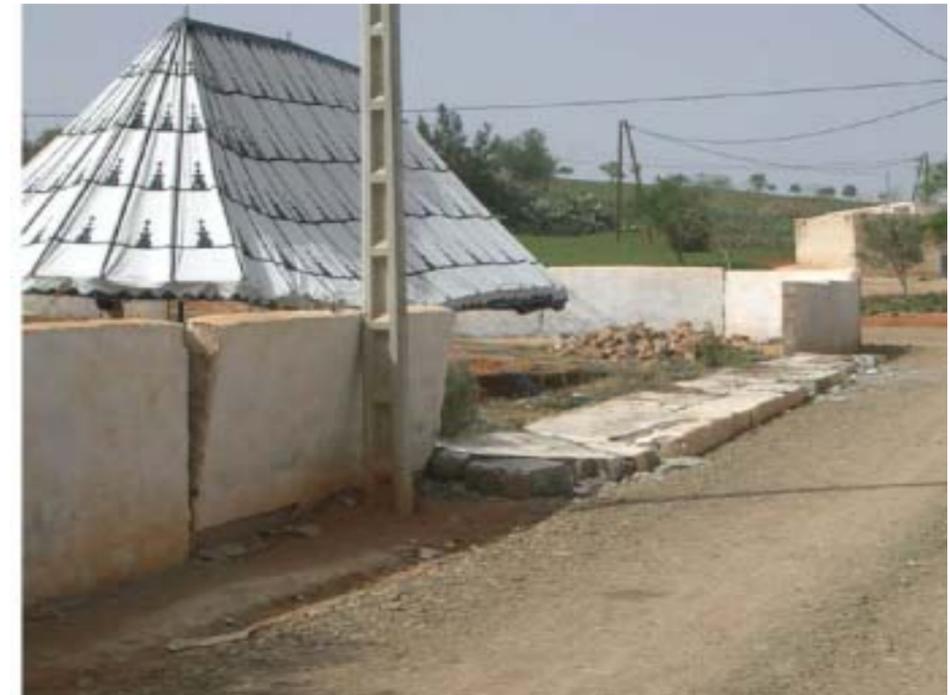
3.1.3 Block wall toppled over – Ait Jamra

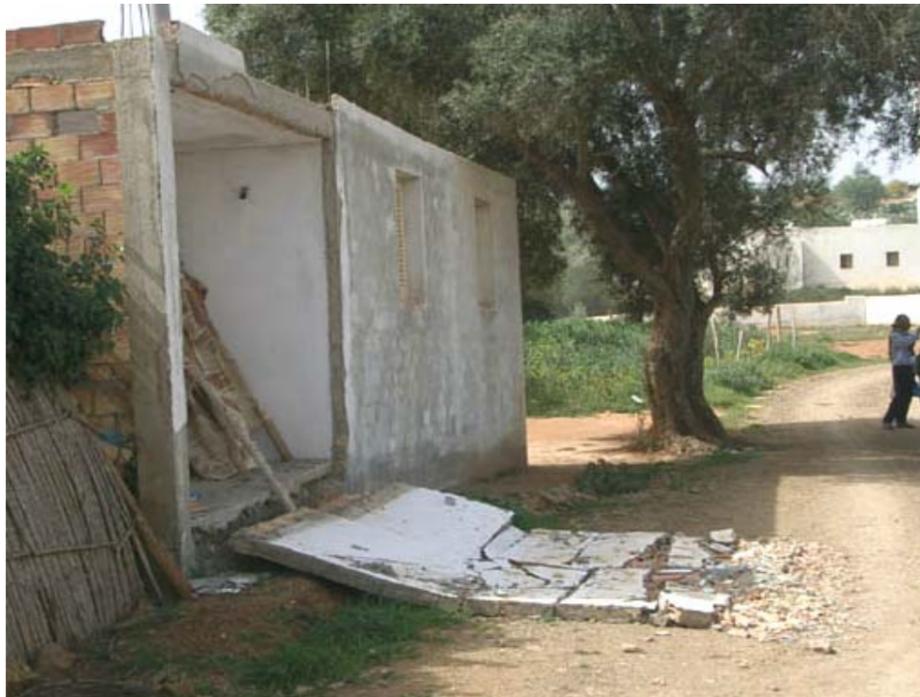
3.1.4 Expelled unconfined block wall with RC frame, Ait Jamra

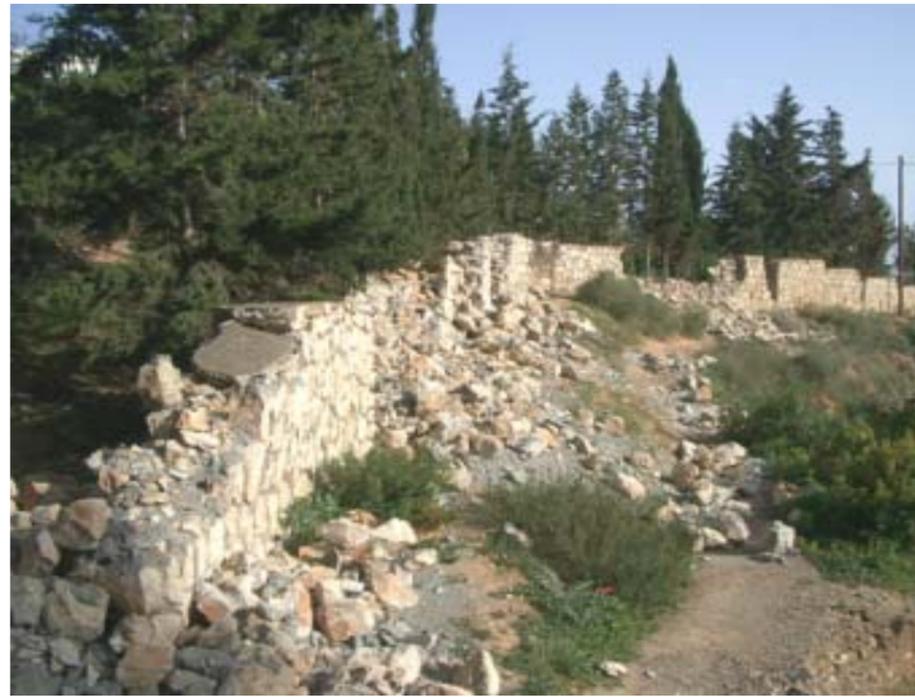
3.1.5 Brittle failure of masonry wall - Ajdir

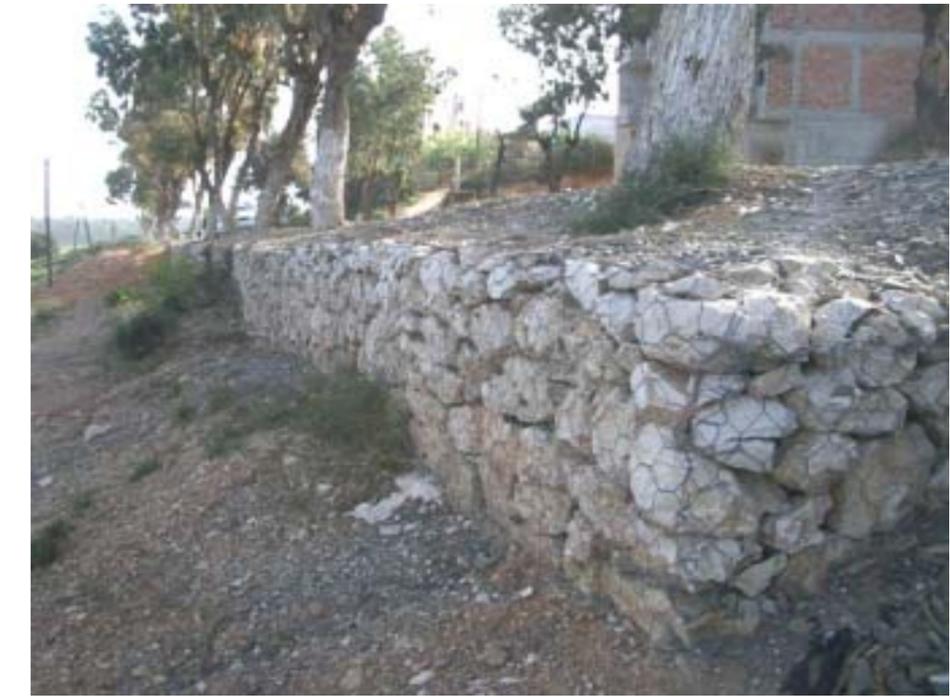
3.1.6 Note good performance of gabbion wall contained in wire - Ajdir

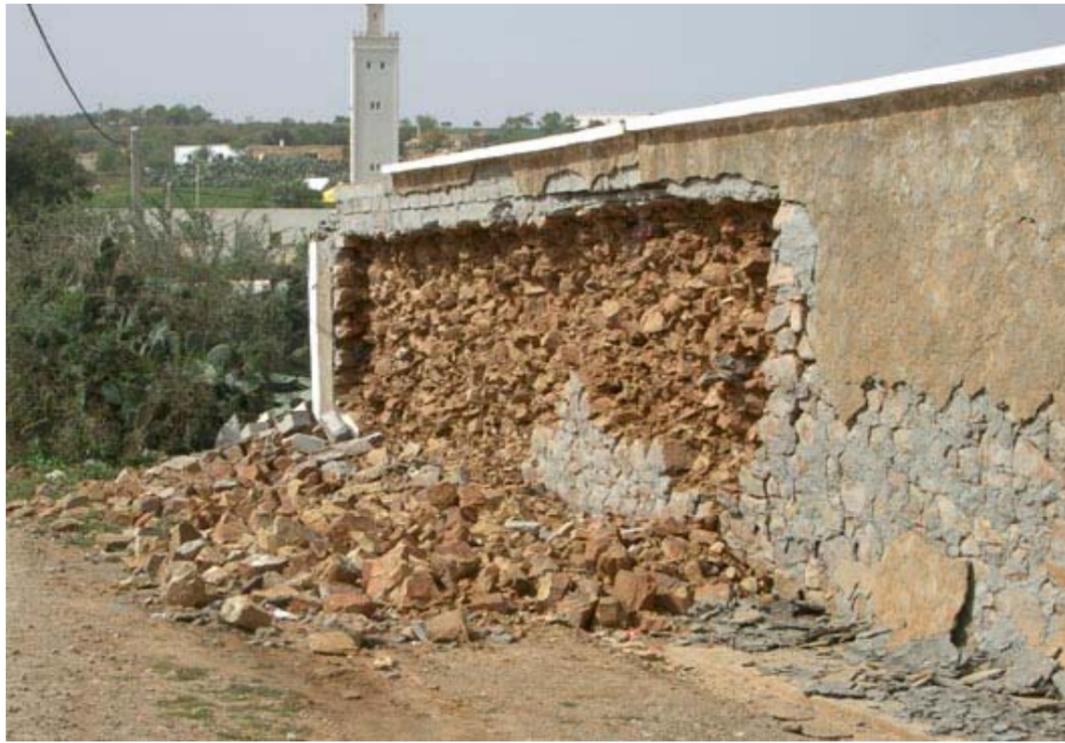
3.3.1 Loss of external skin in Ait Jamra

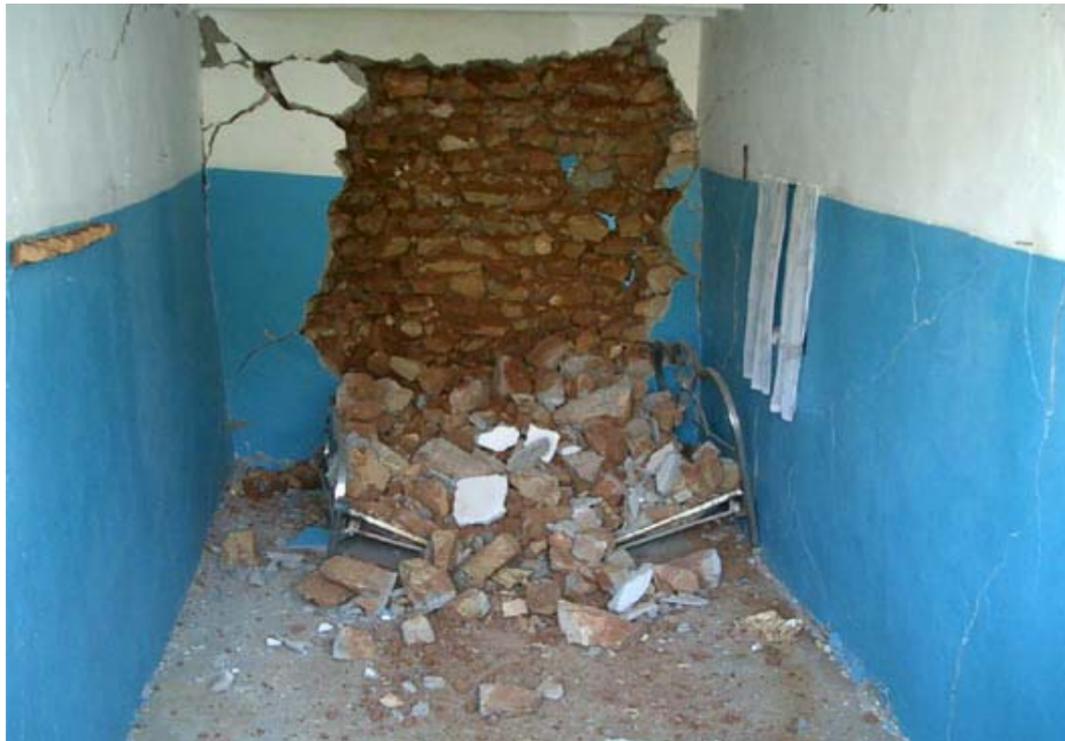
3.3.2 Failure of internal skin over a bed. Ait Jamra.

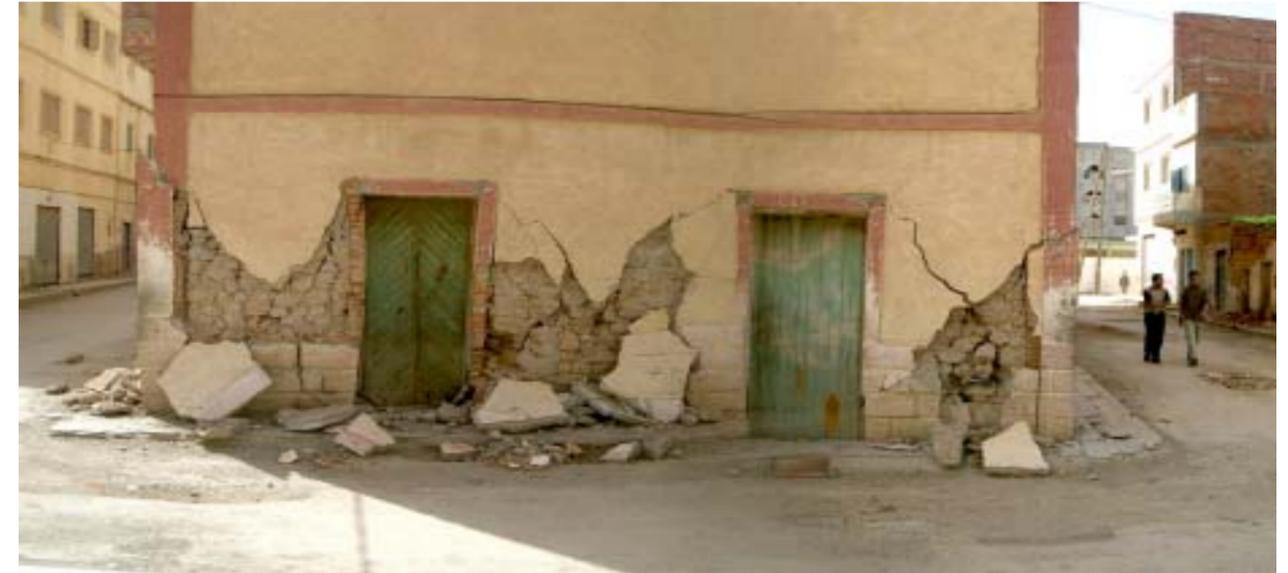
3.4.1 Shear damage to the piers on the ground floor of this unreinforced brick and stone masonry building in Imzurén. (*grade 3 vulnerability A*)

3.4.2 Façade detail of same building.

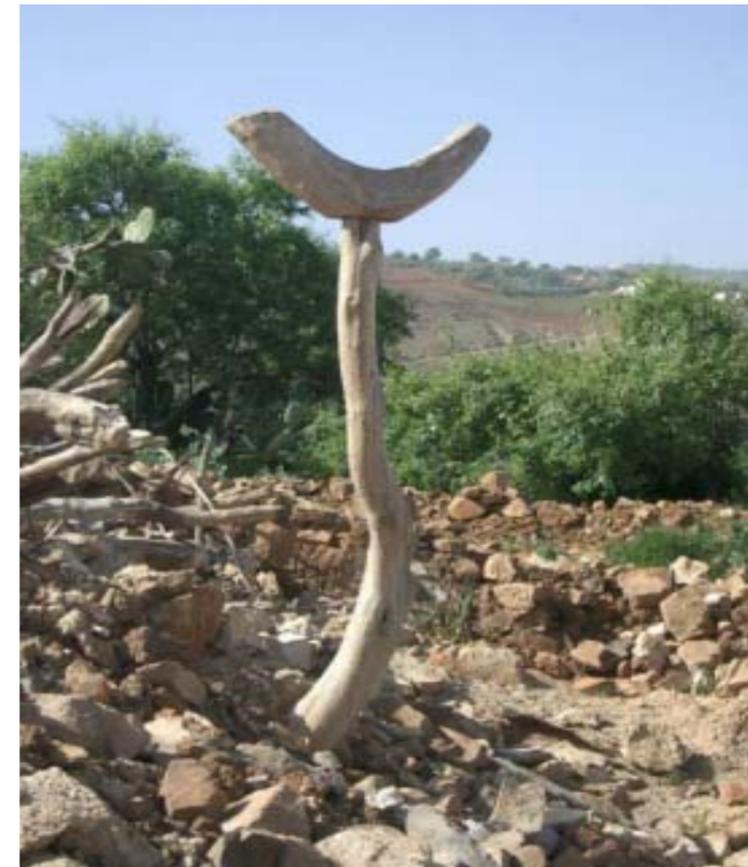
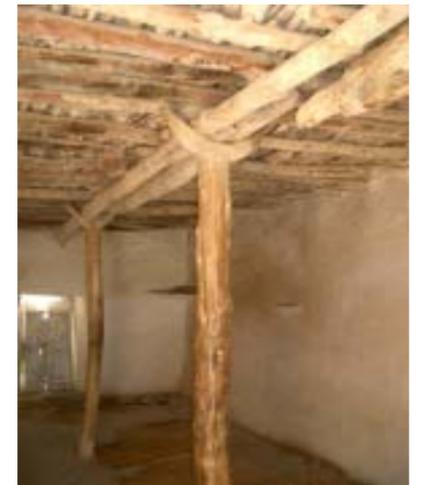
3.8.3 This remaining post confirms the very traditional nature of the former building.

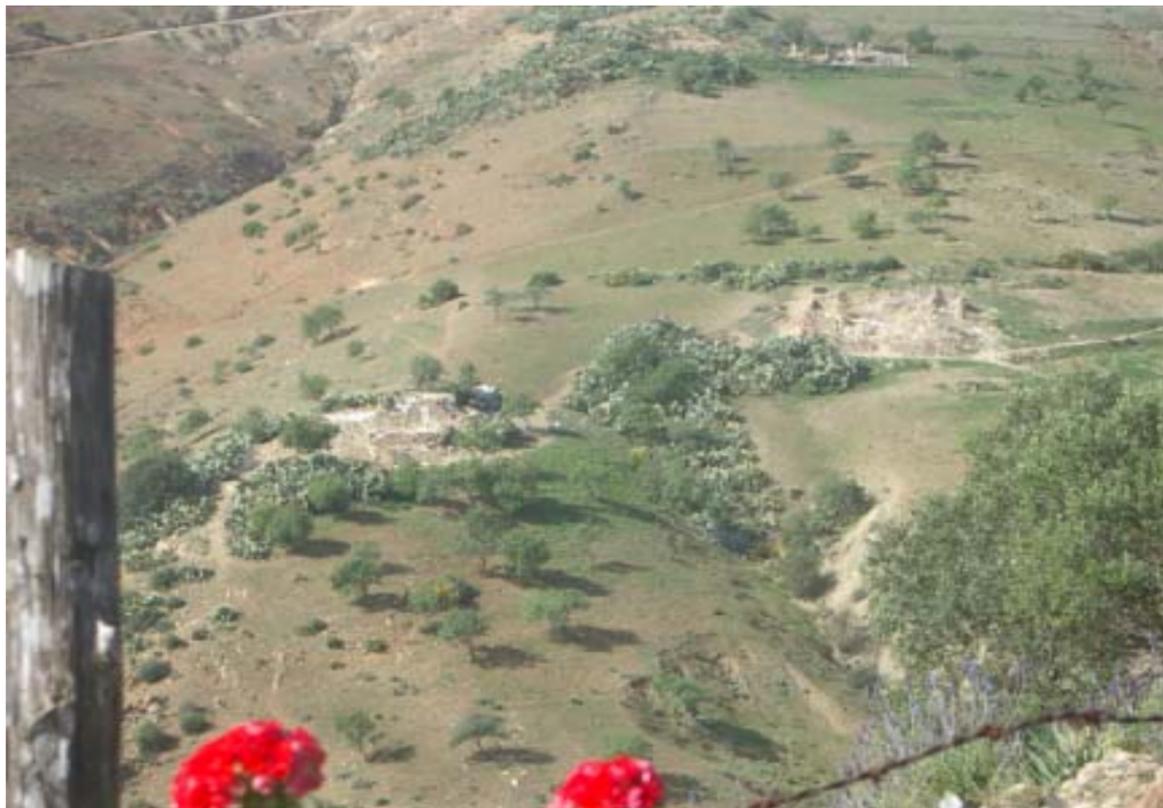
3.9.2 There are three destroyed houses in this view

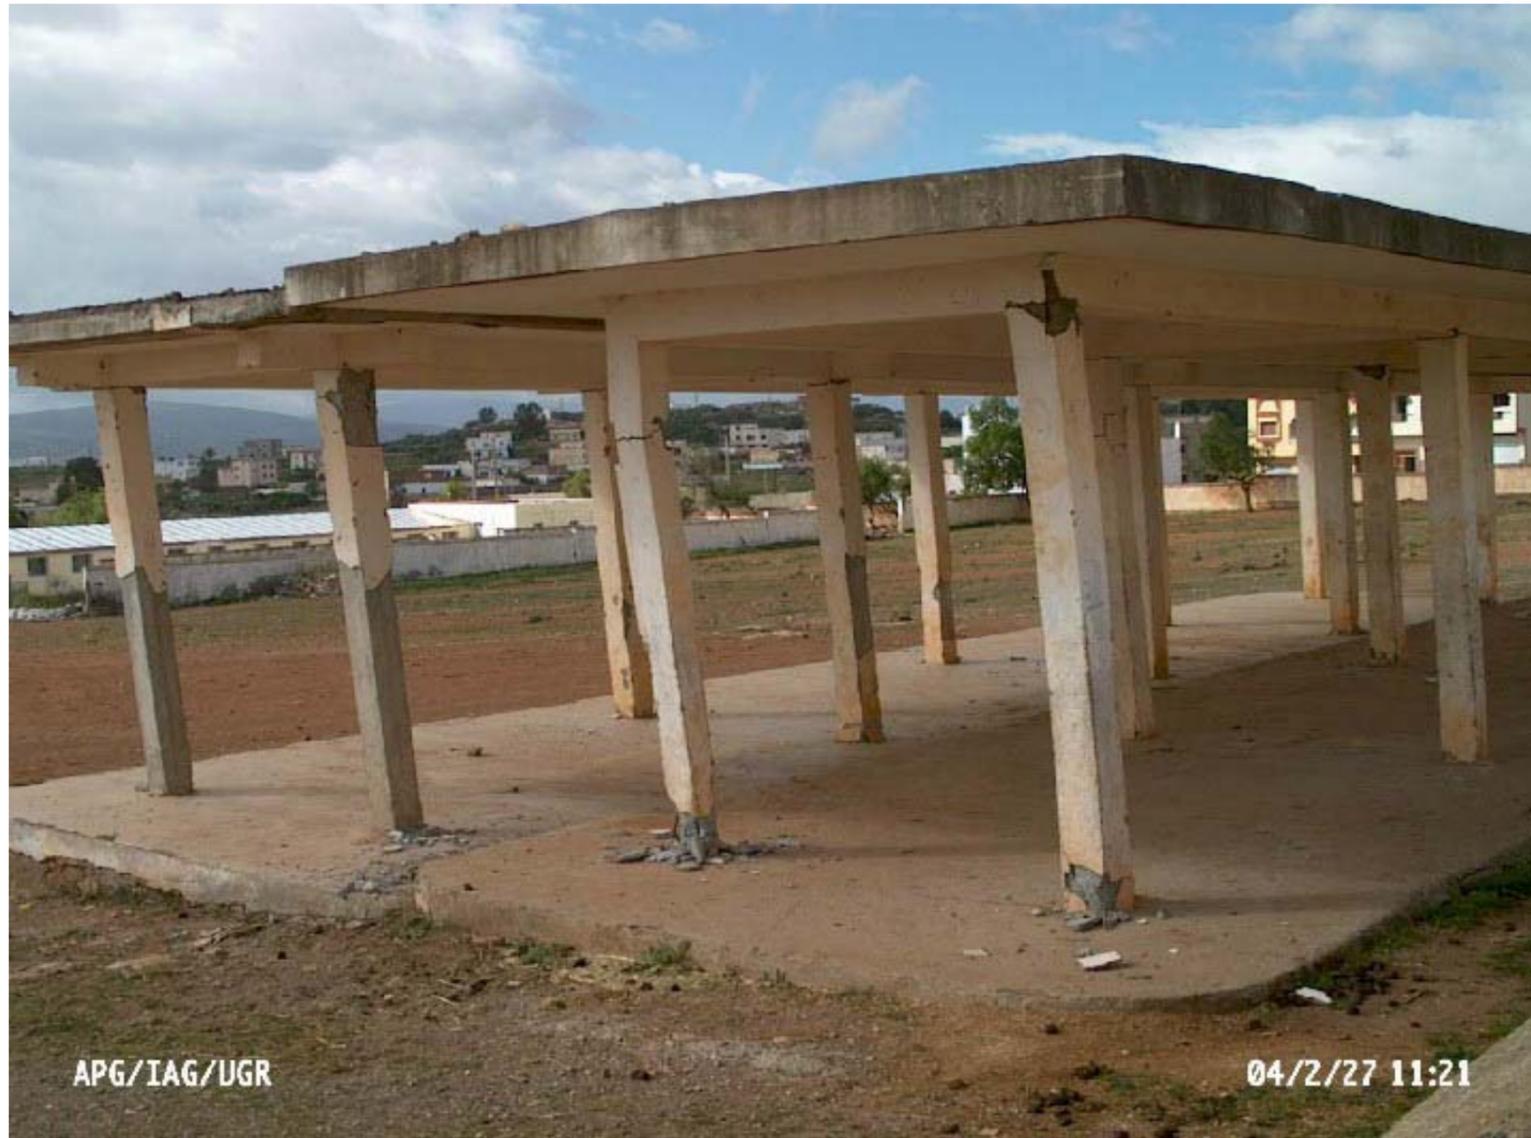
4.1.b.1 Plastic hinges at base and top connections. This is a non-ductile brittle RC frame in Izemurenne. Photograph courtesy of Mercedes Feriche

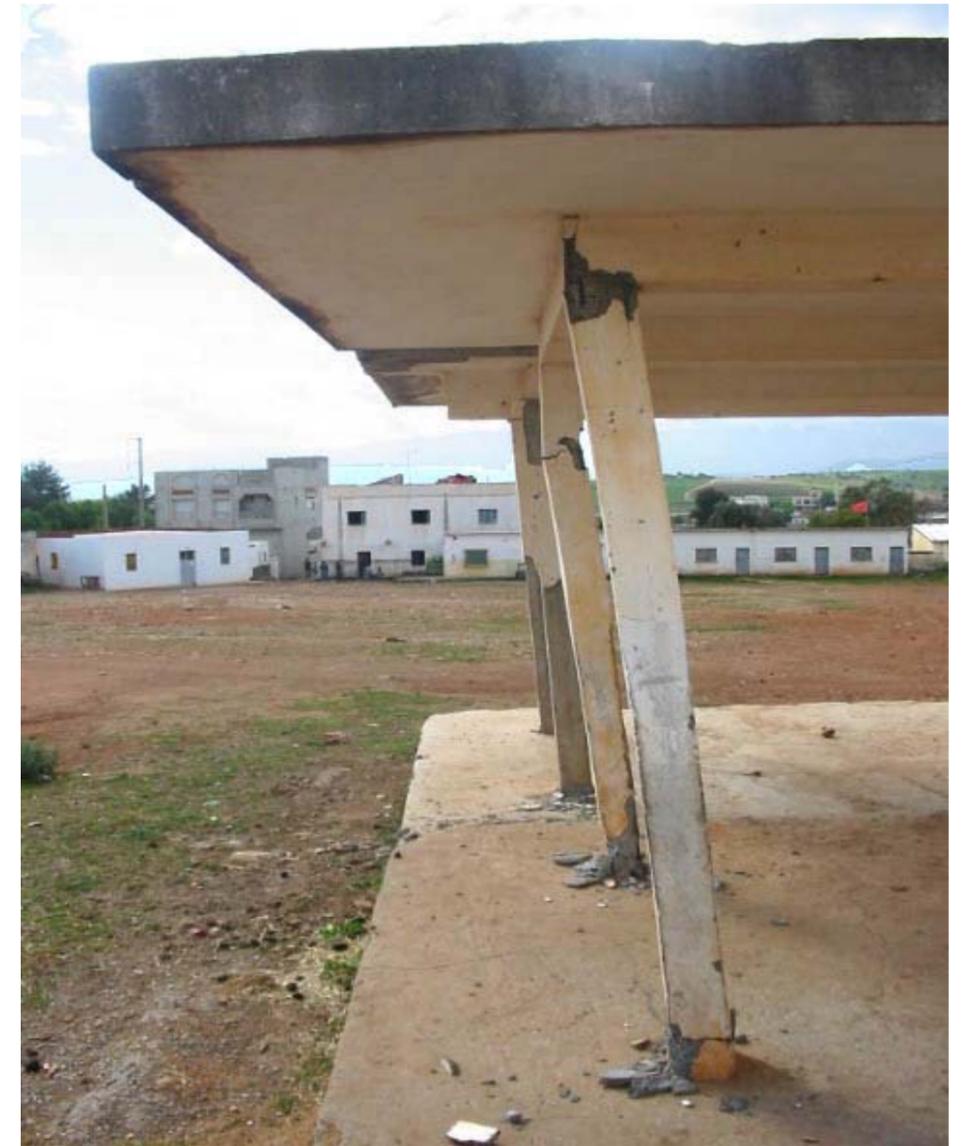
4.1.b.2 Permanent deformations. Photograph courtesy of Mercedes Feriche

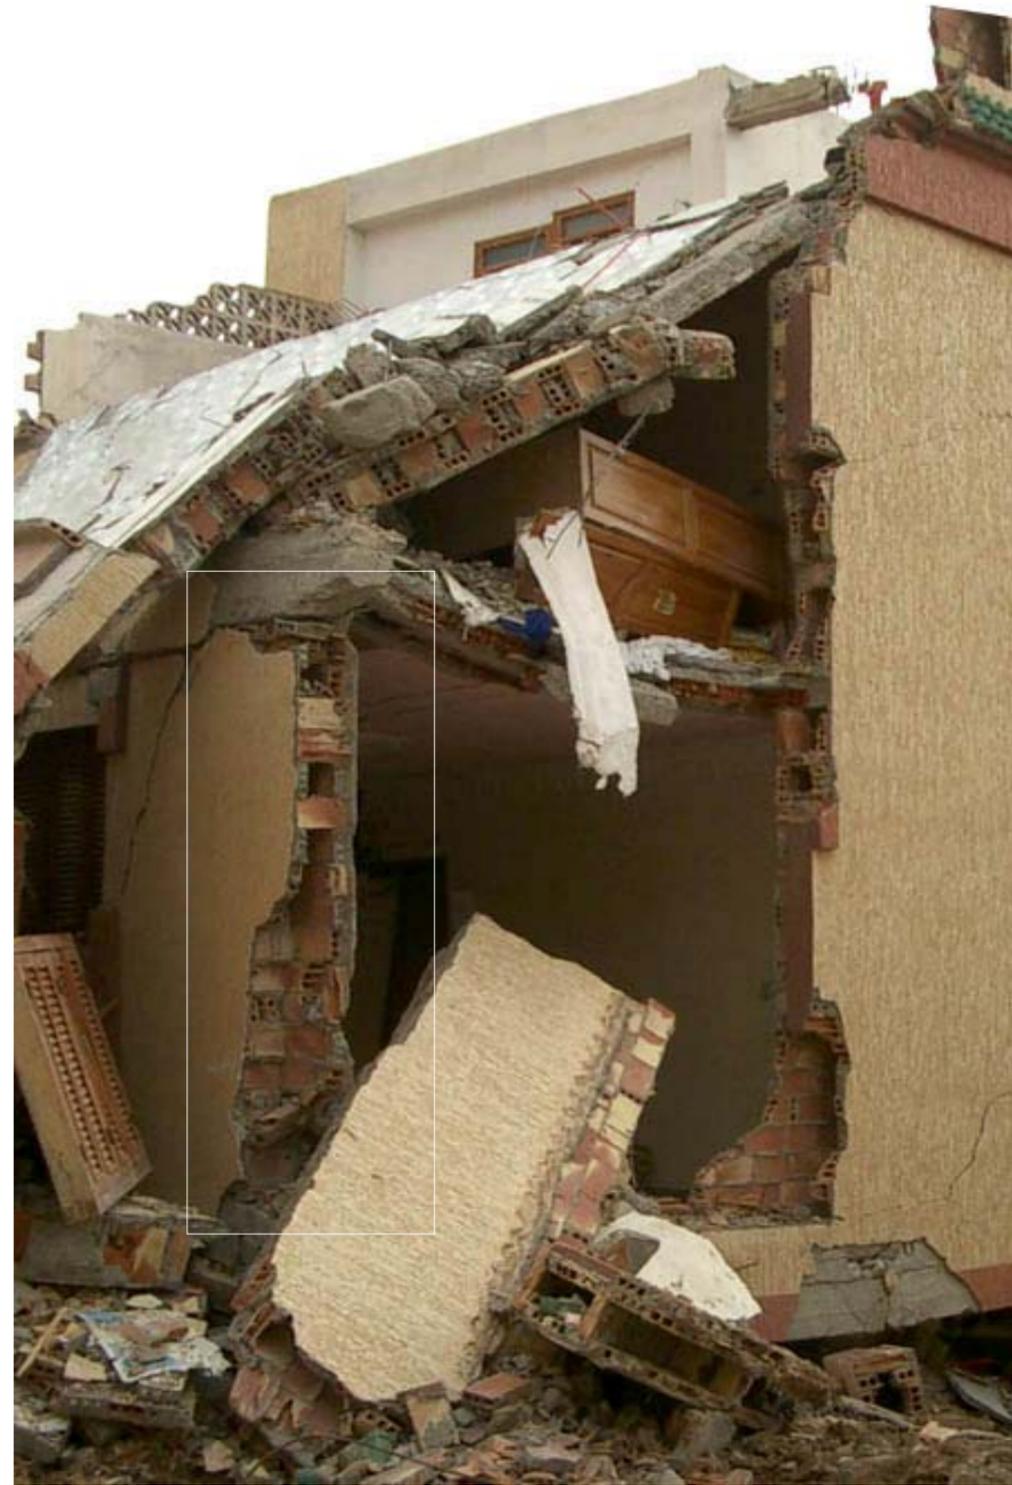
4.2.2 A collapsed RC building in Al-Hoceima showing external skin construction.

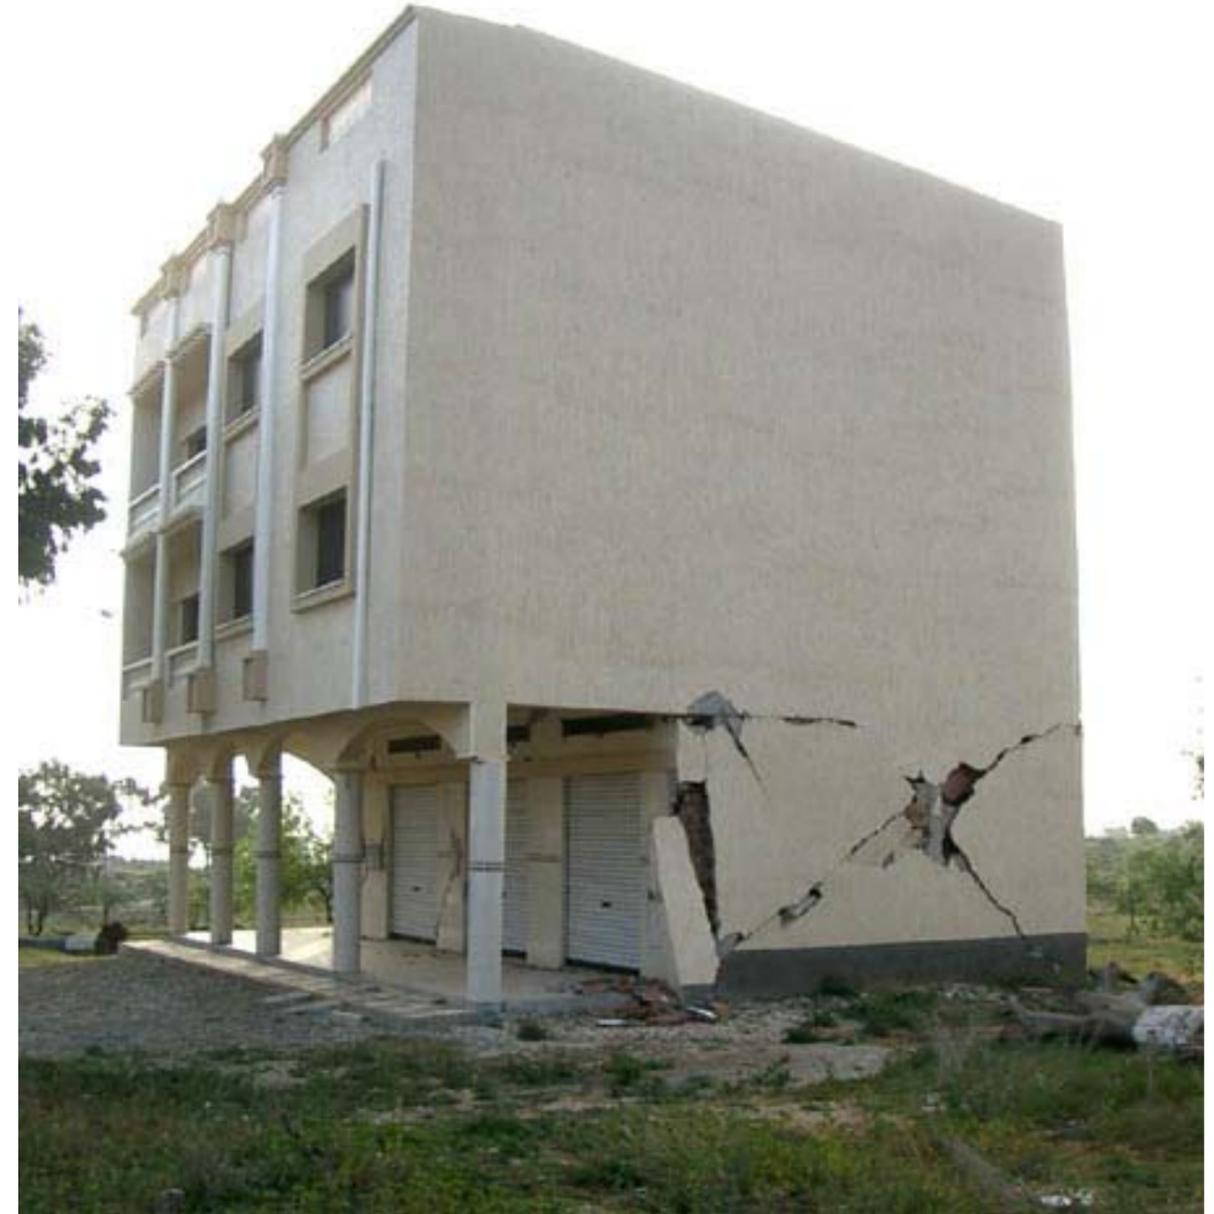
4.8.2 Soft storey damage to this RC building in Ajdir. (grade 3 vulnerability C)

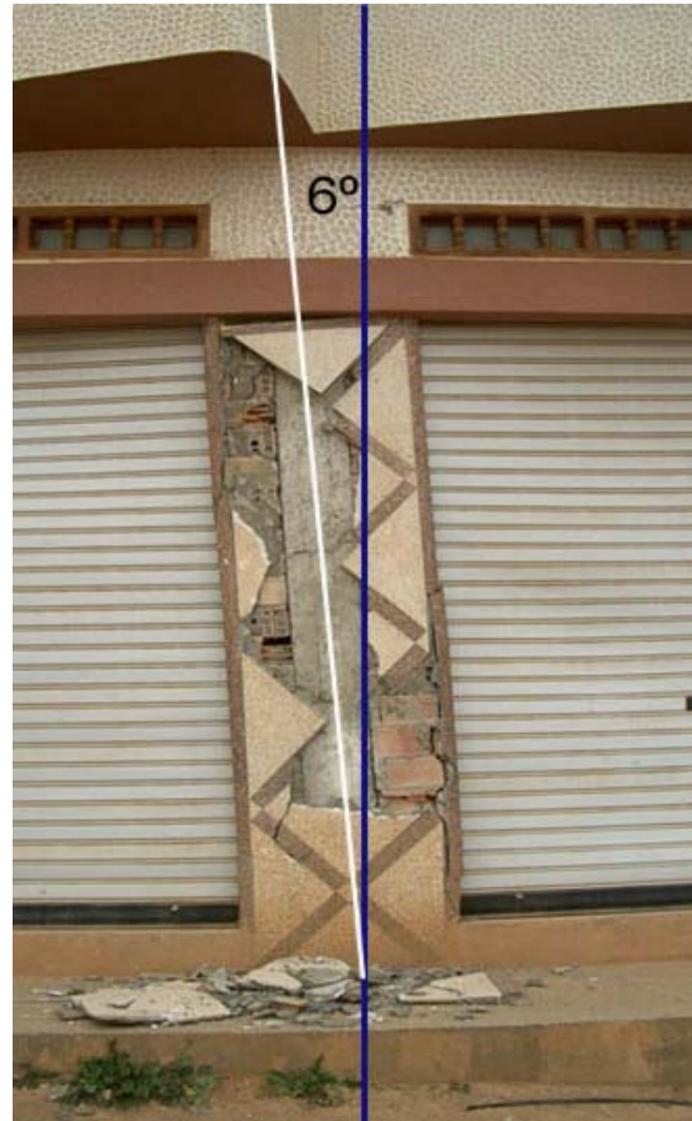
4.9.1 Open plan shops on ground floor with densely compartmented housing above. This was a classic candidate for soft storey damage. In this building in Imzuren the upper floors have drifted over the ground floor causing plastic hinges and permanent deformations. (grade 4 vulnerability C)

4.9.2 6° permanent drift.

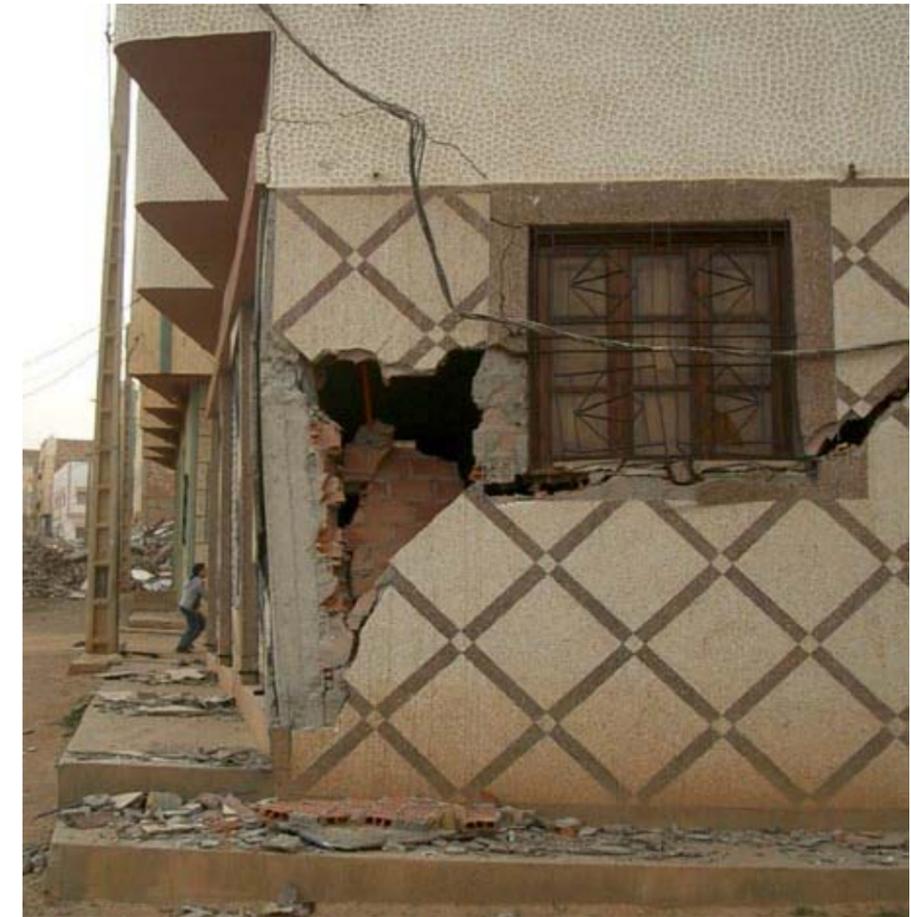
4.9.3 Side view.

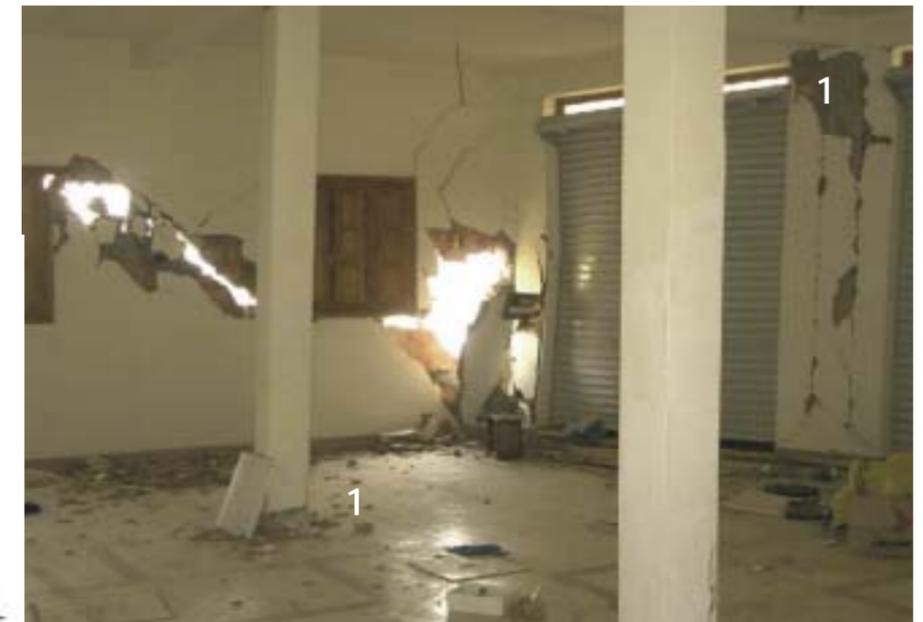
4.9.4 Interior view. Note plastic hinges on column extremities. (1)

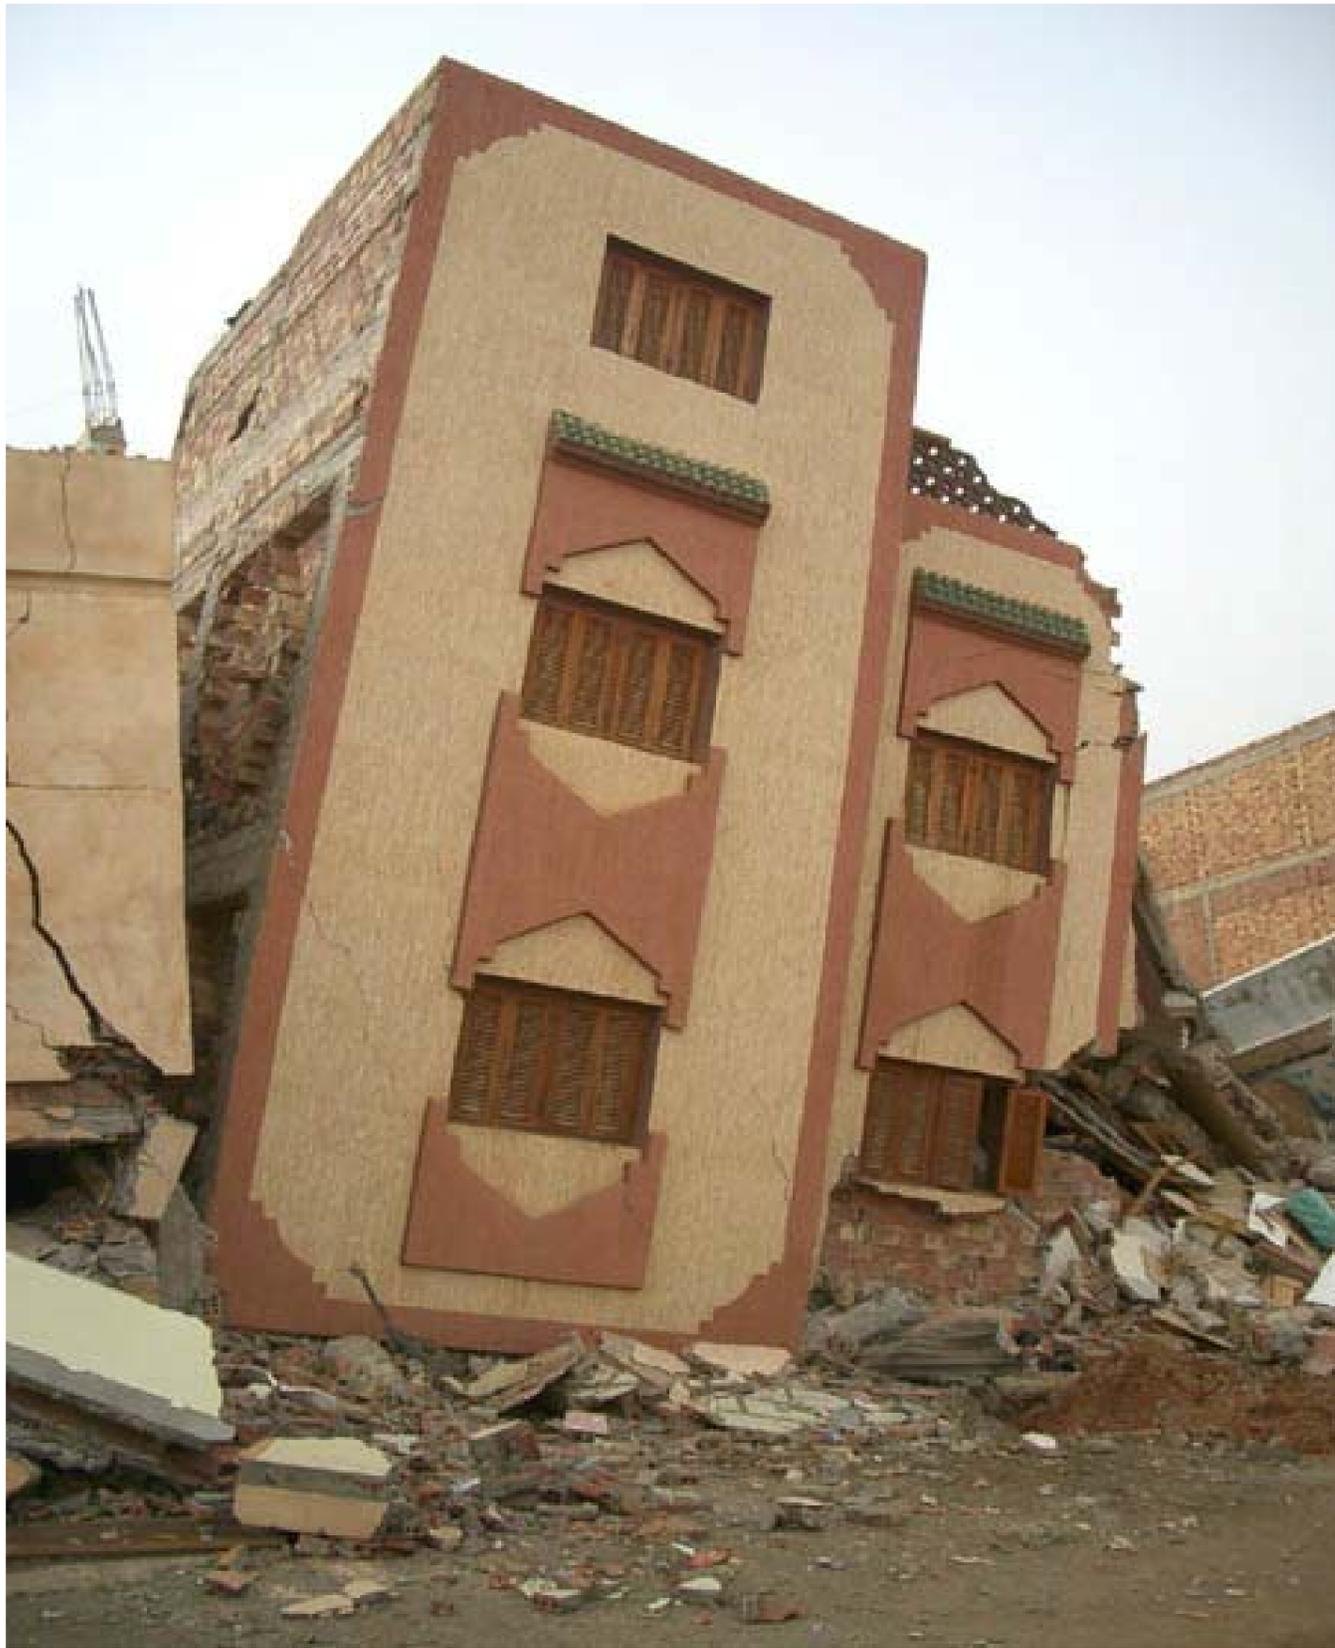
7.1.1 The building from the front, with ground floor collapse. (*grade 5 Vulnerability C*)

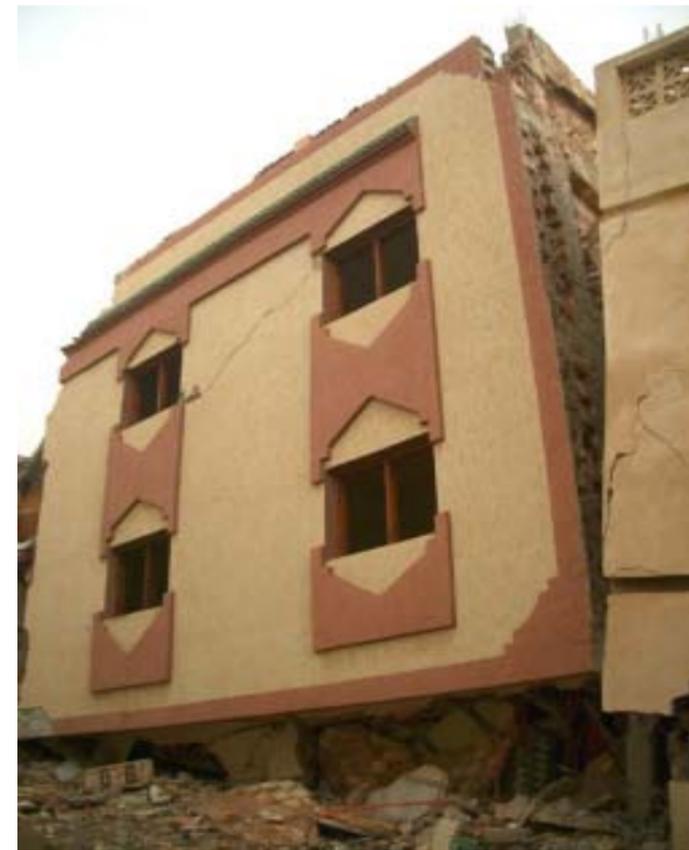
7.1.3 Back view.

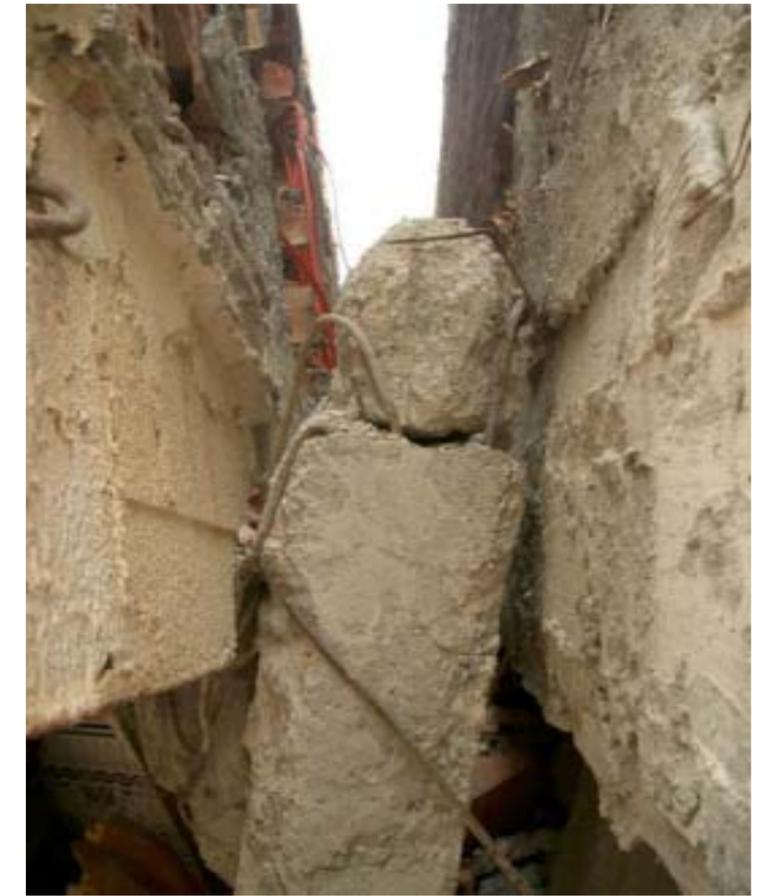
7.2.3 Column head detail. Note plasticated non-corruugated steel and small column section.

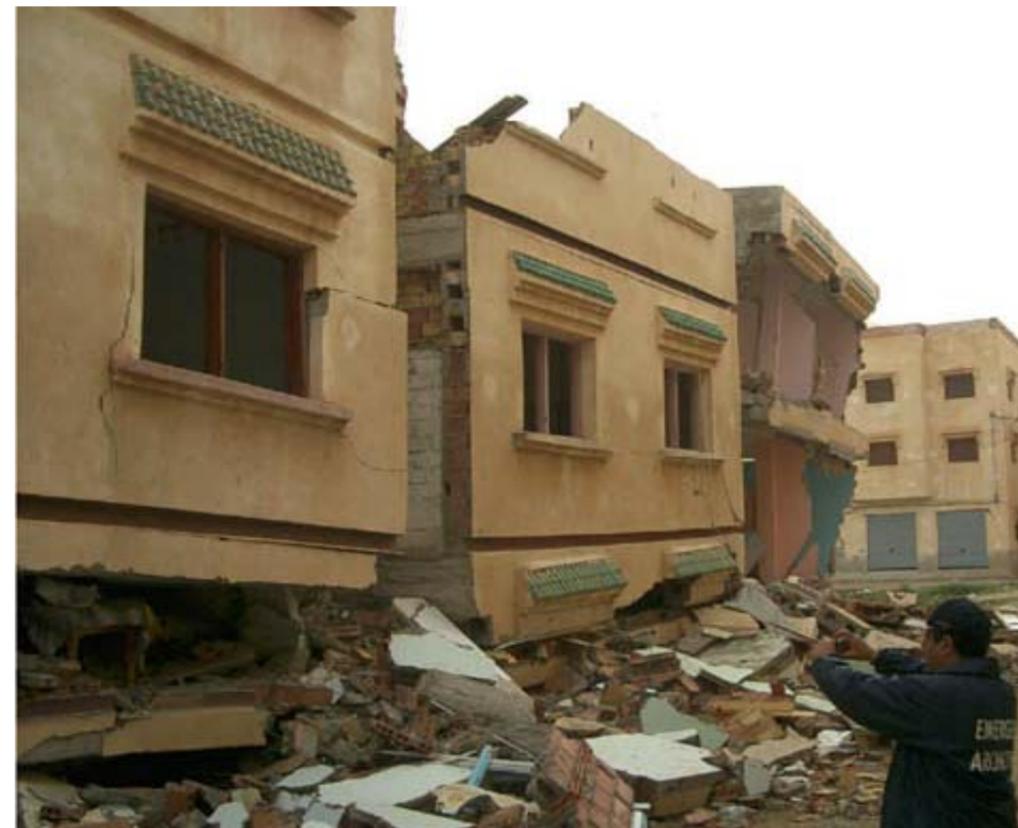
7.3.3 Back view.

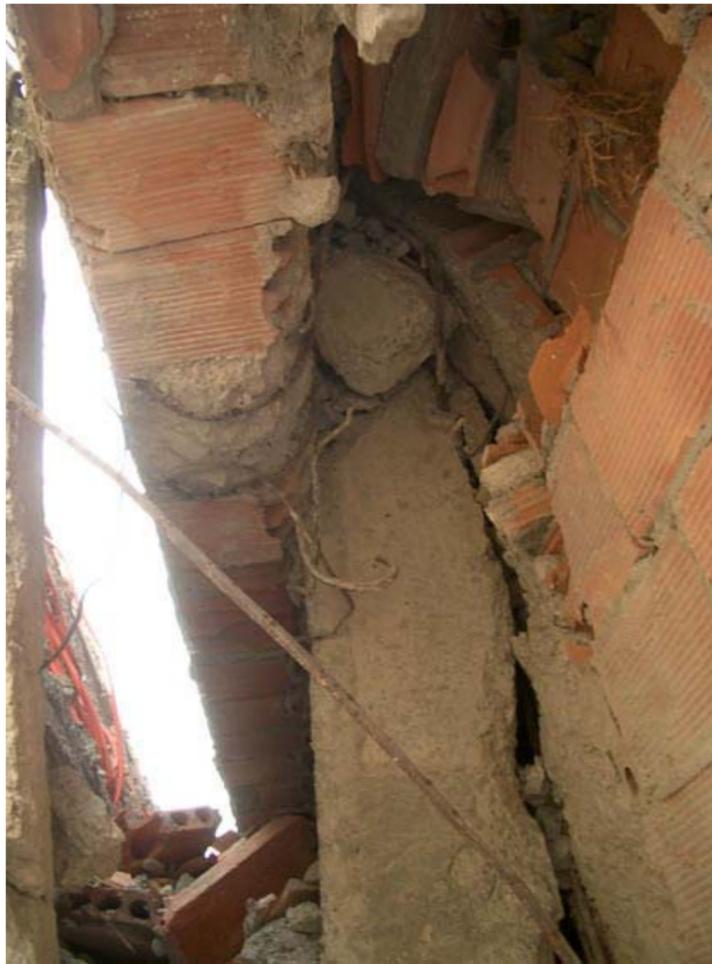
7.4.1 Detail of column shown at right.
