AL-HOCEIMA EARTHQUAKE 24 02 2004

FIELD REPORT

Patrick Murphy Corella *Architect* June 2004

The Al-Hoceima earthquake

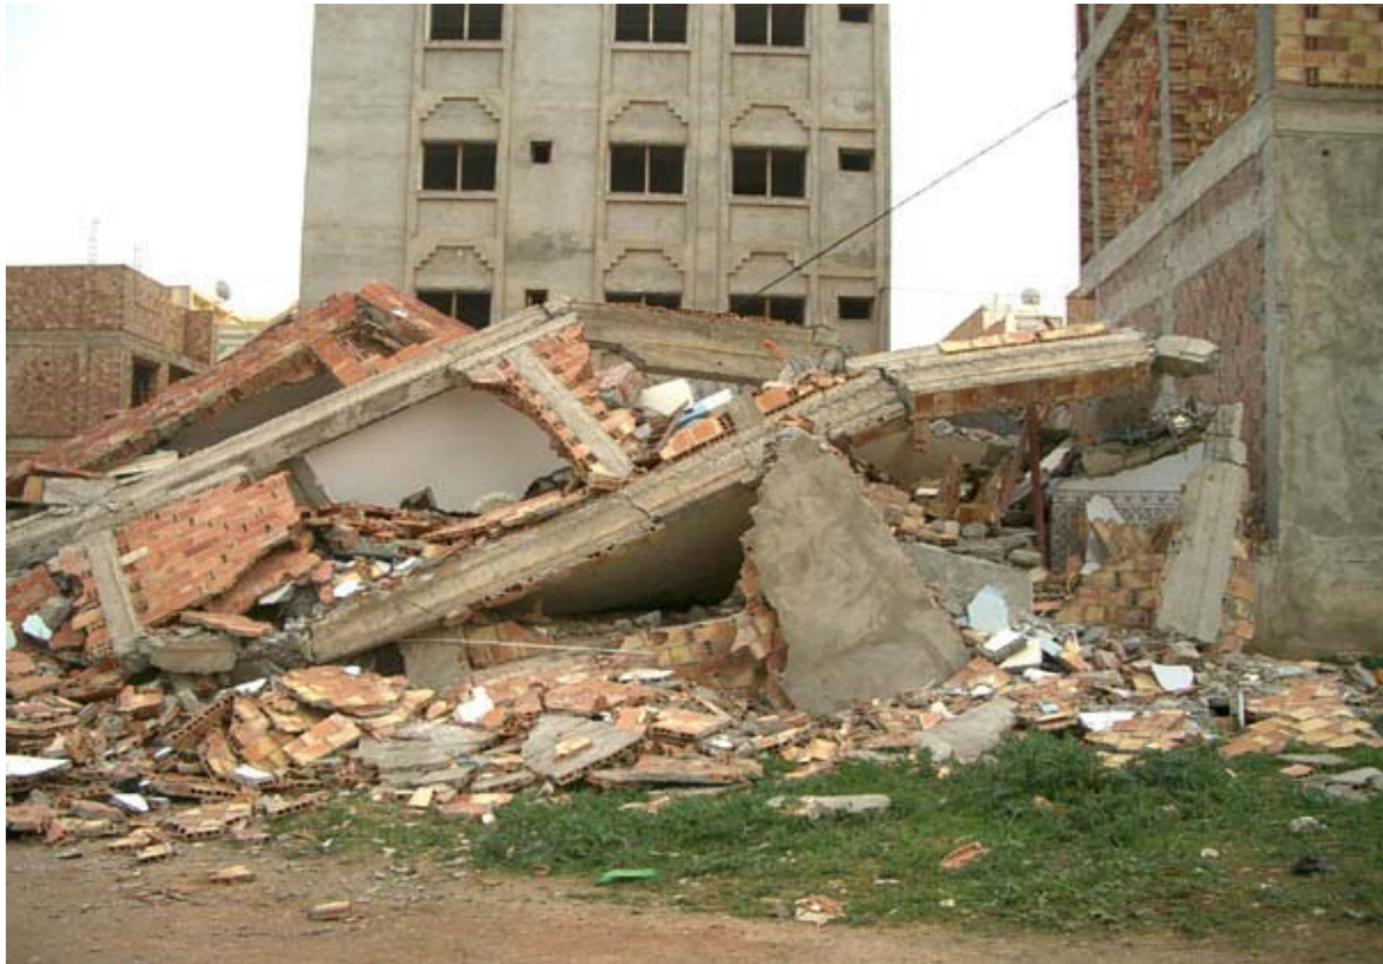
8.1.1 Pancaked building in Imzuren. (*grade 5 Vulnerability C*)

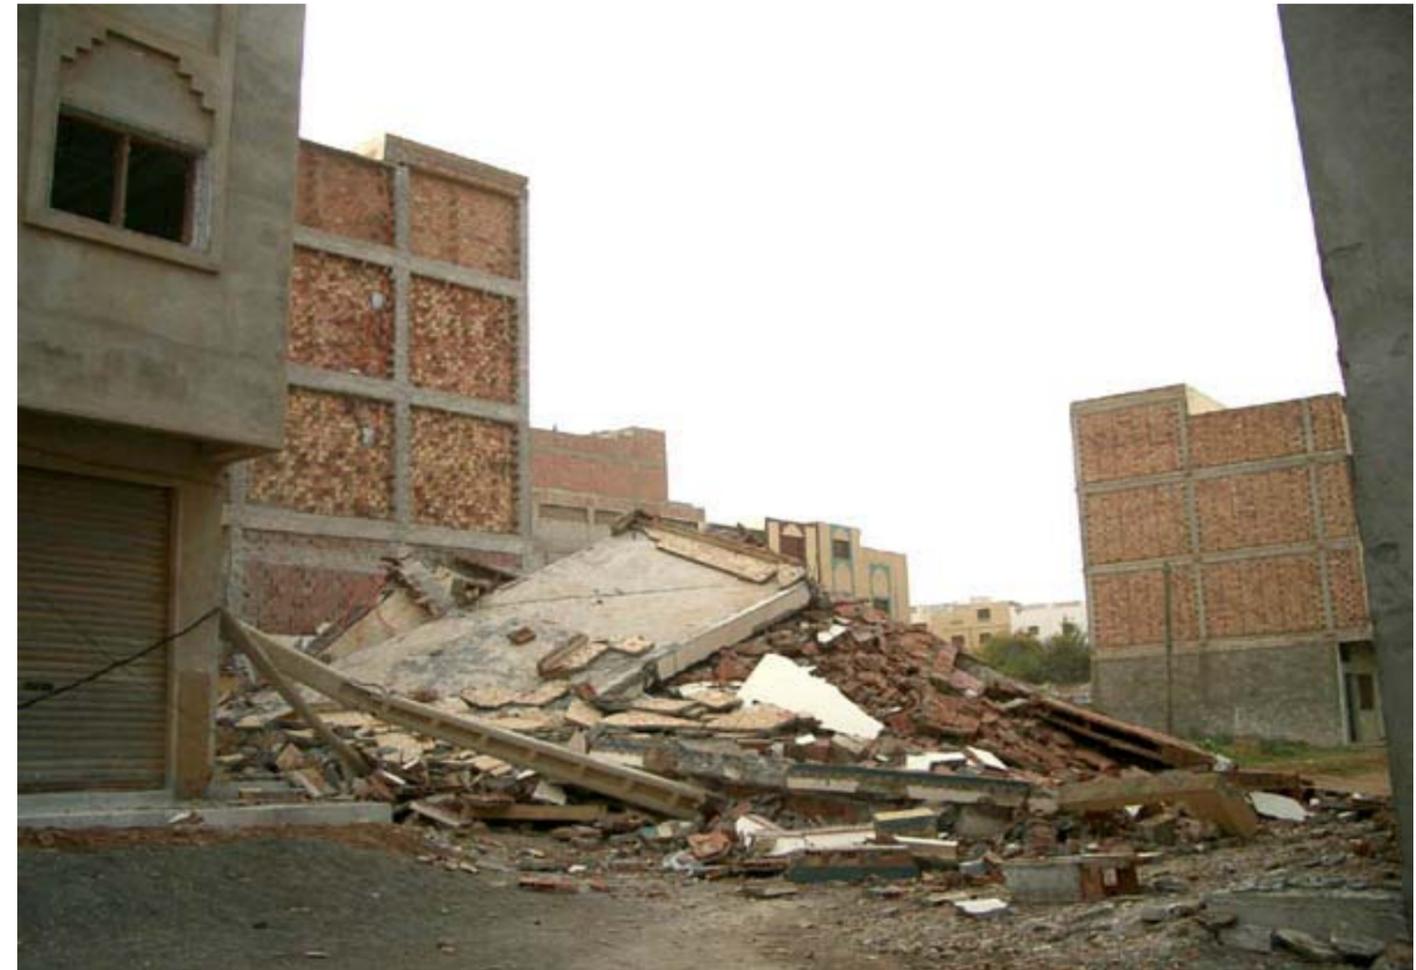
8.1.2 Same building from the front. Note the undamaged former party wall on the left.

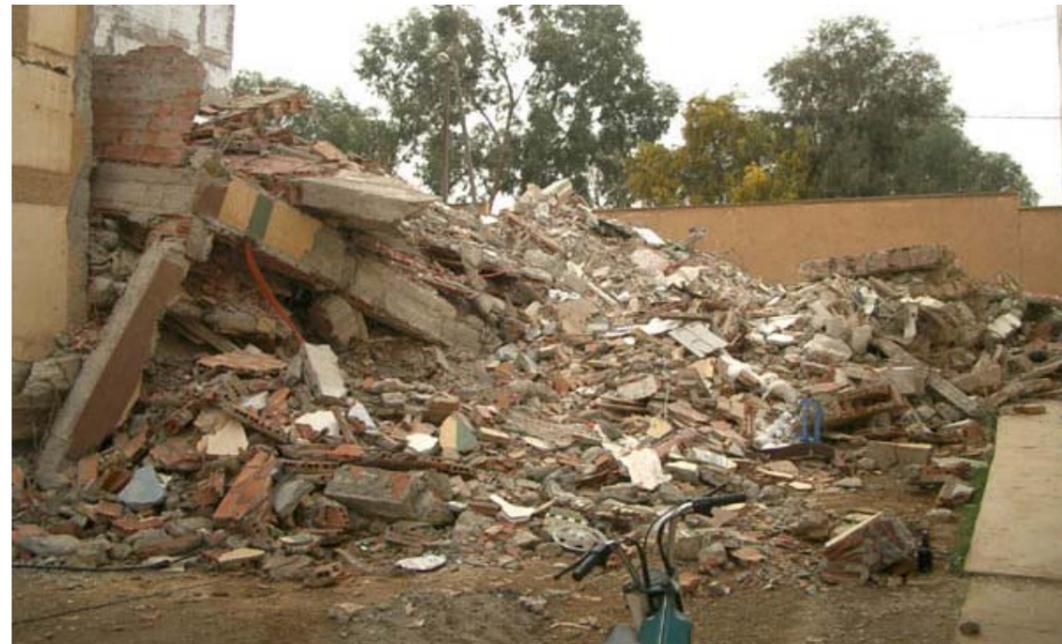
8.1.3 Another pancaked building in Imzuren (*grade 5 vulnerability C*)

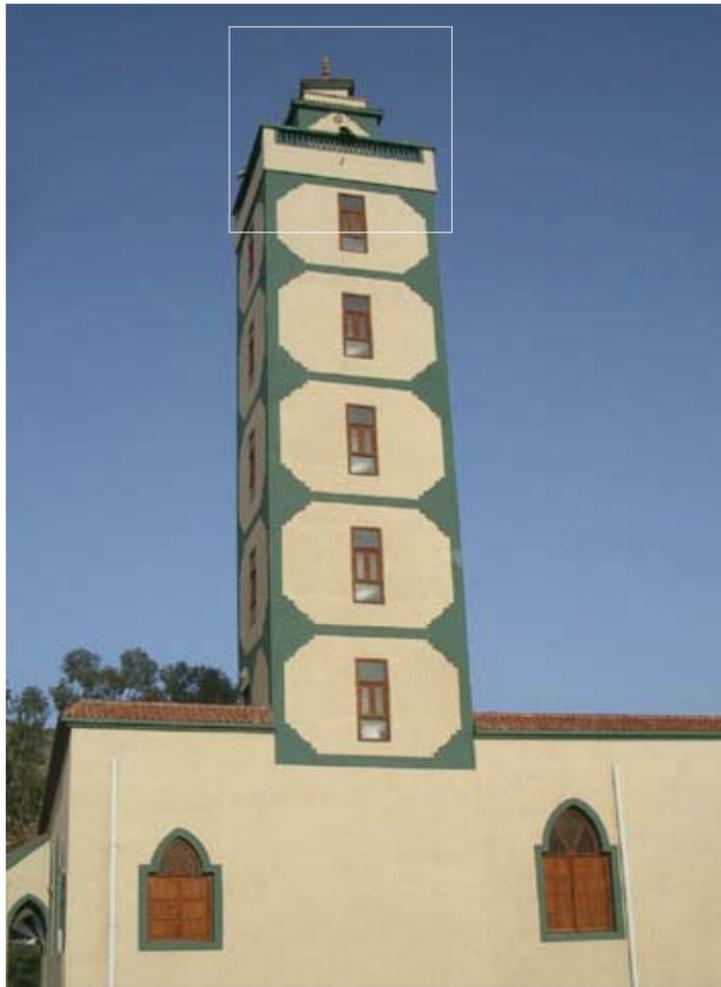
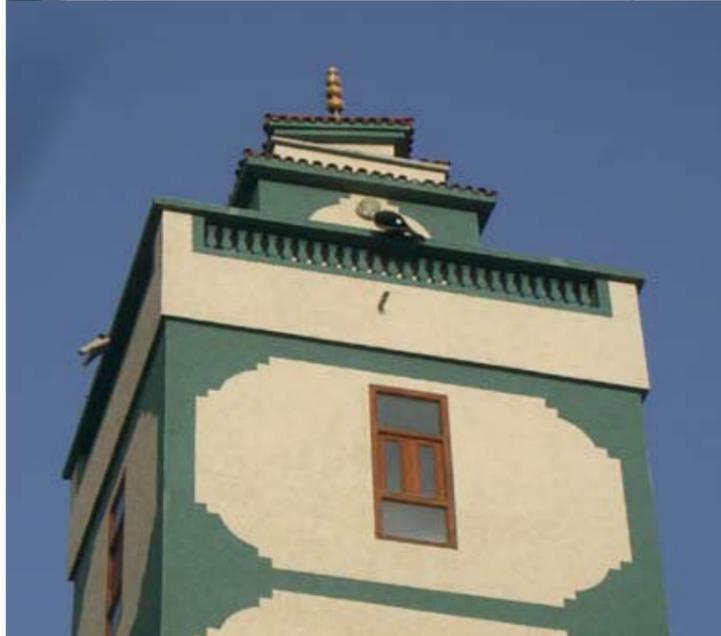
9.2.1 Twisting of the lantern in Ajdir. (*grade 2 vulnerability C*)

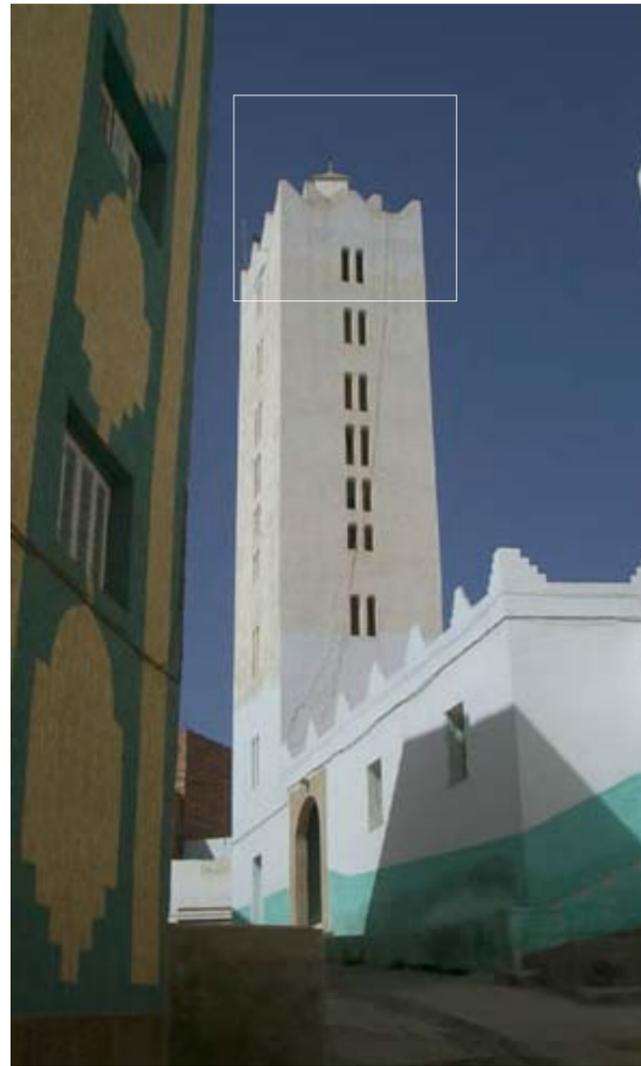
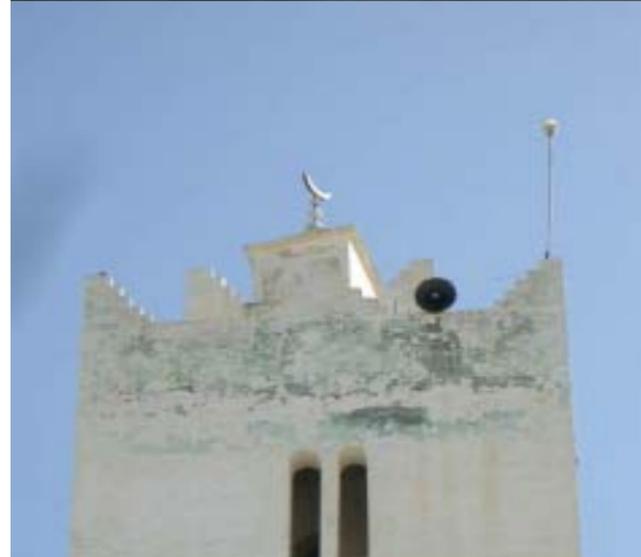
9.2.2 Twisting of the lantern in Imzuren. (*grade 2 vulnerability C*)

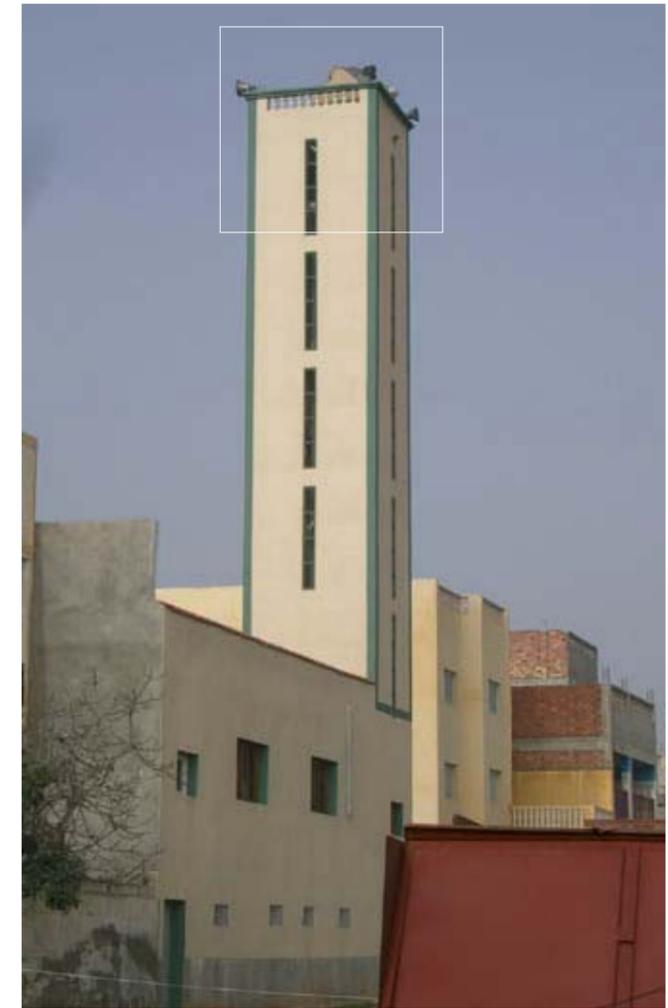
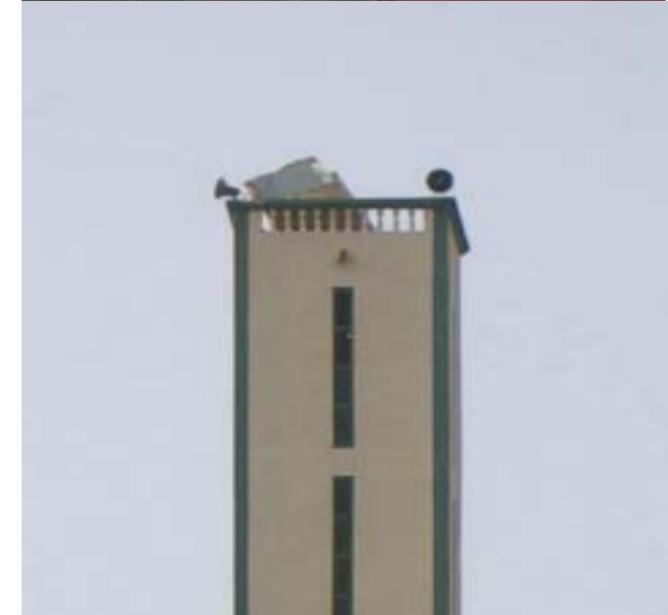
9.2.3 Lantern collapse in Ajdir. (*grade 2 vulnerability C*)

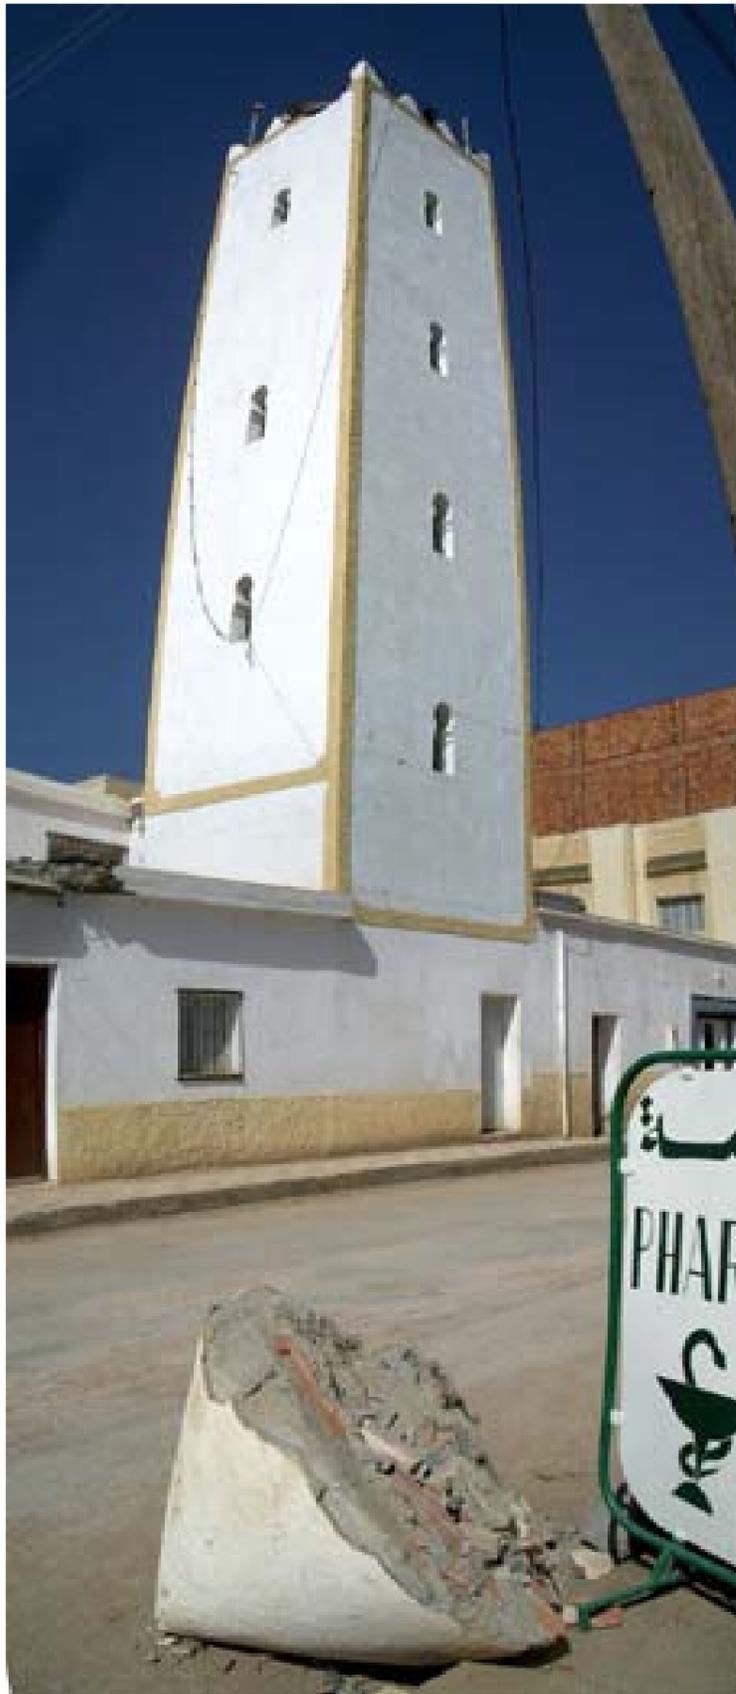
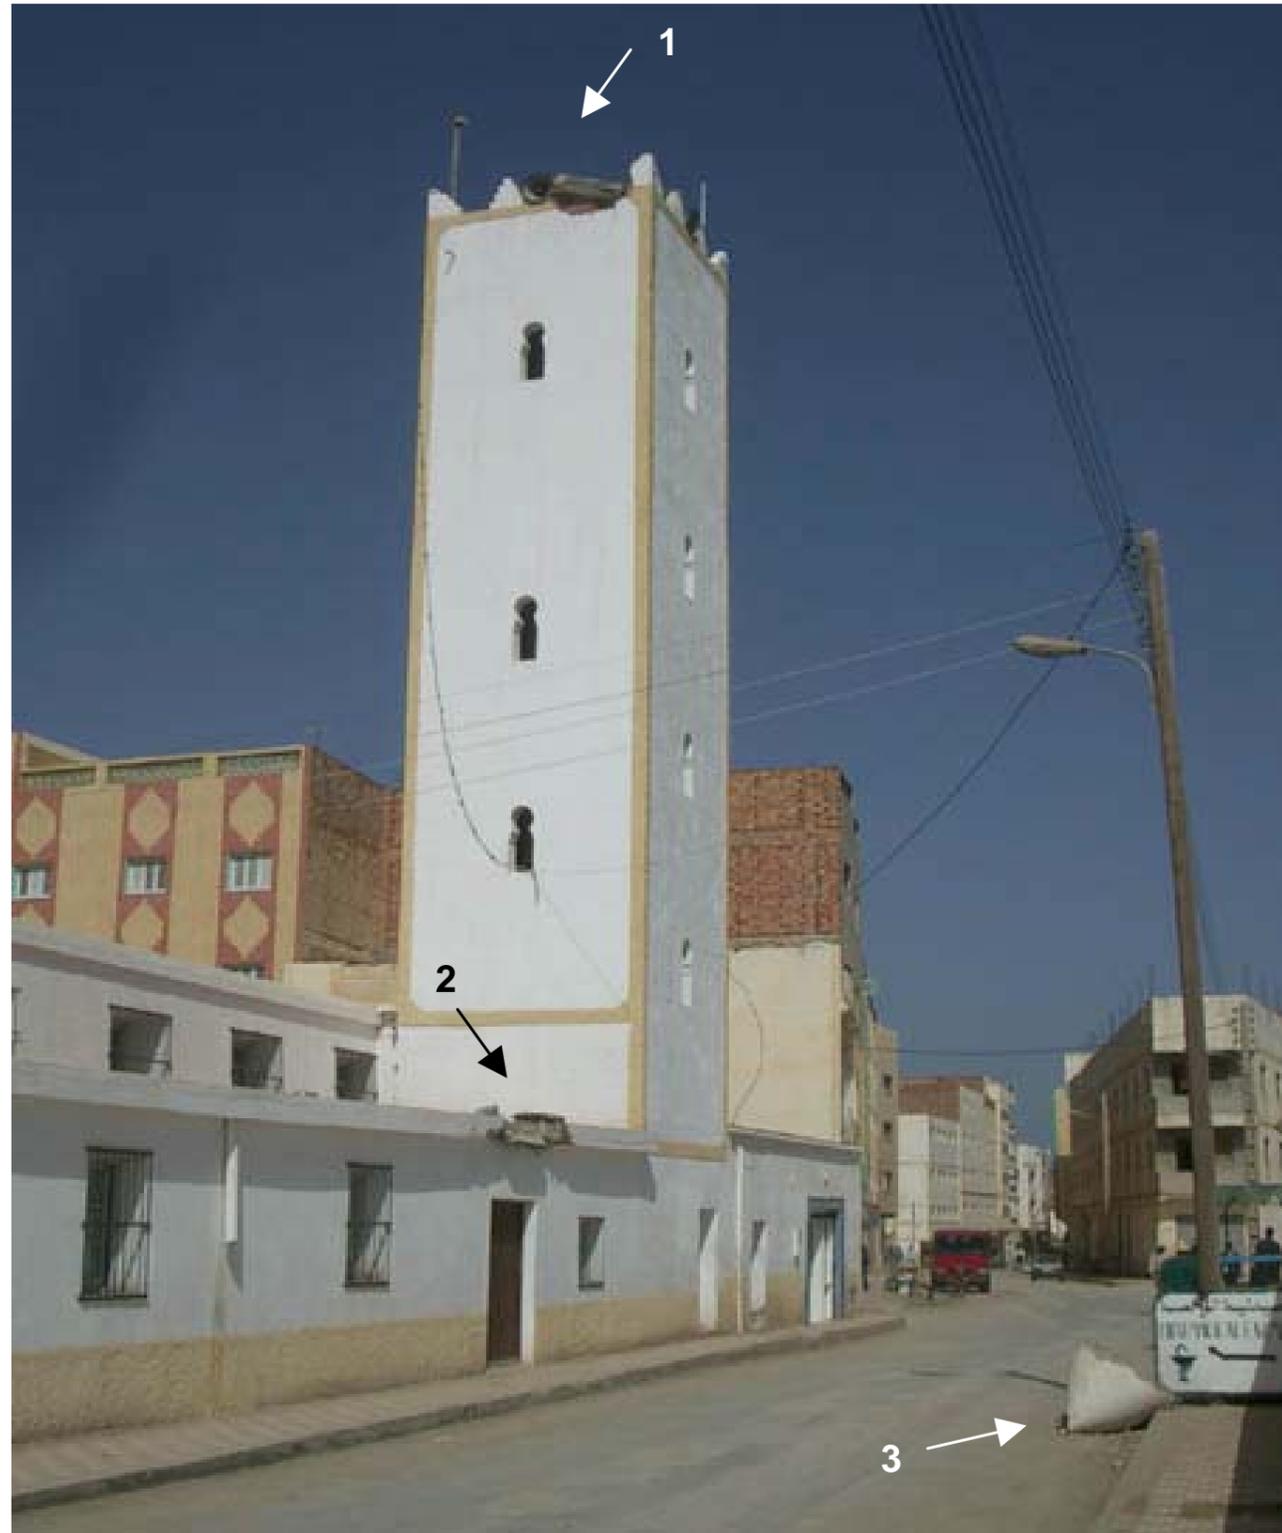
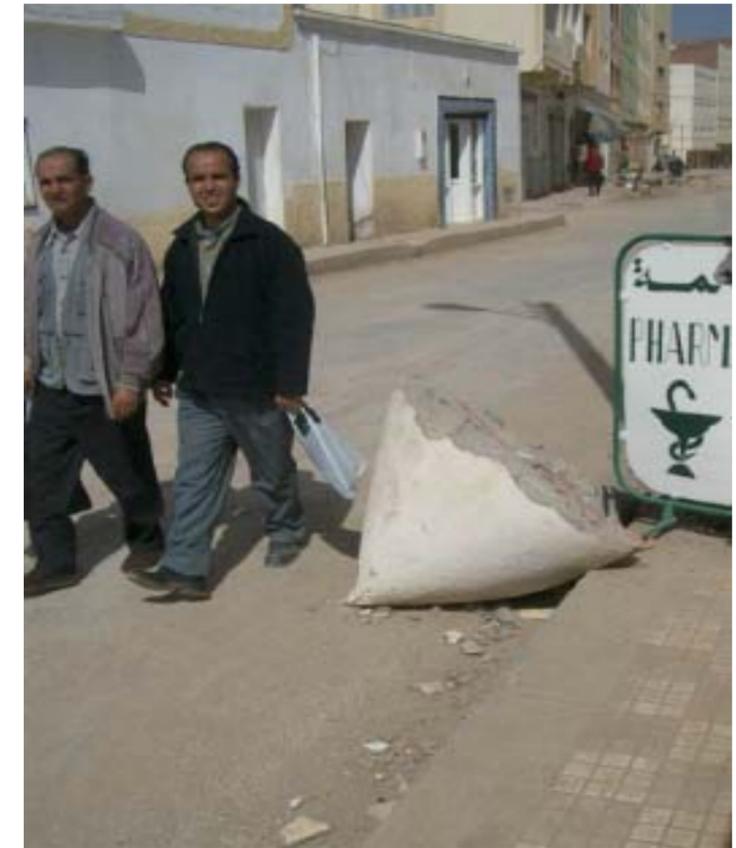
9.5.1 Here the lantern was knocked over (1) striking the entrance area (2) finally rolling over the road. (3) (grade 2 Vulnerability C – some may argue grade 3 'chimneys break at roof level')

9.5.2 Remains of the cupola on the road.

9.5.4 The lantern was roofed with a heavy masonry mass.

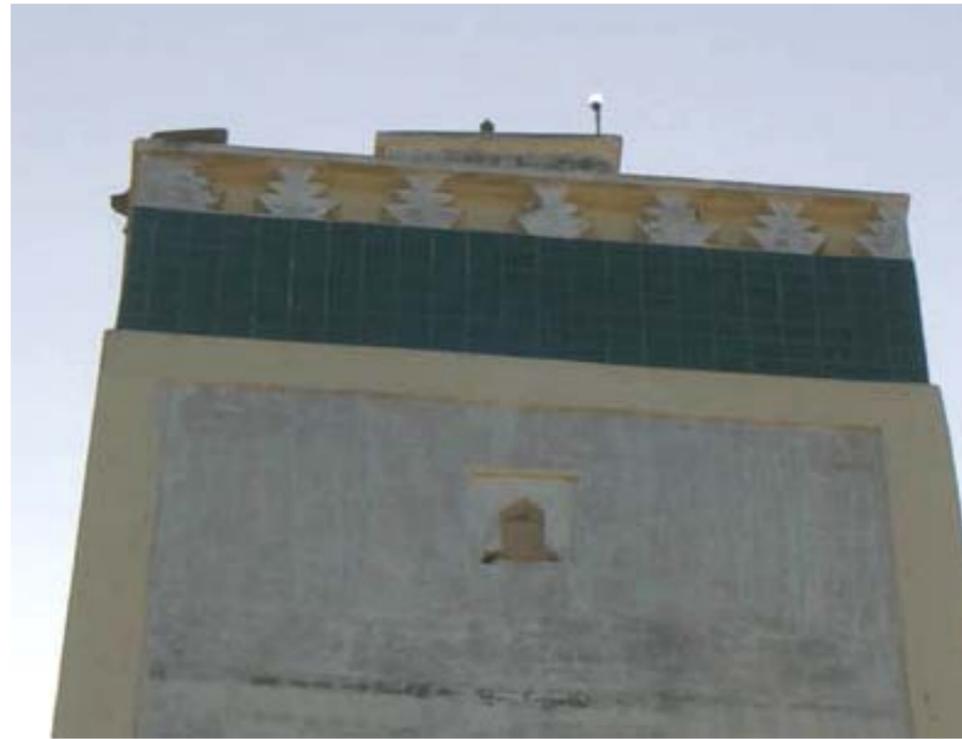
9.6.2 Lantern rotation.

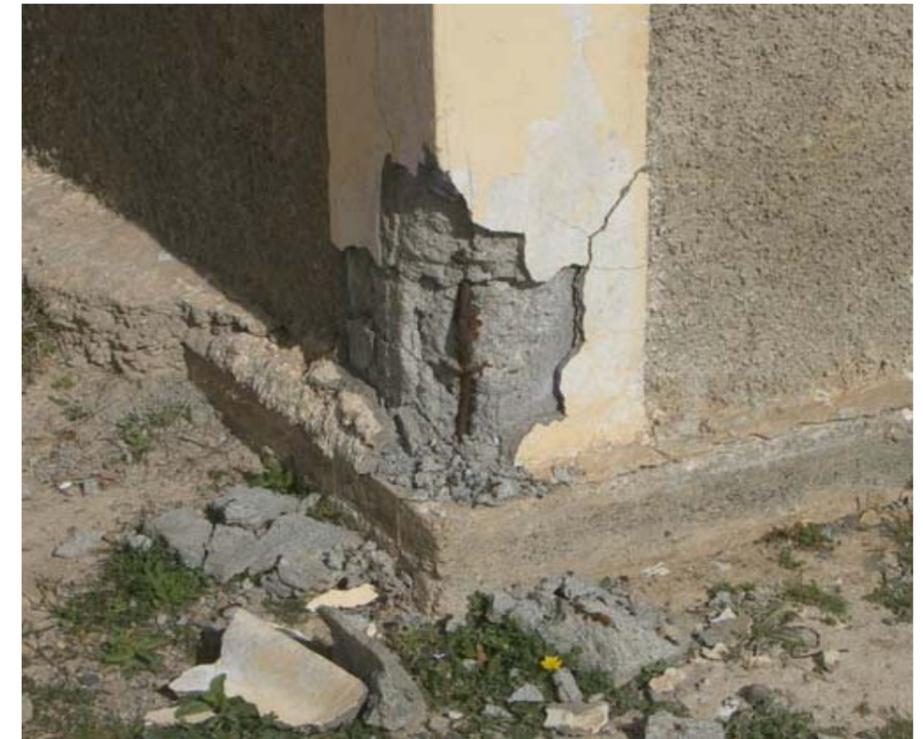
9.6.3 Spalling of concrete; the beginning of a plastic hinge.

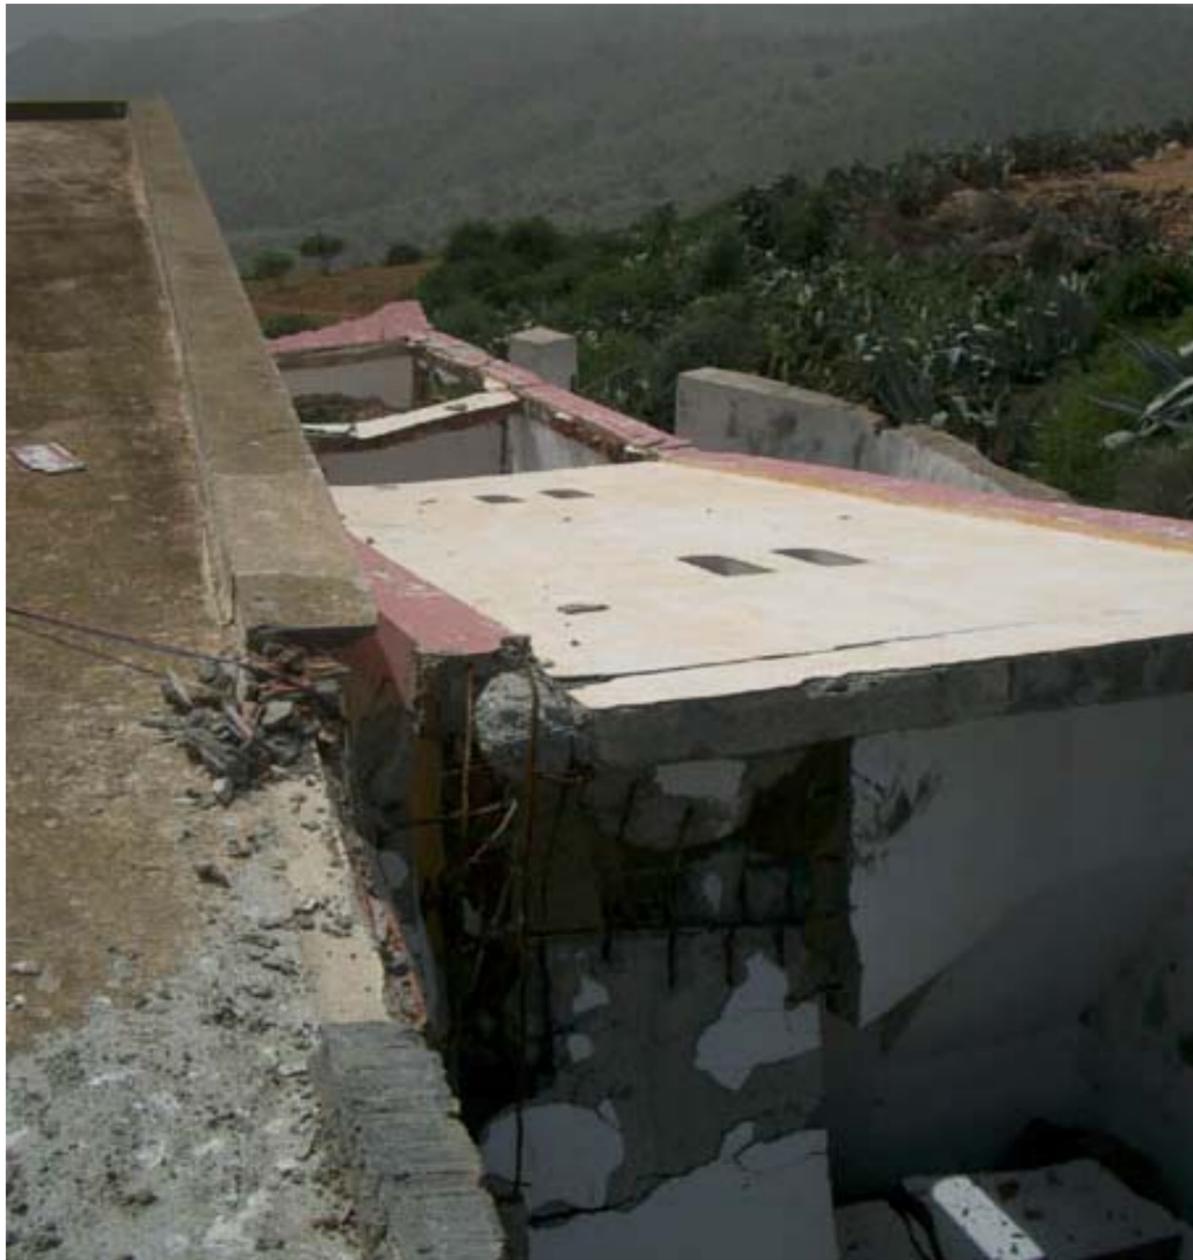
9.8.1 Toppling of a minarette in Ait Jamra. (grade 5 vulnerability C)

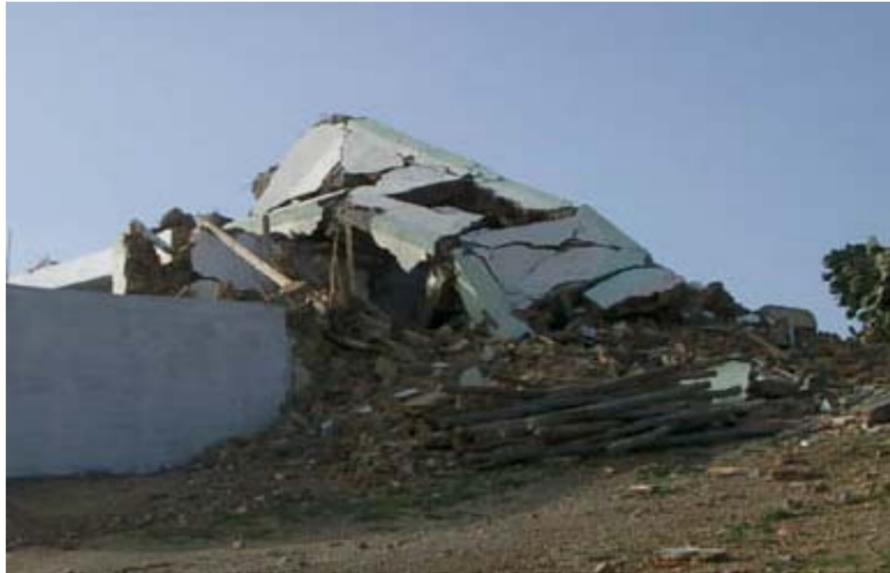
9.9.1 Front view of toppled minarette.

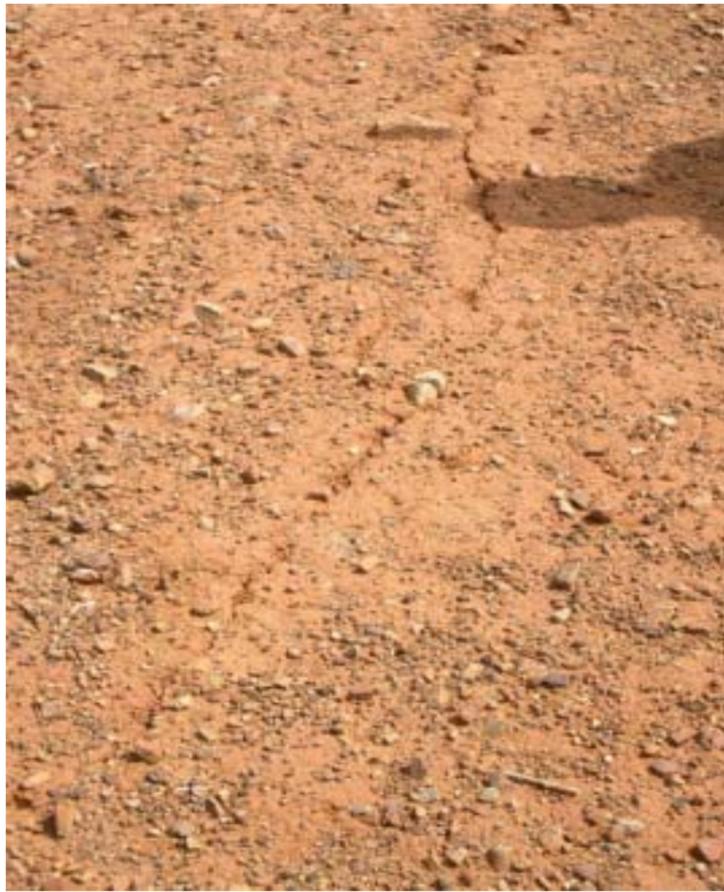
10.1.1 crack in level clay soil - Ait Jamra

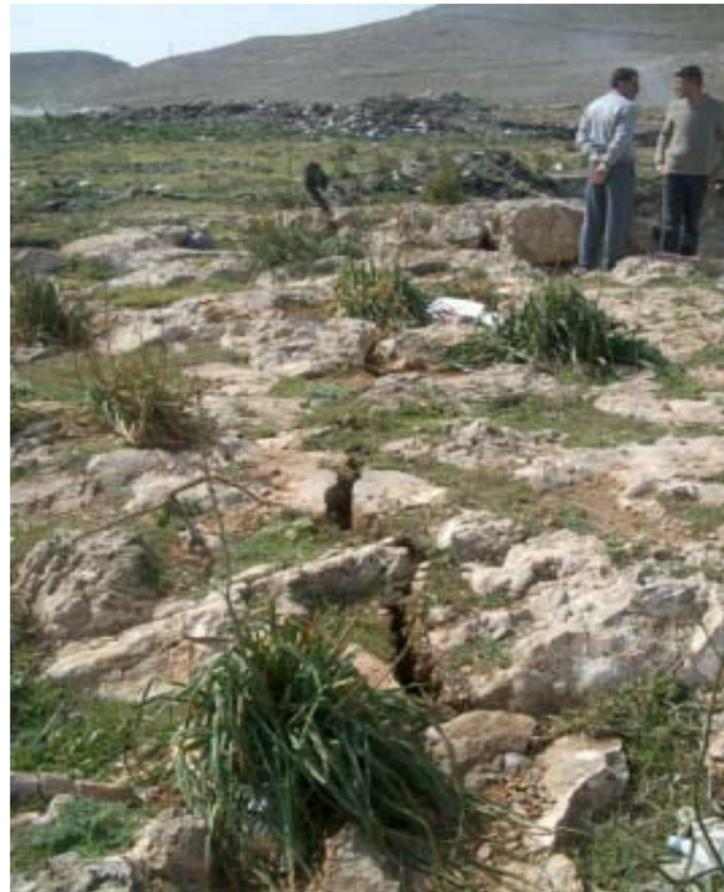
10.1.2 crack in limestone outcrop – Al-Hoceima

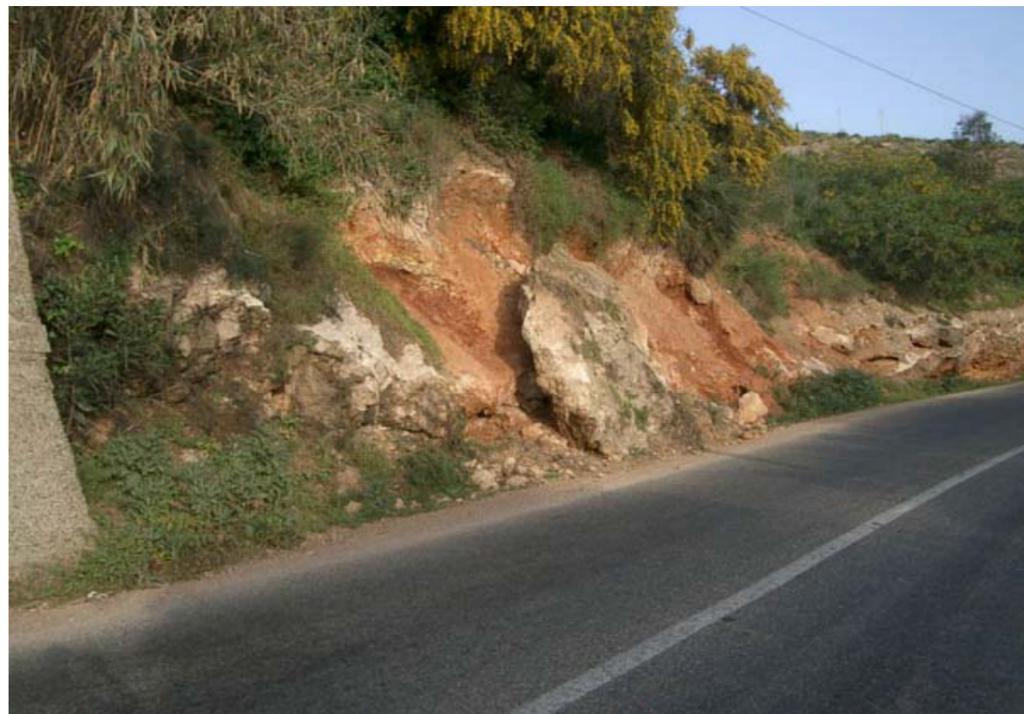
10.1.4 Rockfall on the Al-Hoceima - Ajdir road.

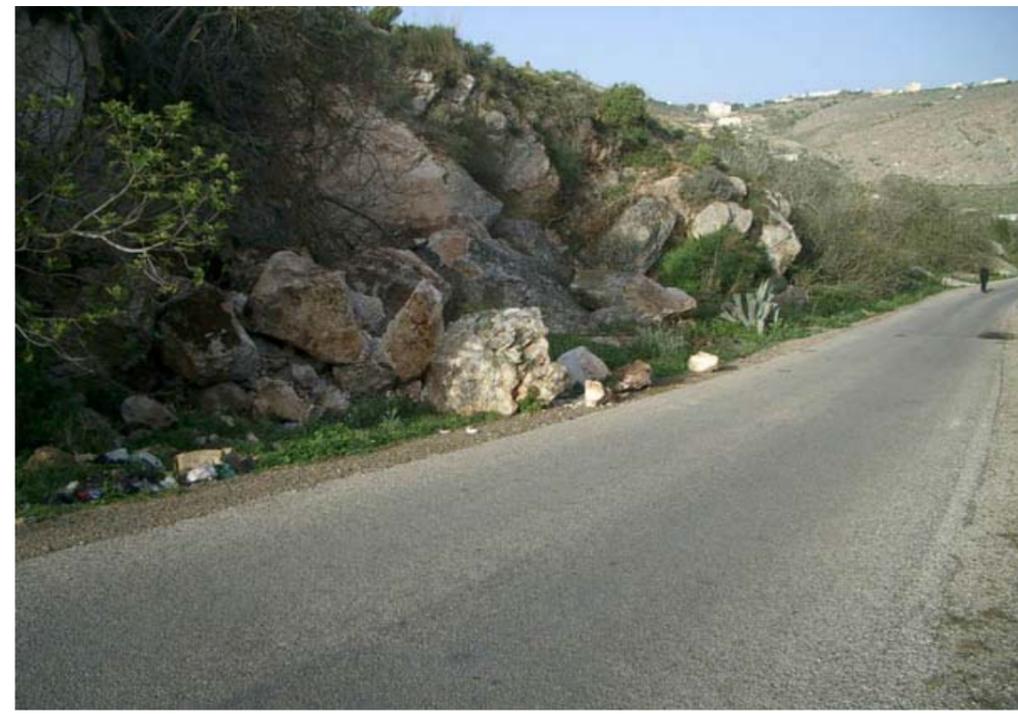
10.1.5 Rockfall on the Al-Hoceima coastal road.
